ORDINANCE

AN ORDINANCE ORDERING THE DEMOLITION AND REMOVAL OF THE DWELLING AT 5000 LAKEVIEW ROAD PURSUANT TO THE HOUSING CODE OF THE CITY OF CHARLOTTE AND ARTICLE 19, PART 6, CHAPTER 160A OF THE GENERAL STATUTES OF NORTH CAROLINA, SAID BUILDING BEING THE PROPERTY OF UNKNOWN HEIRS OF ROBERT D. HILL 5000 LAKEVIEW ROAD CHARLOTTE, NC 28216

5000 Lakeview Road

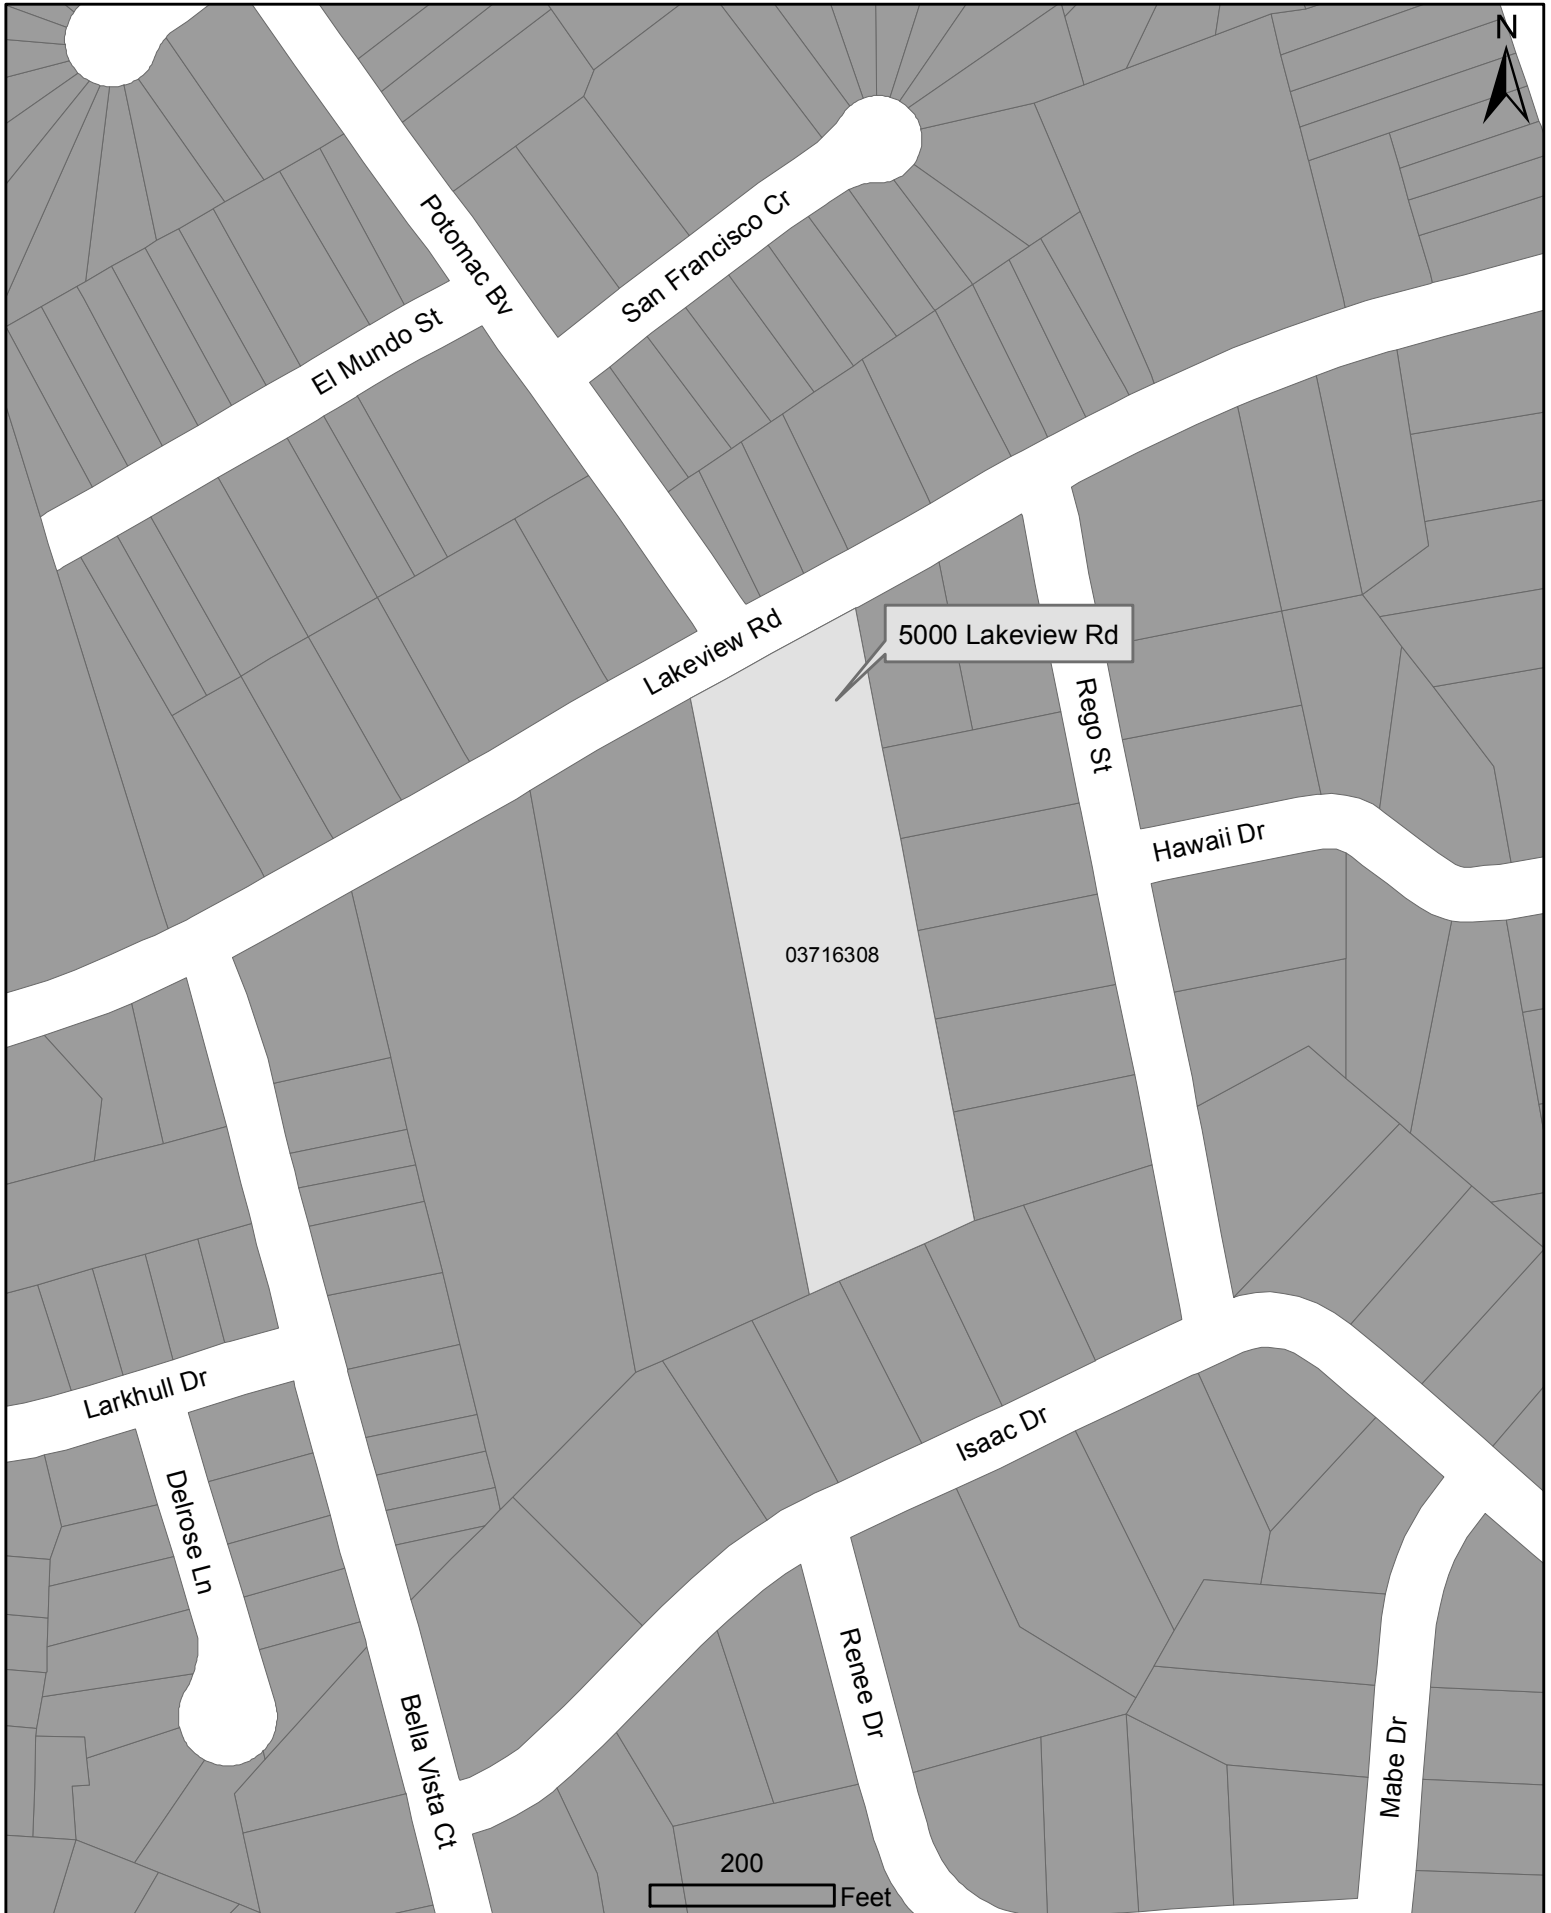
- New construction analysis shows that new construction is not feasible because the cost is prohibitive.
- Violations include: Structural, plumbing, electrical and heating violations: Walls and ceiling covering water damaged. Areas of subflooring missing. Decayed floor girder, joists and sill. Windows are inoperable. Decayed fascia (exterior trim). Areas of missing exterior siding. Roof covering damaged/loose. Roof sheathing decayed. Decayed roof rafters. Damaged plumbing fixtures. Damaged electrical wiring. Heating equipment and ductwork not maintained. Accessory building not in safe substantial condition.

RECOMMENDATION FOR DEMOLITION

- Estimated In-Rem Repair cost of: \$57,432 (\$62.35/sq. ft.), which is 201.51 % of the structure tax value, which is \$28,500.
- City rehab costs analysis shows that rehabilitation is not feasible because the cost is prohibitive.
