AN ORDINANCE ORDERING THE DEMOLITION AND REMOVAL OF THE DWELLING AT 4810 LAMONT DRIVE PURSUANT TO THE HOUSING CODE OF THE CITY OF CHARLOTTE AND ARTICLE 19, PART 6, CHAPTER 160A OF THE GENERAL STATUTES OF NORTH CAROLINA, SAID BUILDING BEING THE PROPERTY OF IRA D. STEWART 4810 LAMONT DRIVE CHARLOTTE, NC 28210

4810 Lamont Drive

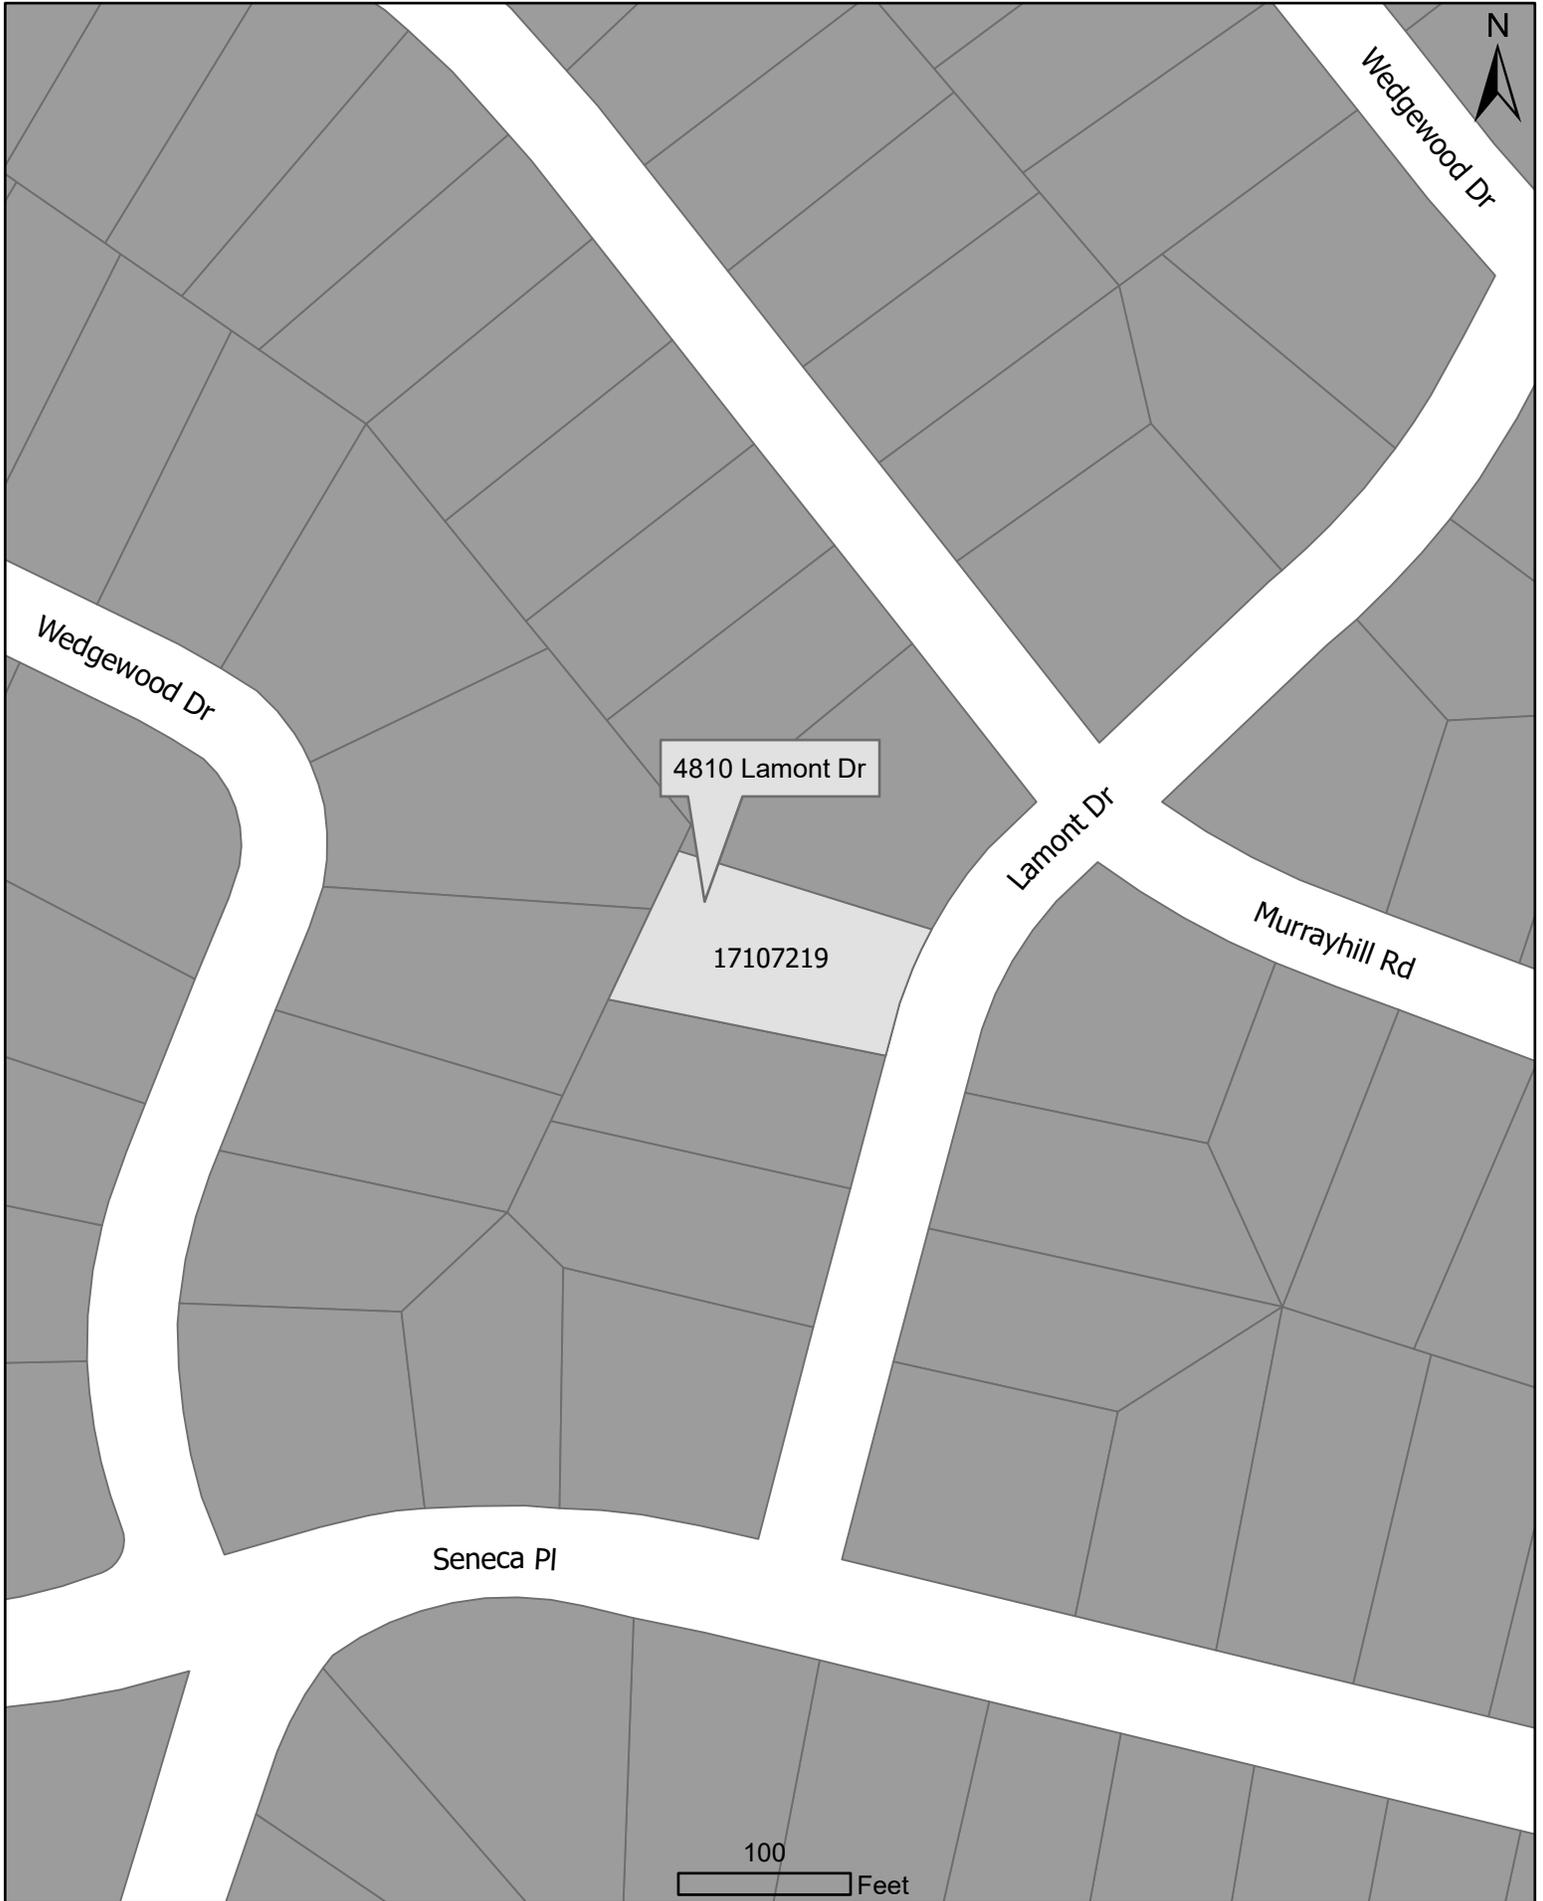
- City rehab costs analysis shows that rehabilitation is not feasible because the cost is prohibitive.
- New construction analysis shows that new construction is not feasible because the cost is prohibitive.
- Violations include: Structural, electrical, plumbing and heating violations. Ceiling and wall covering consists of moisture damaged throughout. Windows are inoperable throughout. Damaged entry doors. Areas of decayed exterior siding and trim. Damaged roof covering. Decayed roof sheathing. Damaged plumbing fixtures. Heating equipment not operational. Accessory building not in safe substantial condition.
- The building is 65 years old and consists of 2,055 square feet total.
- A new 2,055 sq. ft. structure can be built for \$141,795.

Demolition is recommended because:
