AN ORDINANCE ORDERING THE DEMOLITION AND REMOVAL OF THE DWELLING AT 9413 SPRUCE PINE PLACE PURSUANT TO THE HOUSING CODE OF THE CITY OF CHARLOTTE AND ARTICLE 19, PART 6, CHAPTER 160A OF THE GENERAL STATUTES OF NORTH CAROLINA, SAID BUILDING BEING THE PROPERTY OF ALBERT YOUNG 9413 SPRUCE PINE PLACE CHARLOTTE NC 28210

9413 Spruce Pine Place

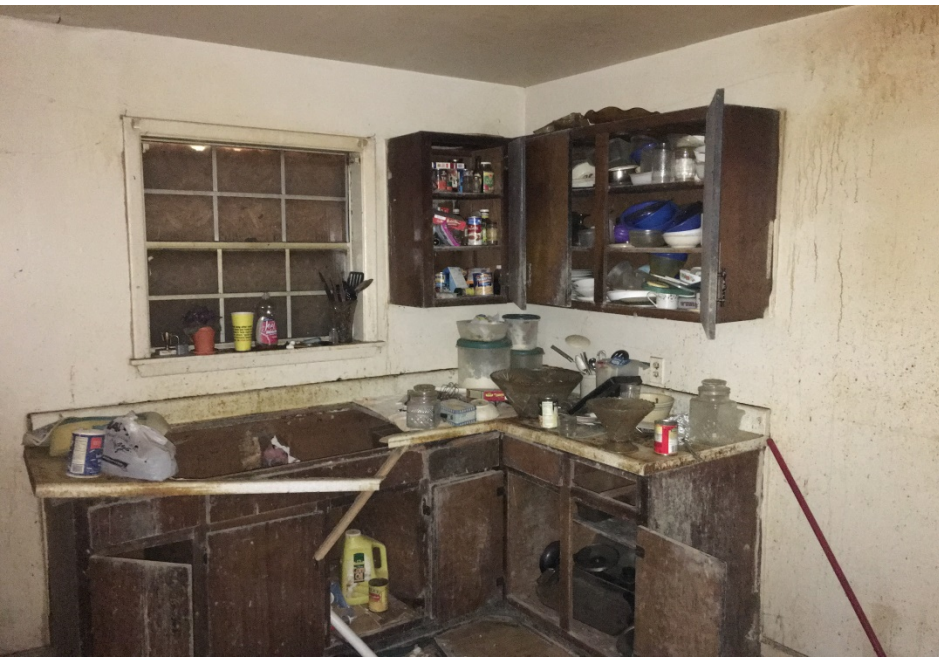
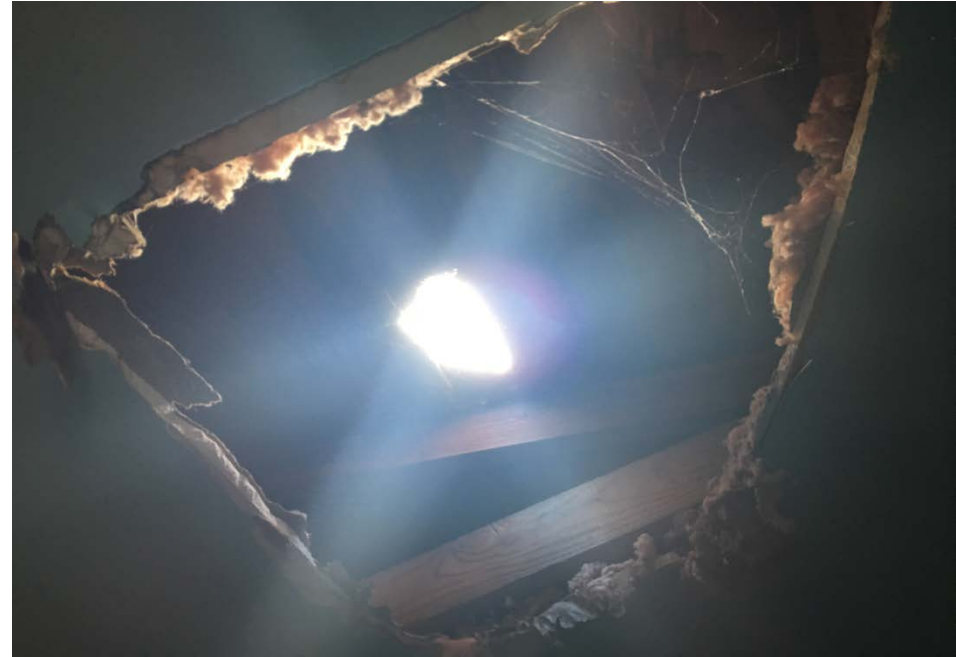
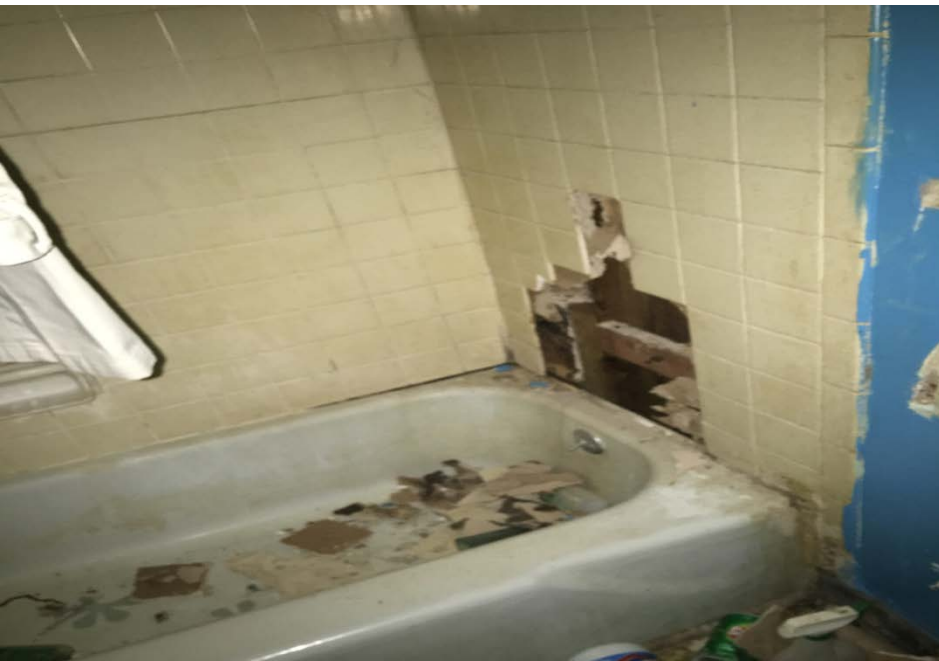
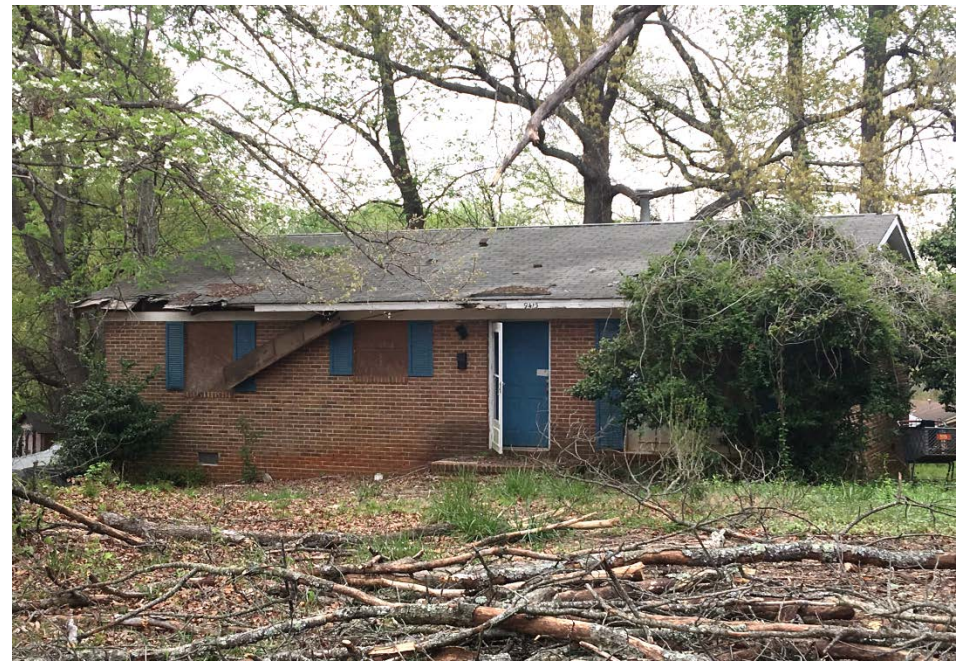
9413 Spruce Pine Place

- City rehab costs analysis shows that rehabilitation is not feasible because the cost is prohibitive.
- New construction analysis shows that new construction is not feasible because the cost is prohibitive.
- Violations include: Structural, electrical, plumbing and heating violations. Moisture damaged walls and ceiling covering. Windows are inoperable. Missing smoke and carbon monoxide detectors. Areas of roof sheathing not structurally sound. Roof covering loose/damaged. Damaged electrical fixtures. Missing plumbing fixtures. Heating equipment not operational.
- The building is 45 years old and consists of 1,014 square feet total.
- A new 1,014 sq. ft. structure can be built for \$69,966.

RECOMMENDATION FOR DEMOLITION
