AN ORDINANCE ORDERING THE DEMOLITION AND REMOVAL OF THE DWELLING AT 2000 PURSER DRIVE PURSUANT TO THE HOUSING CODE OF THE CITY OF CHARLOTTE AND ARTICLE 19, PART 6, CHAPTER 160A OF THE GENERAL STATUTES OF NORTH CAROLINA, SAID BUILDING BEING THE PROPERTY OF RBP INVESTMENTS, LLC PO BOX 11113 CHARLOTE, NC 28220.

2000 Purser Drive

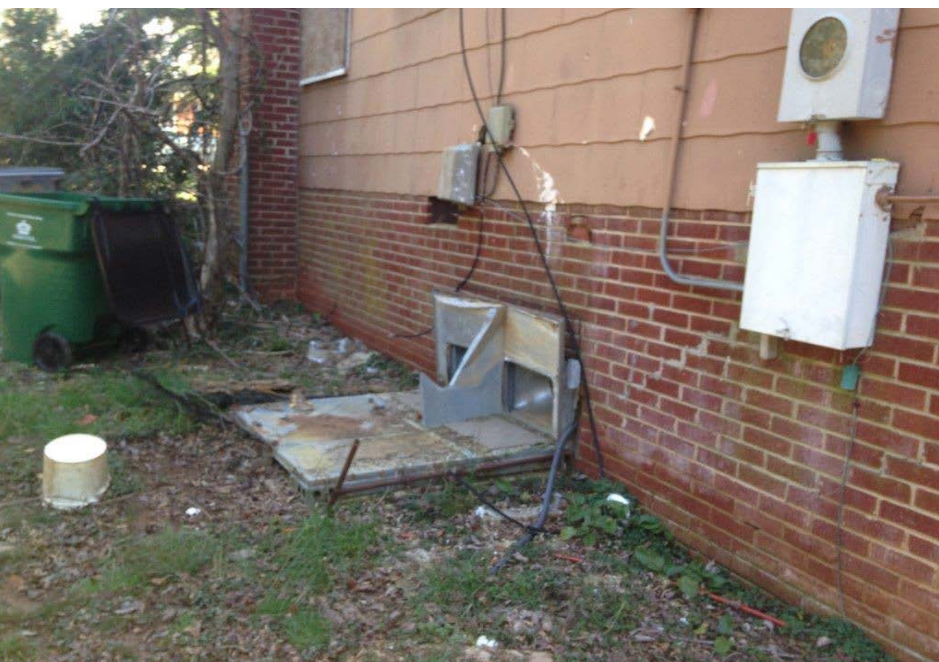
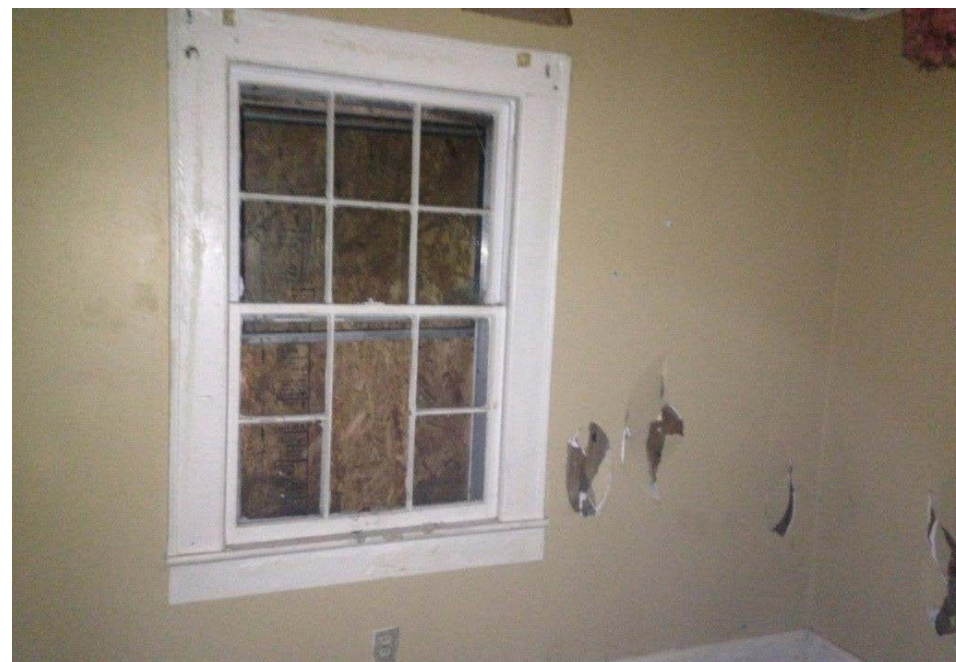
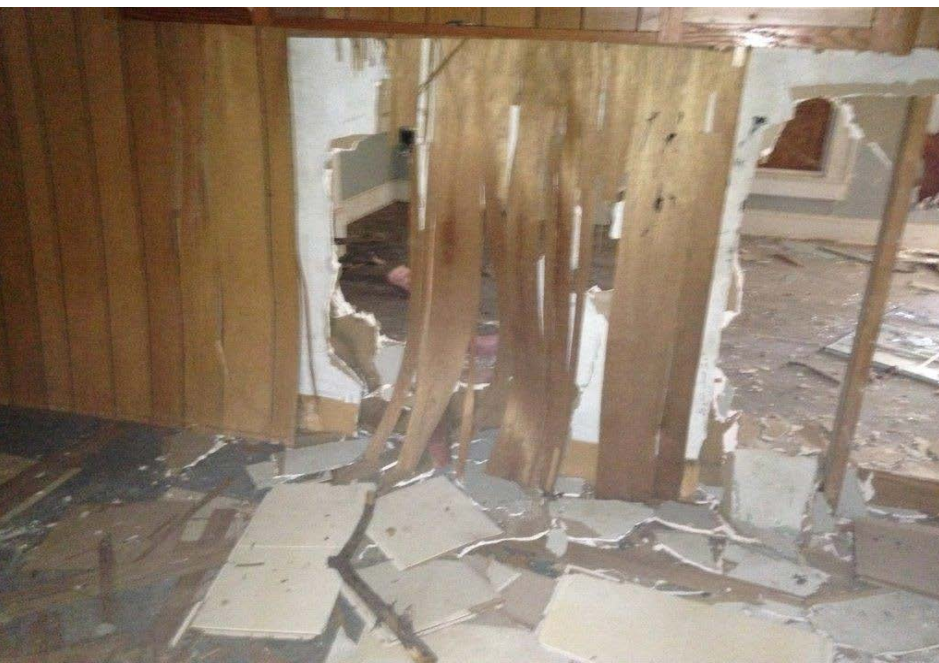
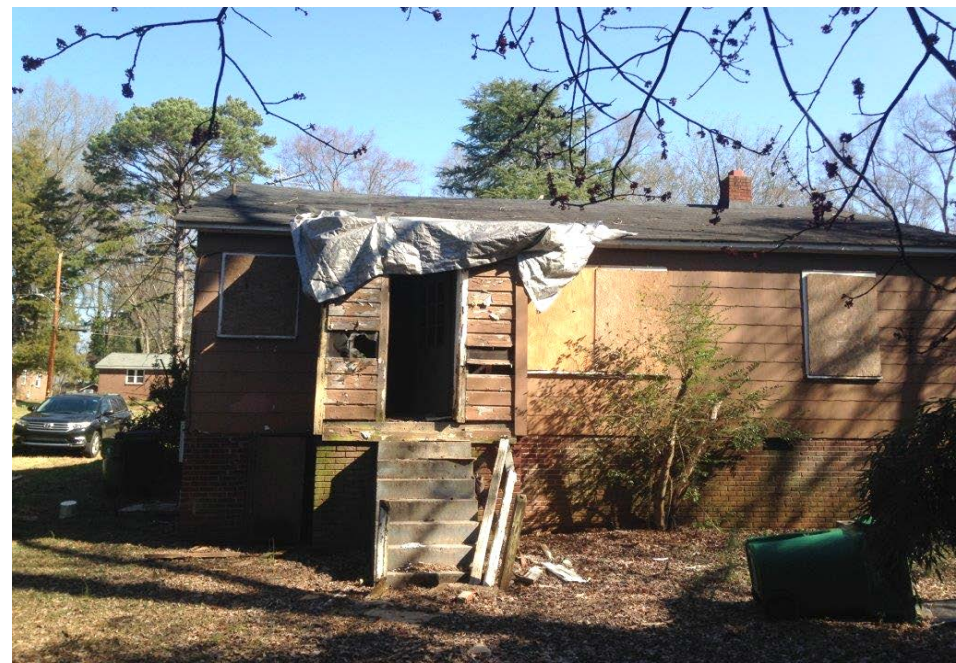
2000 Purser Drive

- City rehab costs analysis shows that rehabilitation is not feasible because the cost is prohibitive.
- New construction analysis shows that new construction is not feasible because the cost is prohibitive.
- Violations include: Structural, electrical, plumbing and heating violations. Holes in walls and ceiling covering. Multiple broken window glass. Missing smoke and carbon monoxide detectors. Utility room areas of roof sheathing not structurally sound, roof covering loose/damaged. Sections of electrical wiring missing/cut. Missing plumbing fixtures. Heating equipment not present.
- The building is 66 years old and consists of 1,227 square feet total.
- A new 1,227 sq. ft. structure can be built for \$84,663.

Demolition is recommended because:
