ORDINANCE

AN ORDINANCE ORDERING THE DEMOLITION AND REMOVAL OF THE DWELLING AT 10620 INDEPENDENCE HILL ROAD PURSUANT TO THE HOUSING CODE OF THE CITY OF CHARLOTTE AND ARTICLE 19, PART 6, CHAPTER 160A OF THE GENERAL STATUTES OF NORTH CAROLINA, SAID BUILDING BEING THE PROPERTY OF KNOWN AND UNKNOWN HEIRS OF DORIS MOORE MAXWELL, KNOWN AND UNKNOWN HEIRS OF RICHARD BENJAMIN MAXWELL, DORIS MOORE MAXWELL TRUST, CATHERINE JANE MAXWELL, THOMAS M. MAXWELL, THERESIA H. MAXWELL, IAN ALEXANDER MAXWELL TRUST, JOHN K. MAXWELL, SANDRA R. MAXWELL, OLIVER KIMBLE MAXWELL TRUST, EDISON KIMBLE MAXWELL TRUST 3141 BUTTER CHURN LANE MATTHEWS, NC 28105

GENERAL INFORMATION	
Property Address	10620 Independence Hill Road
Neighborhood	Neighborhood Profile Area 277
Council District	Mecklenburg County / Unincorporated
Owner(s)	Known and Unknown Heirs of Doris Maxwell Moore, Known and Unknown Heirs of Richard Benjamin Maxwell, Catherine Jane Maxwell, Thomas M. Maxwell, Theresia H. Maxwell, Ian Alexander Maxwell Trust, John K. Maxwell, Sandra R. Maxwell, Oliver Kimble Maxwell Trust, Edison Kimble Maxwell Trust
Owner(s) Address	3141 Butter Churn Lane Matthews, NC 28105
KEY FACTS	
Focus Area	Housing & Neighborhood De

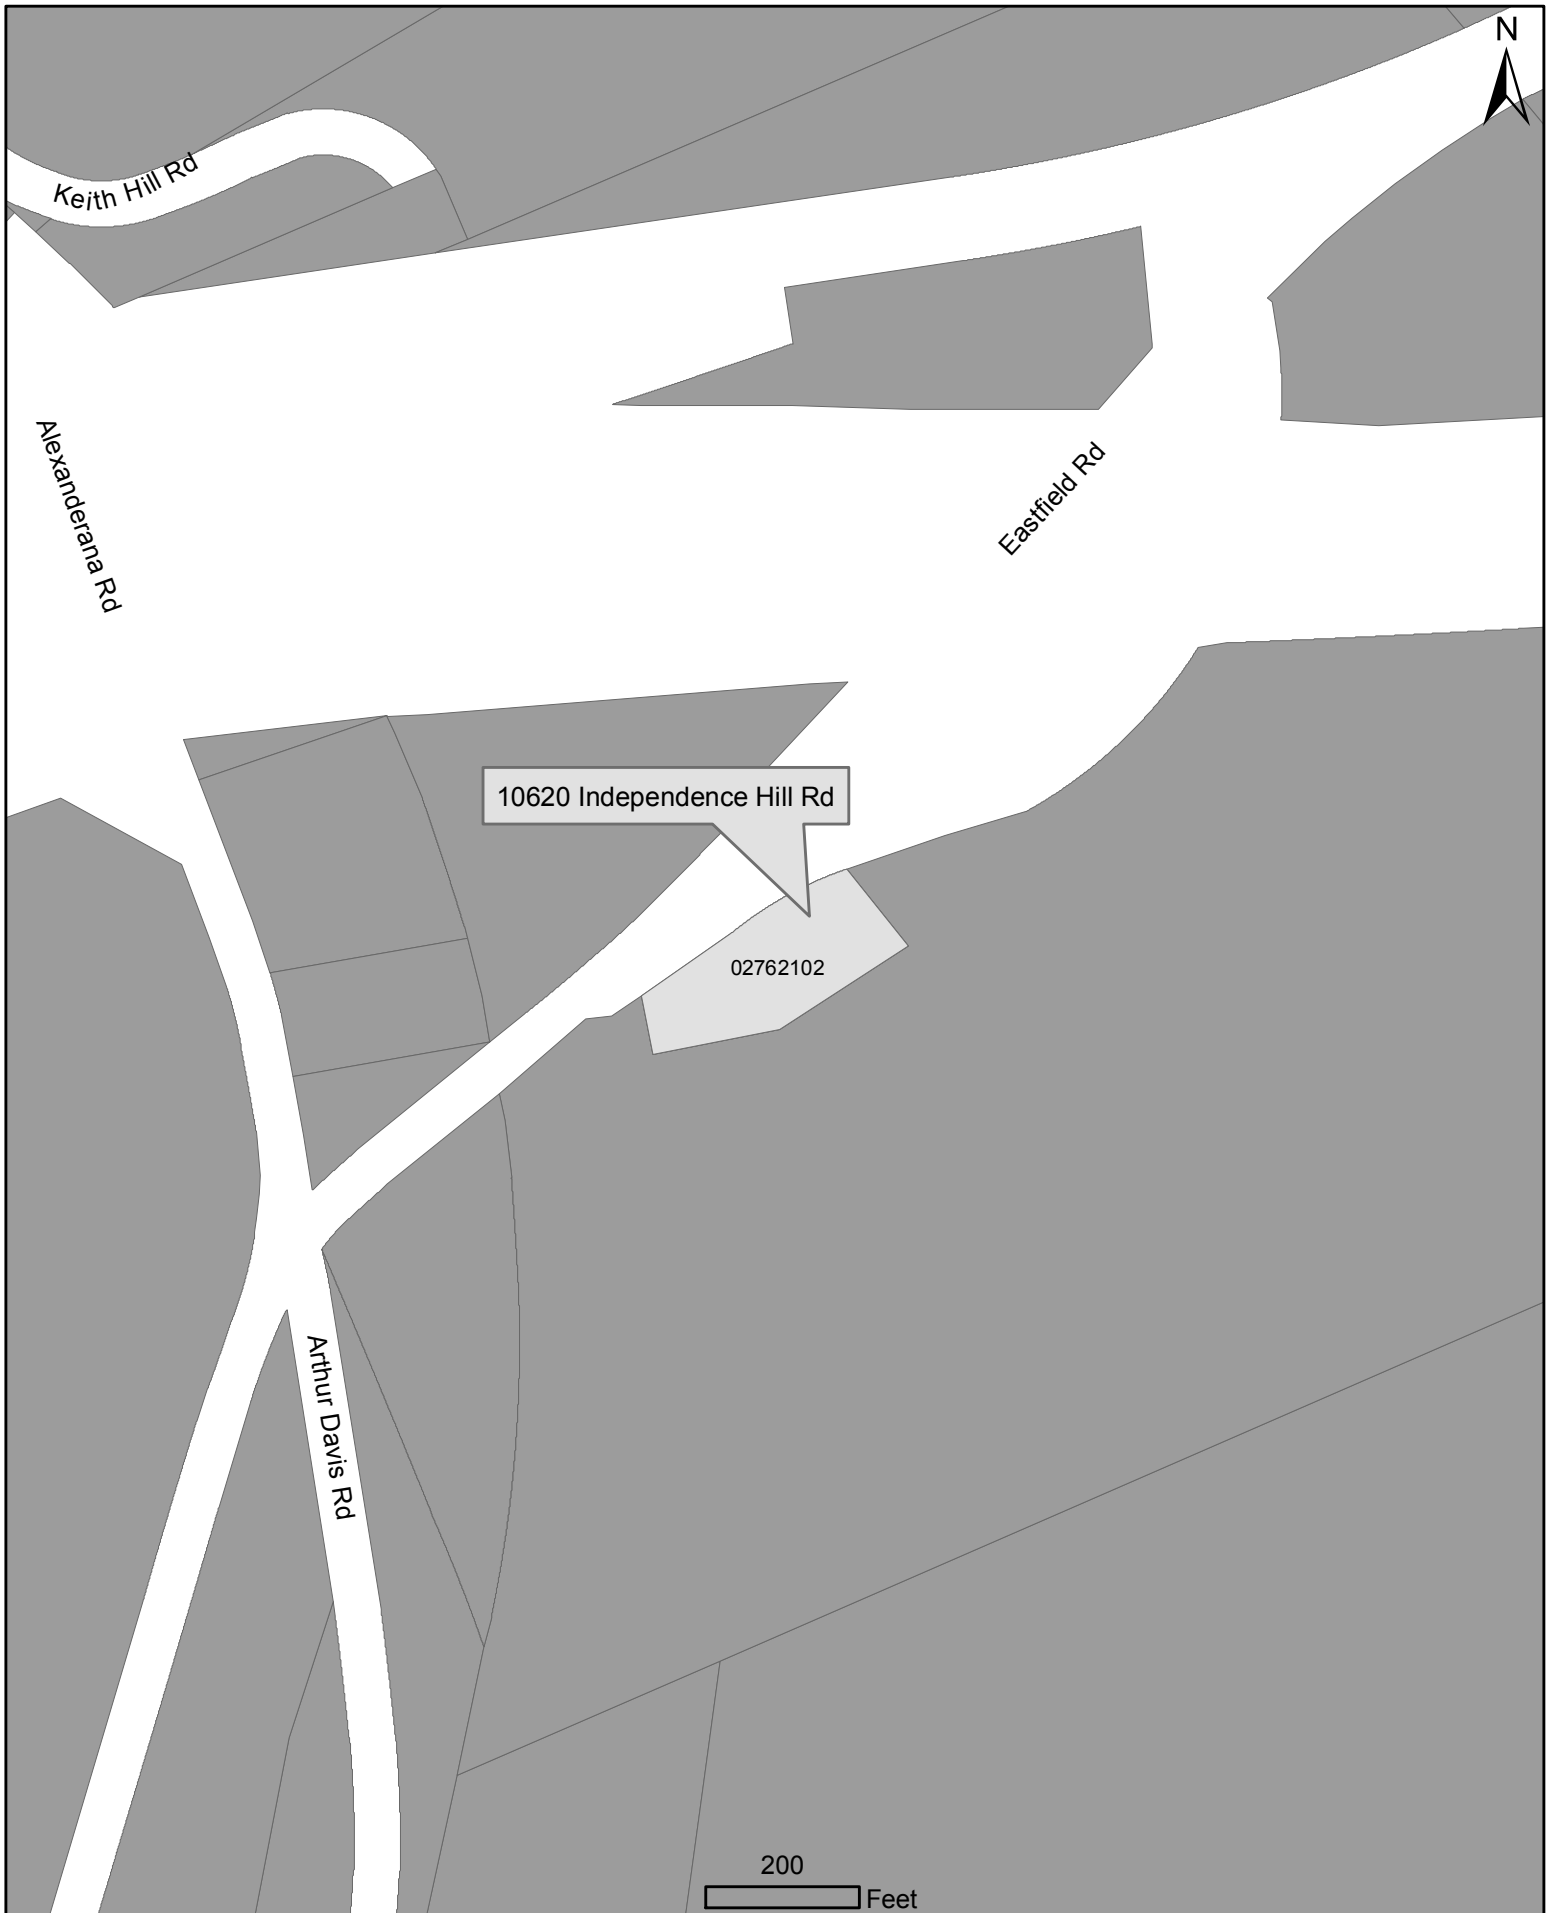
10620 Independence Hill Road

- City rehab costs analysis shows that rehabilitation is not feasible because the cost is prohibitive.
- New construction analysis shows that new construction is not feasible because the cost is prohibitive.
- Violations include: Structural, electrical, plumbing and heating violations. Missing walls and ceiling covering throughout. Holes/Openings in flooring. Decayed floor joists. Roof covering damaged/loose. Roof sheathing decayed. Roof rafters broken/decayed. Damaged electrical fixtures. Missing plumbing fixtures. Damaged supply and drain piping. Heating ductwork damaged.
- The building is 67 years old and consists of 2,127 square feet total.
- A new 2,127 sq. ft. structure can be built for \$146,763.
