AN ORDINANCE ORDERING THE DEMOLITION AND REMOVAL OF THE DWELLING AT 2029 QUEENS ROAD EAST PURSUANT TO THE HOUSING CODE OF THE CITY OF CHARLOTTE AND ARTICLE 19, PART 6, CHAPTER 160A OF THE GENERAL STATUTES OF NORTH CAROLINA, SAID BUILDING BEING THE PROPERTY OF ALAN CRAIG SHELTON 2131 CUMBERLAND AVENUE CHARLOTTE, NC 28203.

2029 Queens Road East

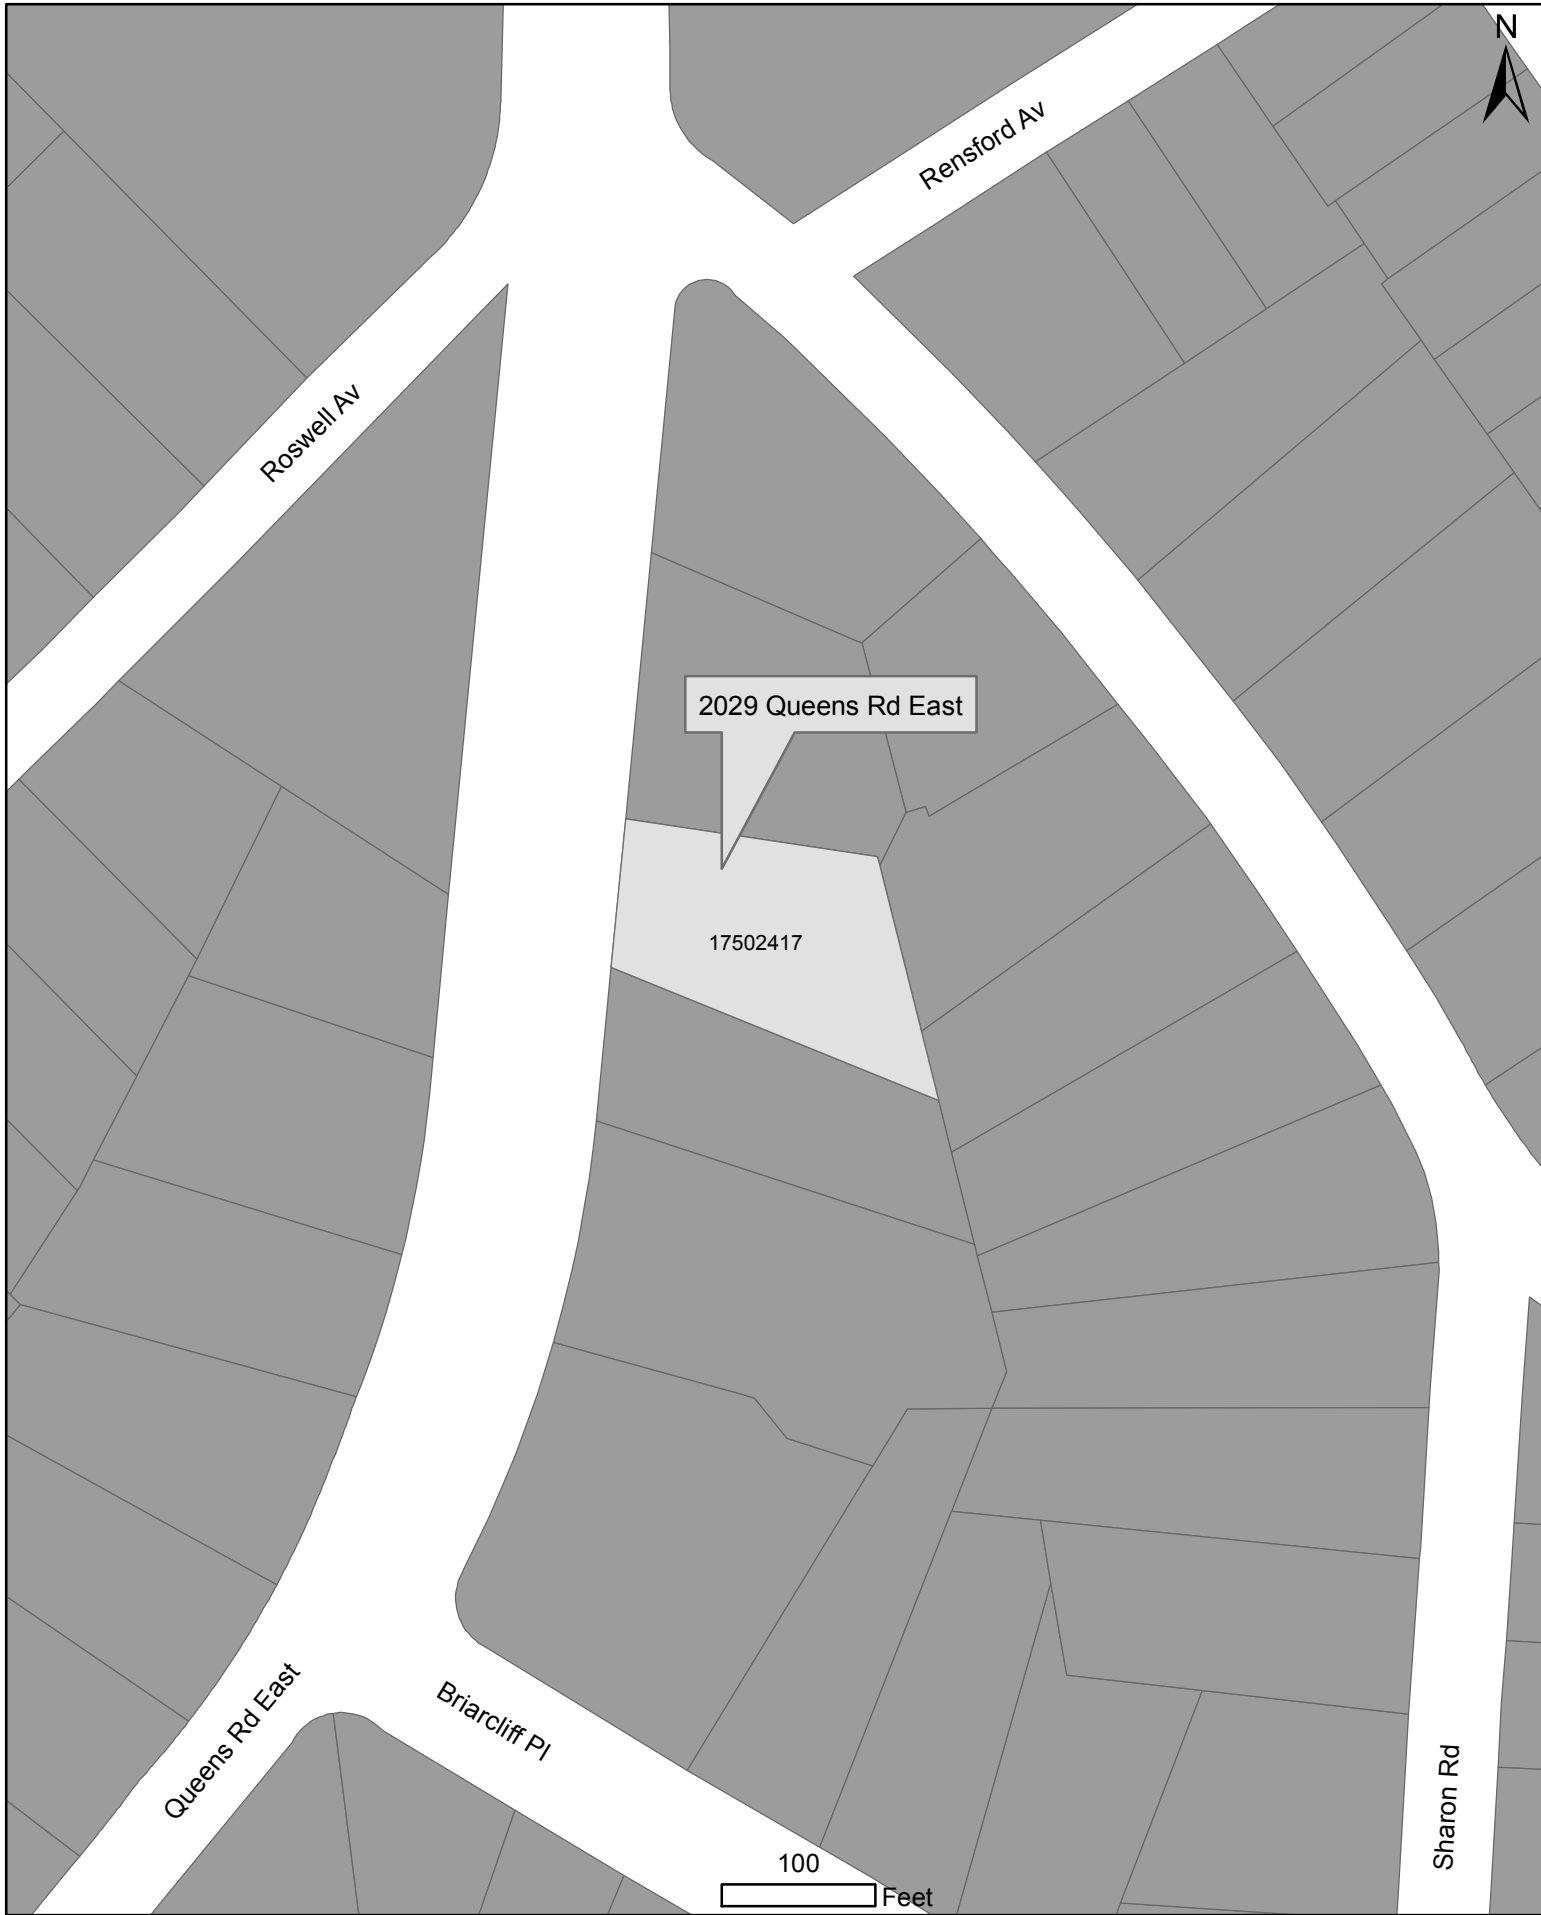
- Violations include: Structural, electrical, plumbing and heating violations. Walls, floor and ceiling covering unclean/unsanitary. Holes/cracks in finish of ceiling material. Decayed floor joists. Damaged entry doors. Exterior siding and trim decayed. Loose and decayed stair treads. Loose and damaged roof covering. Areas of decayed roof sheathing. Unsafe electrical wiring. Damaged electrical breaker box. No potable water supply. Heating equipment not operational. Loose and damaged roof covering. Areas of decayed roof sheathing. Accessory building (detached garage) not in safe substantial condition.

RECOMMENDATION FOR DEMOLITION

Demolition is recommended because:
