## ORDINANCE

AN ORDINANCE ORDERING THE DEMOLITION AND REMOVAL OF THE DWELLING AT 501 FRANK DRIVE PURSUANT TO THE HOUSING CODE OF THE CITY OF CHARLOTTE AND ARTICLE 19, PART 6, CHAPTER 160A OF THE GENERAL STATUTES OF NORTH CAROLINA, SAID BUILDING BEING THE PROPERTY OF KNOWN AND UNKNOWN HEIRS OF MAXWELL JAMES KIRKLAND, KNOWN AND UNKNOWN HEIRS OF LOIS MARIE C. KIRKLAND 501 FRANK DRIVE CHARLOTTE, NC 28215

# 501 Frank Drive

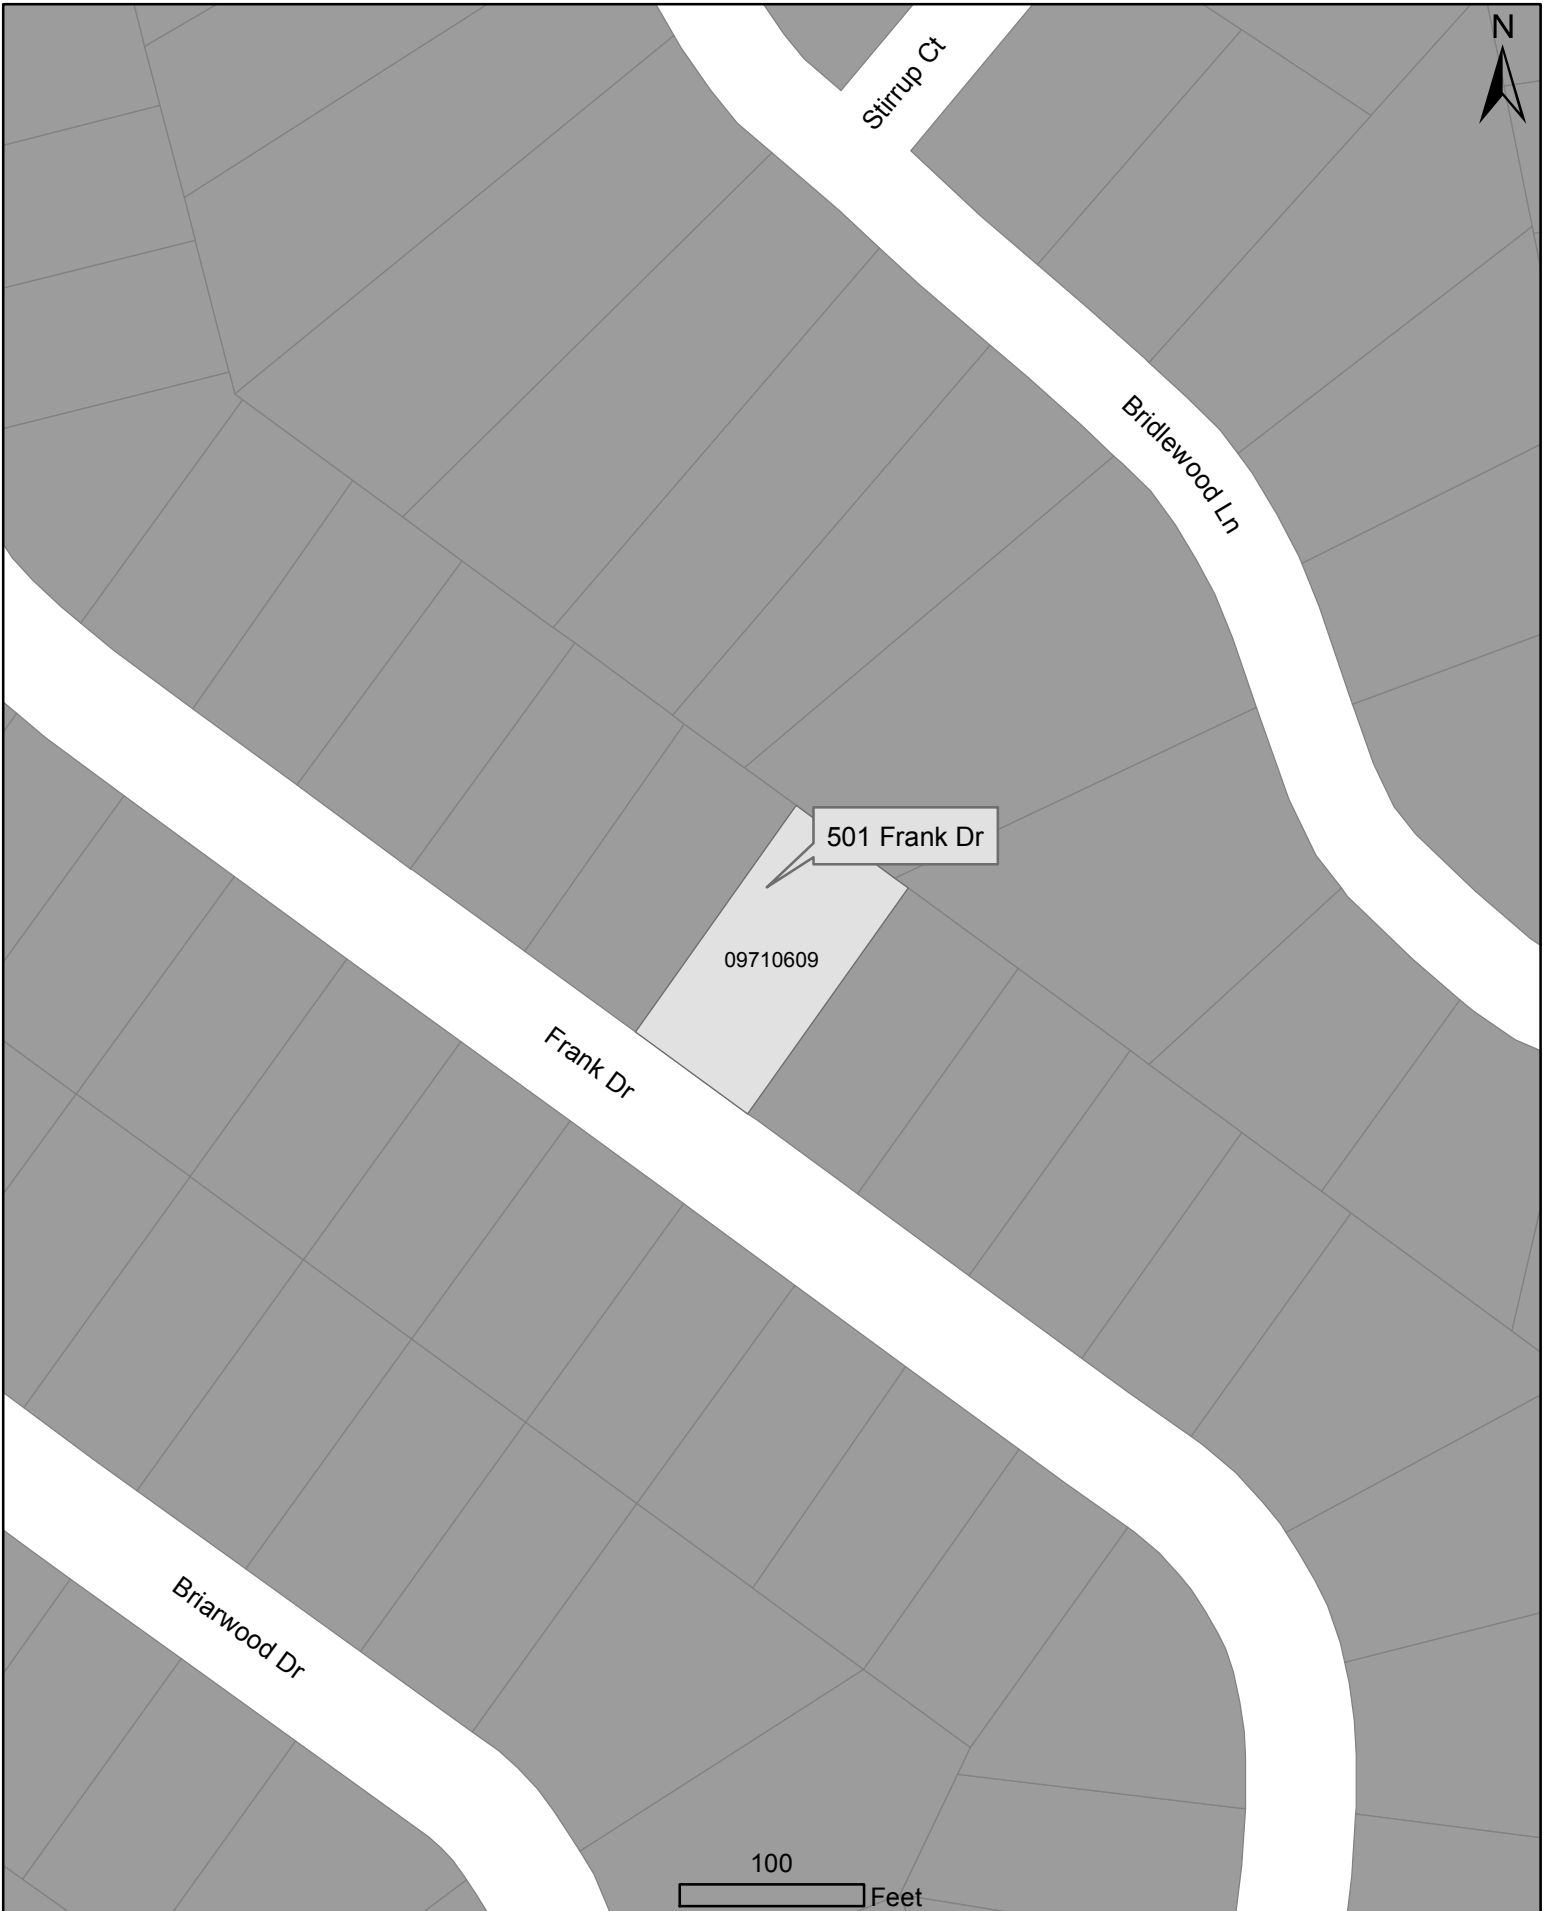
- New construction analysis shows that new construction is not feasible because the cost is prohibitive.
- Violations include: Structural, electrical, plumbing and heating violations: Flooring and sub-structure is loose, rotted, or missing in several places. Walls and ceiling covering moisture damaged. Decayed wall studs. Damaged entry door. Carbon monoxide and smoke detectors missing. Roof covering loose/damaged. Decayed roof sheathing and rafters. Missing and damaged electrical receptacles and switches. Damaged water heater. No heat source provided.

- Estimated In-Rem Repair cost of: \$64,910 (\$49.93 /sq. ft.), which is 115.293% of the structure tax value, which is \$56,300.
- City rehab costs analysis shows that rehabilitation is not feasible because the cost is prohibitive.
