**Designation Report  
On The  
William H. Peeps House**

1. **Name and Location of the Property.** The property known as the William H. Peeps House is located at 831 East Worthington Avenue, Charlotte, NC 28203-5351.

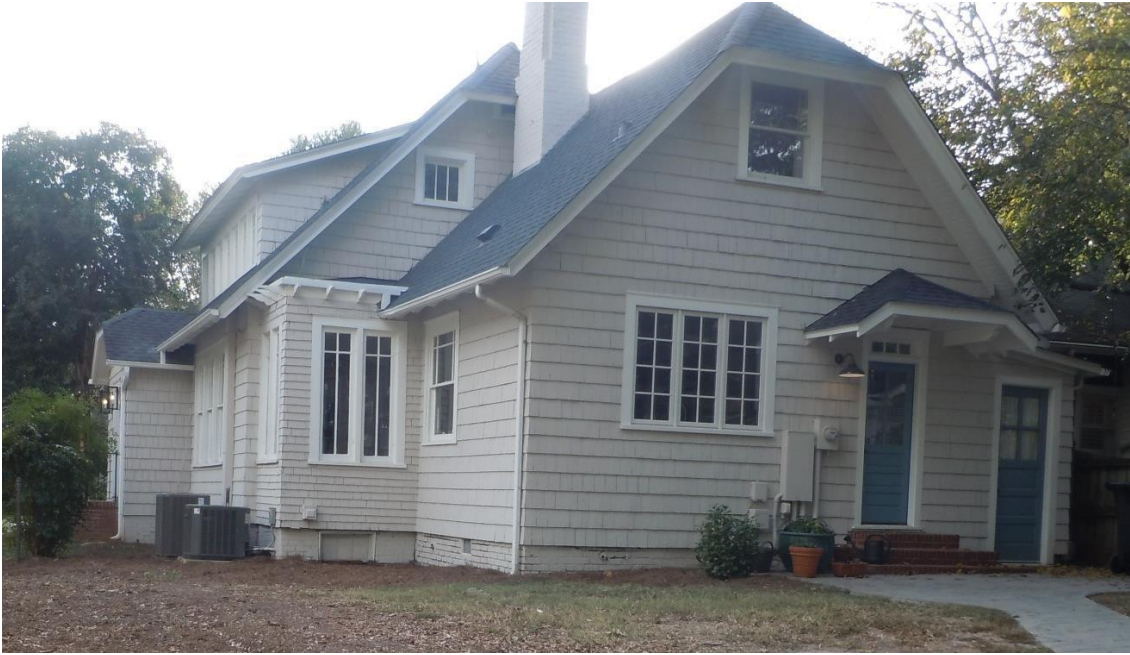
*Rear elevation (top); west elevation (bottom)*

- 5) At the rear elevation, the kitchen windows are replaced with a triple unit of eight pane casements. A clipped hip horizontal bracketed canopy is added over the door and brick steps.
