ORDINANCE

AN ORDINANCE ORDERING THE DEMOLITION AND REMOVAL OF THE DWELLING AT 905 AILEEN CIRCLE PURSUANT TO THE HOUSING CODE OF THE CITY OF CHARLOTTE AND ARTICLE 19, PART 6, CHAPTER 160A OF THE GENERAL STATUTES OF NORTH CAROLINA, SAID BUILDING BEING THE PROPERTY OF UNKNOWN HEIRS OF IRA B. LAUDERDALE 905 AILEEN CIRCLE PINEVILLE, NC 28134

905 Aileen Circle

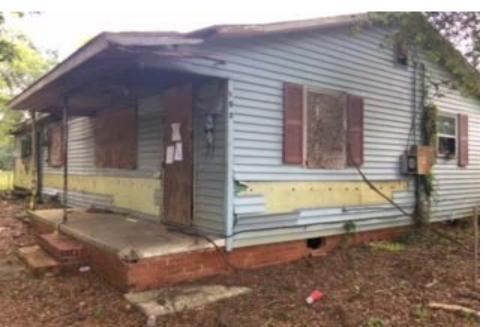
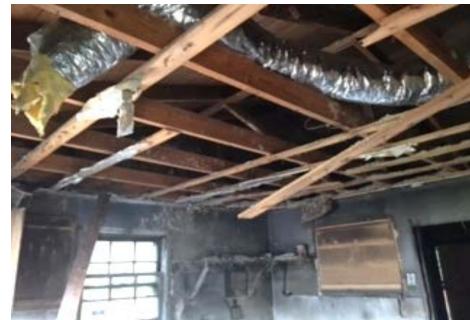
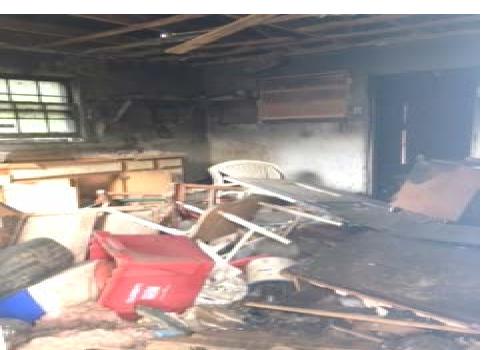
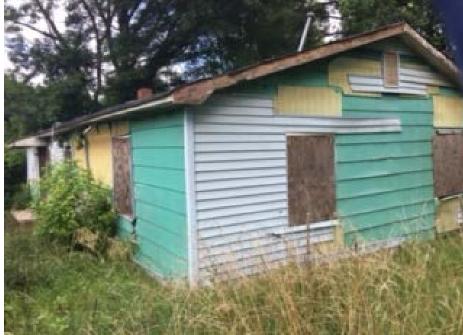
905 Aileen Circle

- City rehab costs analysis shows that rehabilitation is not feasible because the cost is prohibitive.
- New construction analysis shows that new construction is not feasible because the cost is prohibitive.
- Violations include: Structural, plumbing, electrical and heating violations: Wall framing not structurally sound. Interior walls and ceiling covering missing. Decayed window sills. Missing areas of exterior siding and trim. Damaged entry doors. Damaged plumbing fixtures. Cut/damaged electrical wiring. Heating equipment missing.
- The building is 59 years old and consists of 1,048 square feet total.
- A new 1,048 sq. ft. structure can be built for \$72,312.

Demolition is recommended because:
