Addendum to the Survey and Research Report for Hennigan Place

HENNIGAN PLACE

This report was written on November 7, 1979

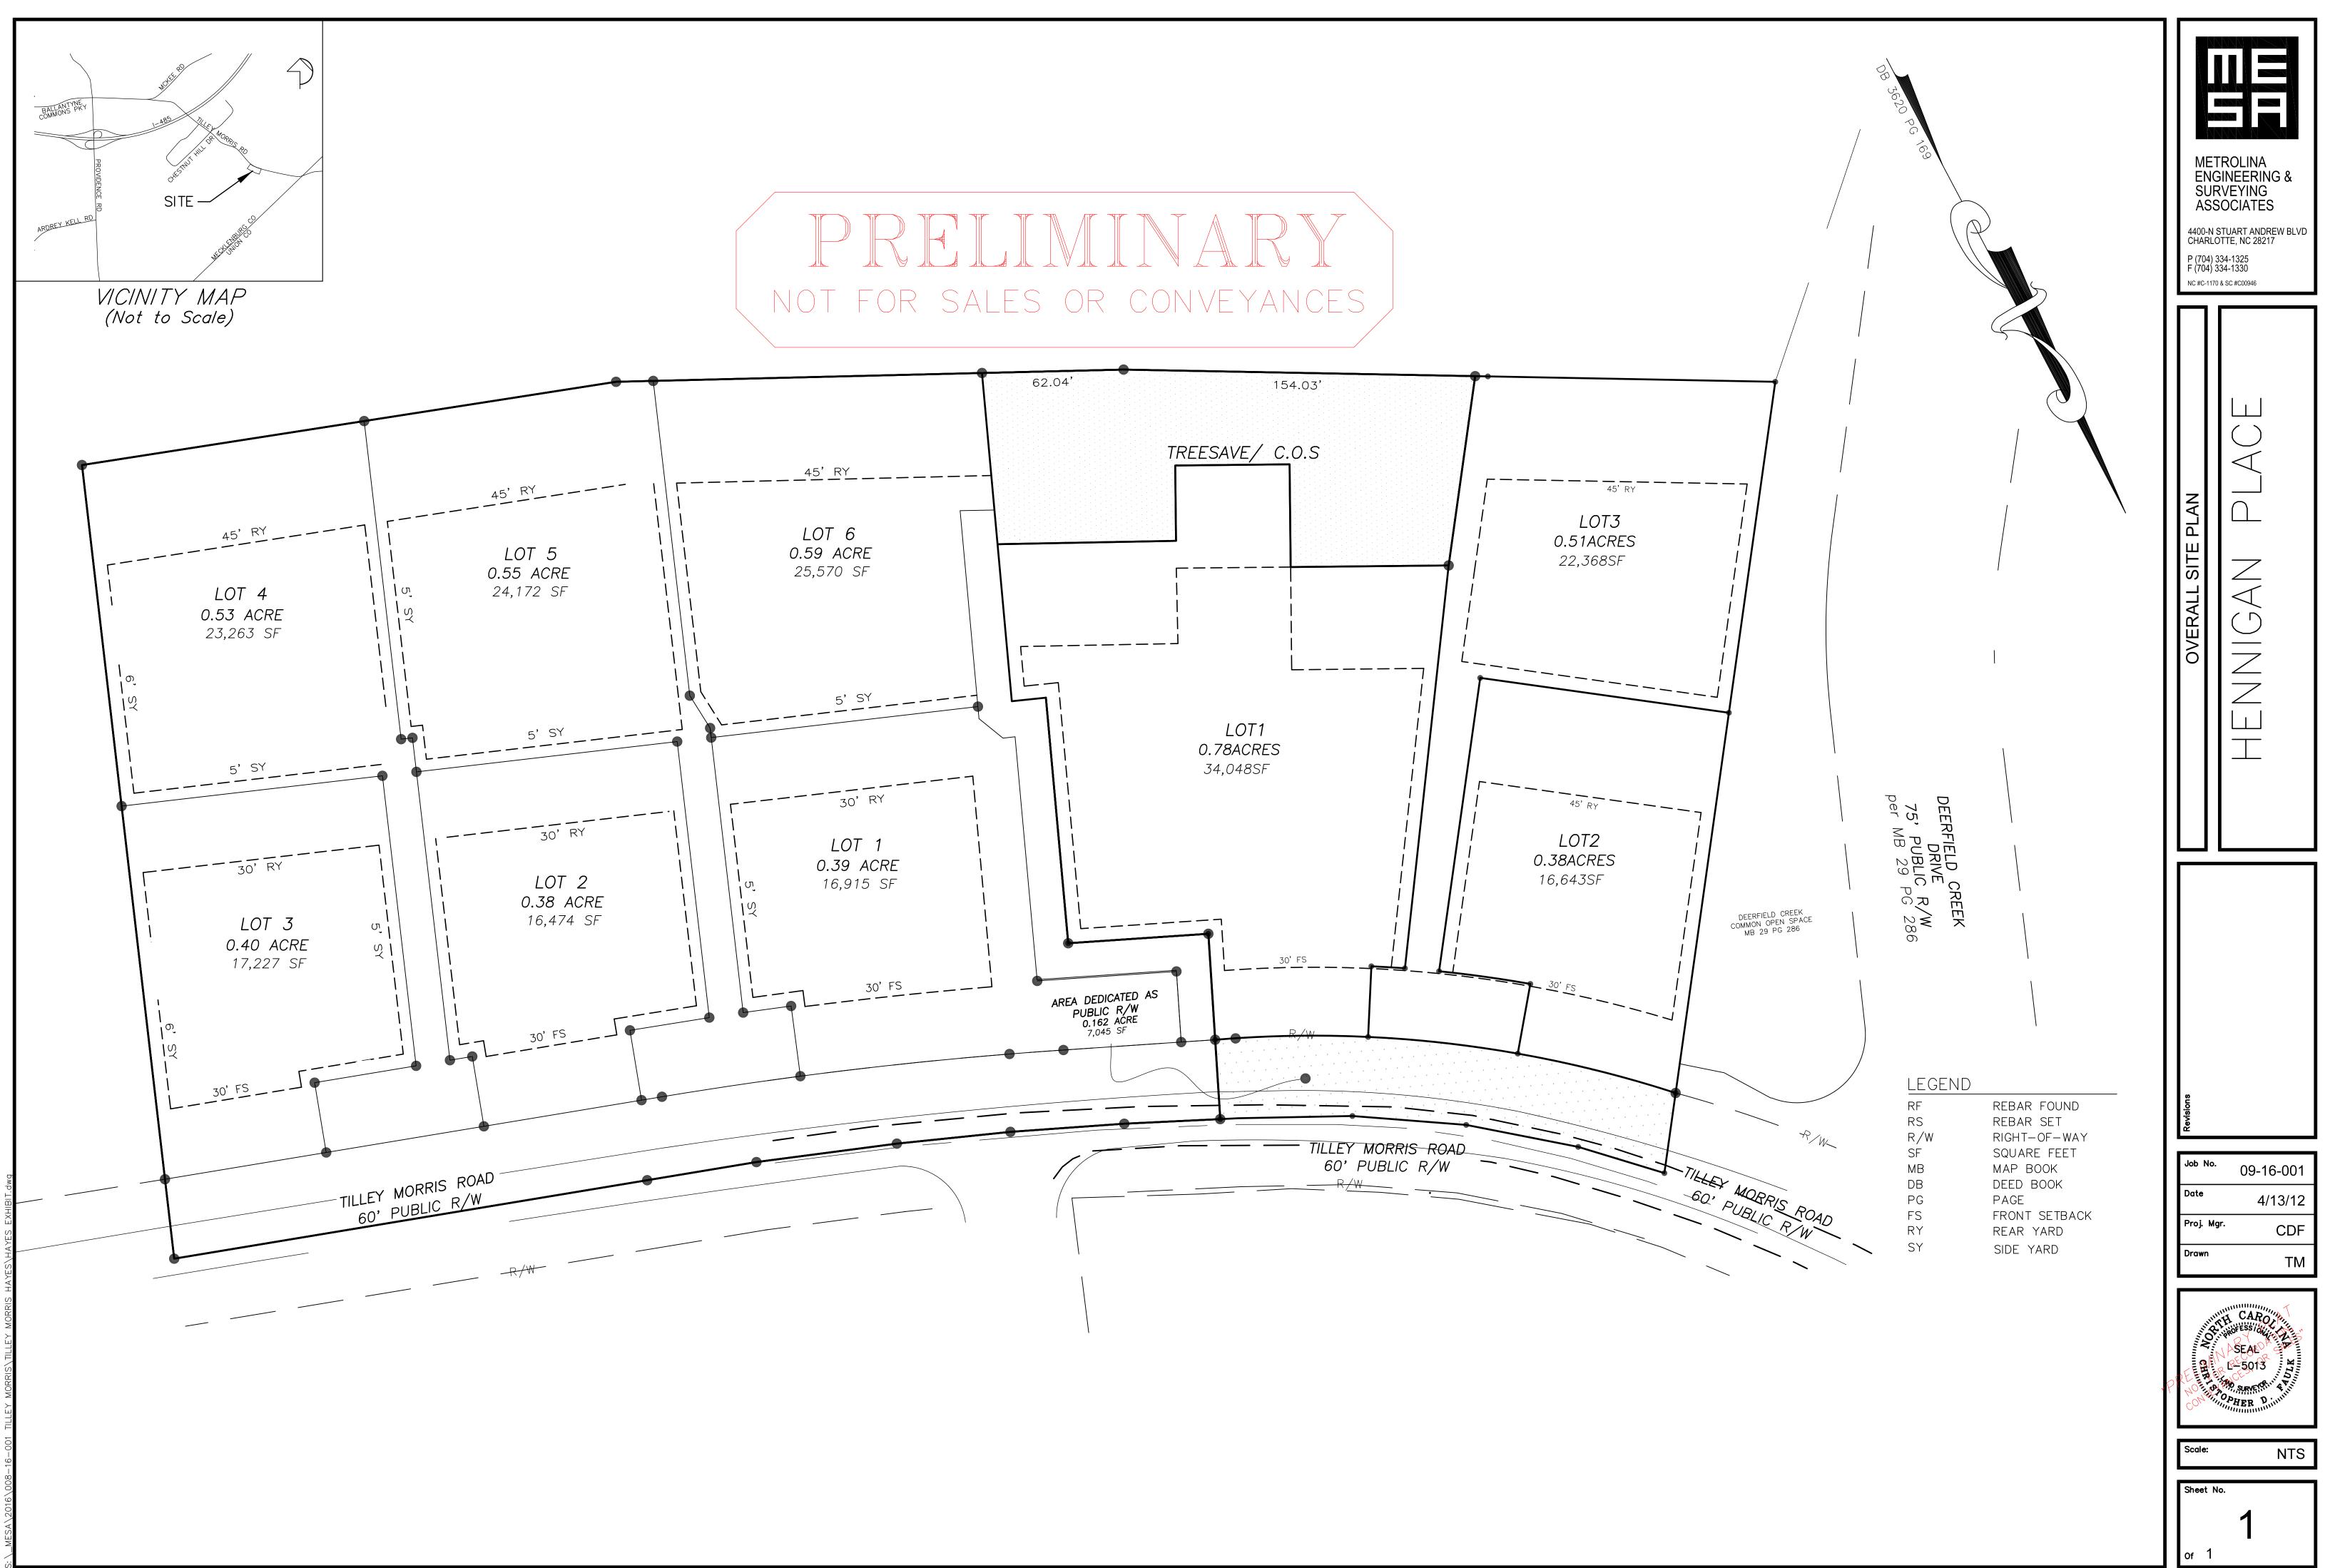
The current owner is requesting that the designation be removed from the property with the exception of the lot containing the historic house, shown as "Lot 1, .78 ACRES" on the attached site plan. The HLC voted to recommend that the designation be removed from the property with the exception of the lot containing the historic house on the condition that:
