**LOCAL HISTORIC LANDMARK
DESIGNATION REPORT**

Stafford-Holcombe Farm

Charlotte, Mecklenburg County, North Carolina

February 2021

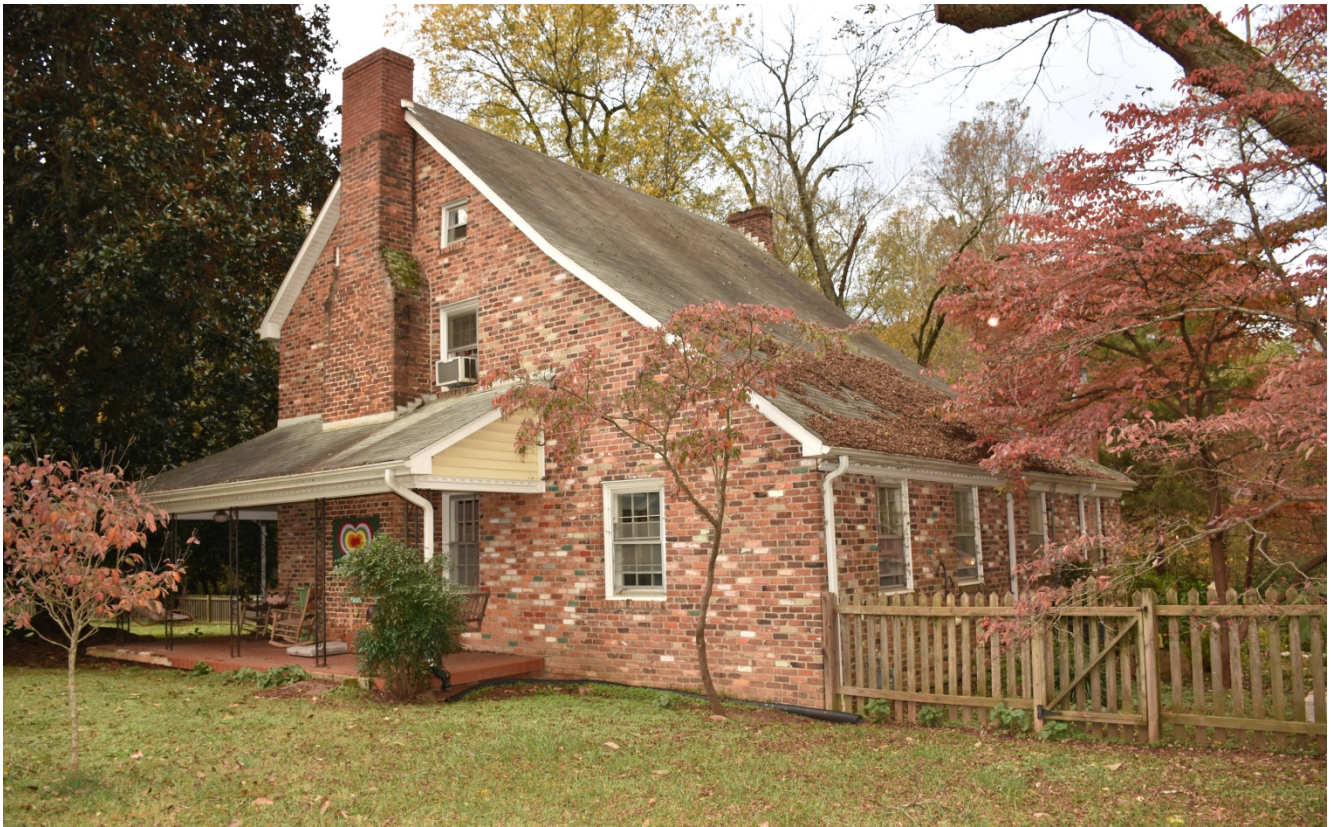
Northeast oblique and east lawn

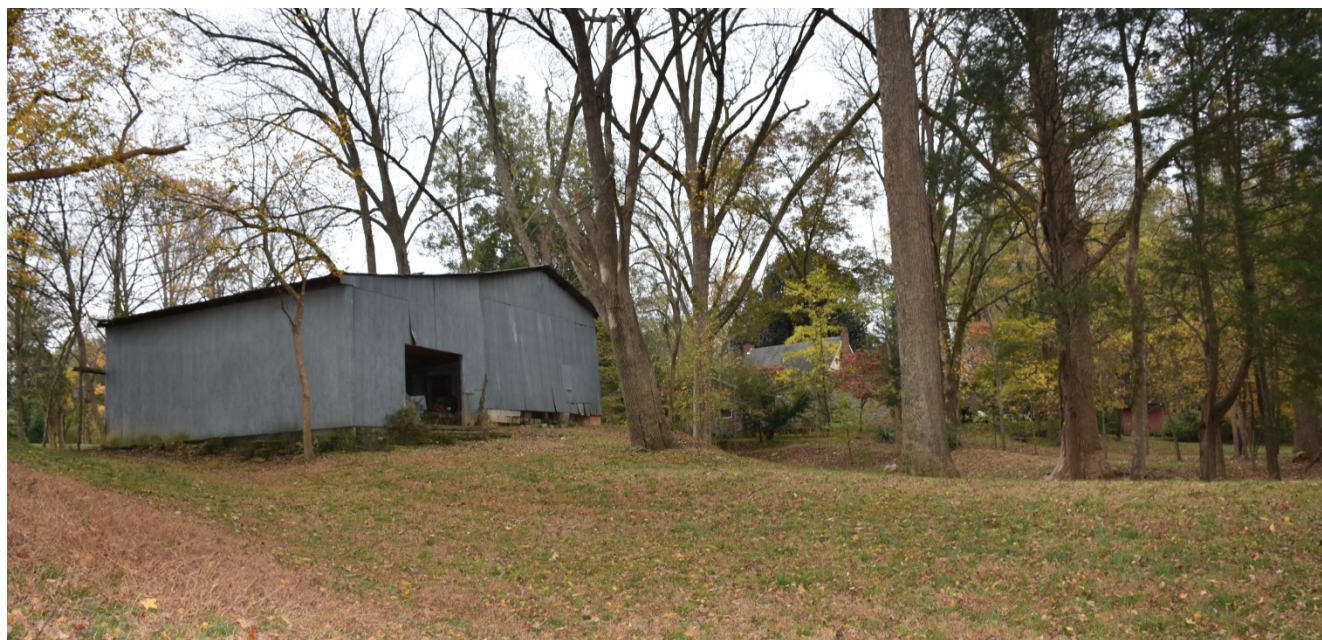
Looking southeast toward the 1966 barn and Stafford-Holcombe House

The Holcombes erected the front-gable-roofed frame barn that faces Plaza Road Extension north of the relocated frame outbuilding in September 1966. The north shed addition was erected soon after the original portion. Corrugated-metal panels sheath the walls and roof. The windowless barn rests on a concrete-block foundation and has an earth floor. On the east elevation, sliding corrugated-metal doors secure two wide ground-floor entrances and two openings that provide loft access. Long, shallow, metal canopies shelter each opening. The wide opening on the addition's west elevation does not have a door. The site grade slopes down west of the barn. The wood structural system is exposed on the interior, which comprises open north and south bays and three central stalls with board-and-batten doors accessed from the south bay. A wall-mounted wood ladder leads to the loft.

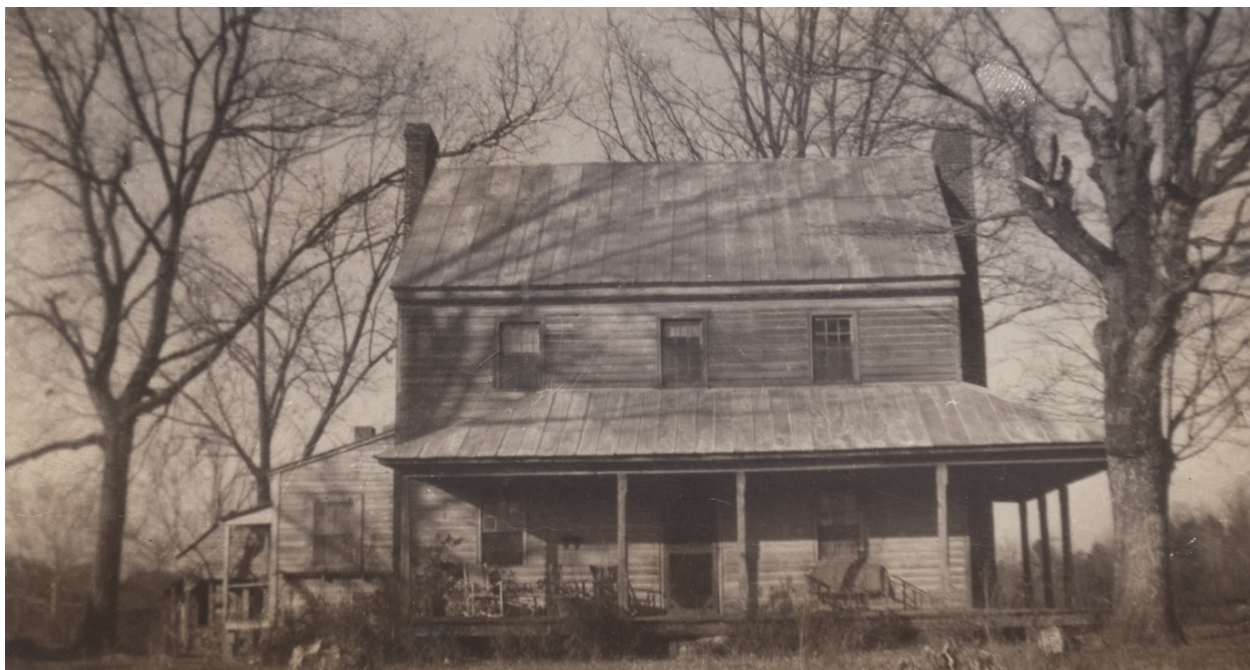
Stafford-Holcombe House, circa 1940 photograph in the possession of Leslie Mursch Freeman (above) and south elevation (below)

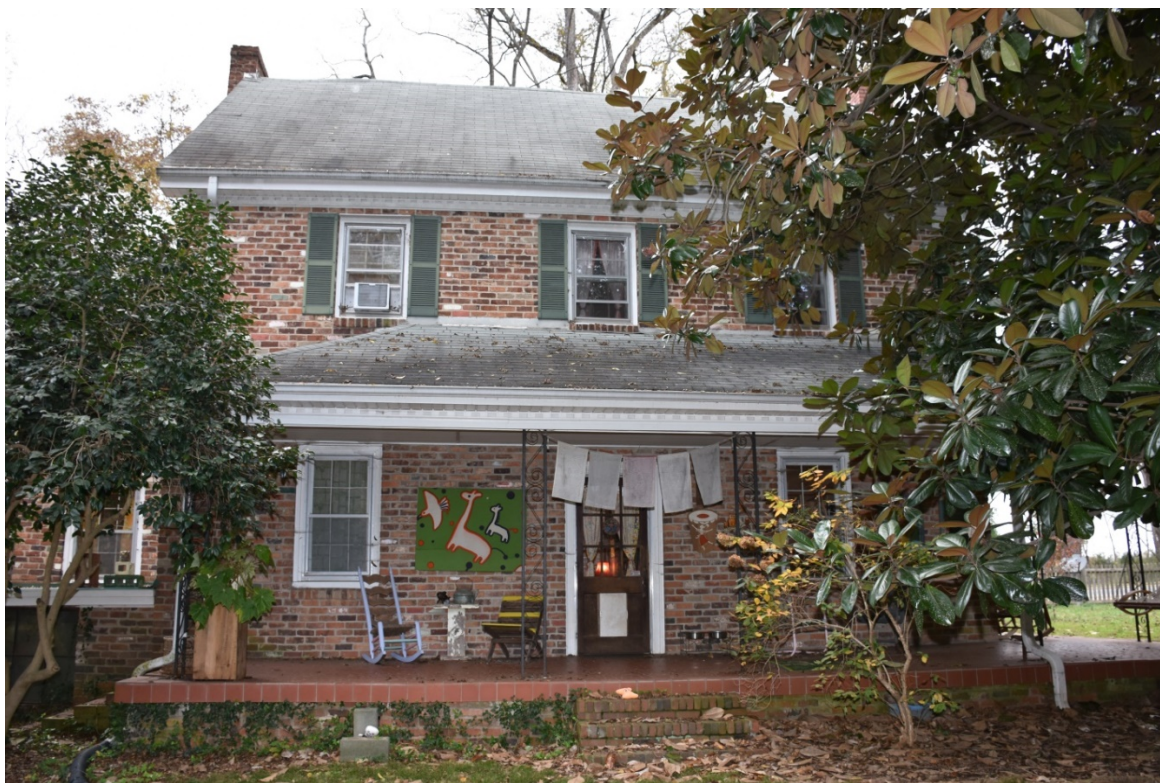
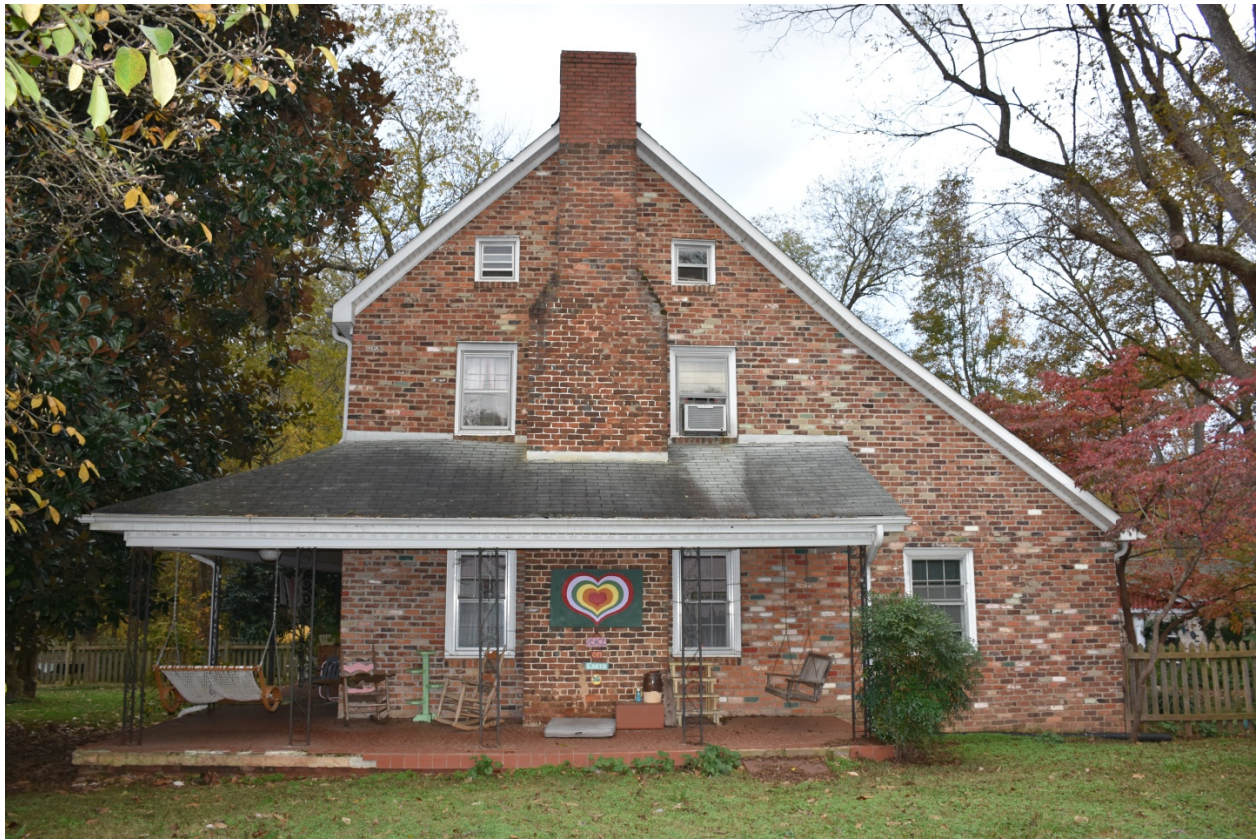
East elevation (above) and northwest oblique (below)

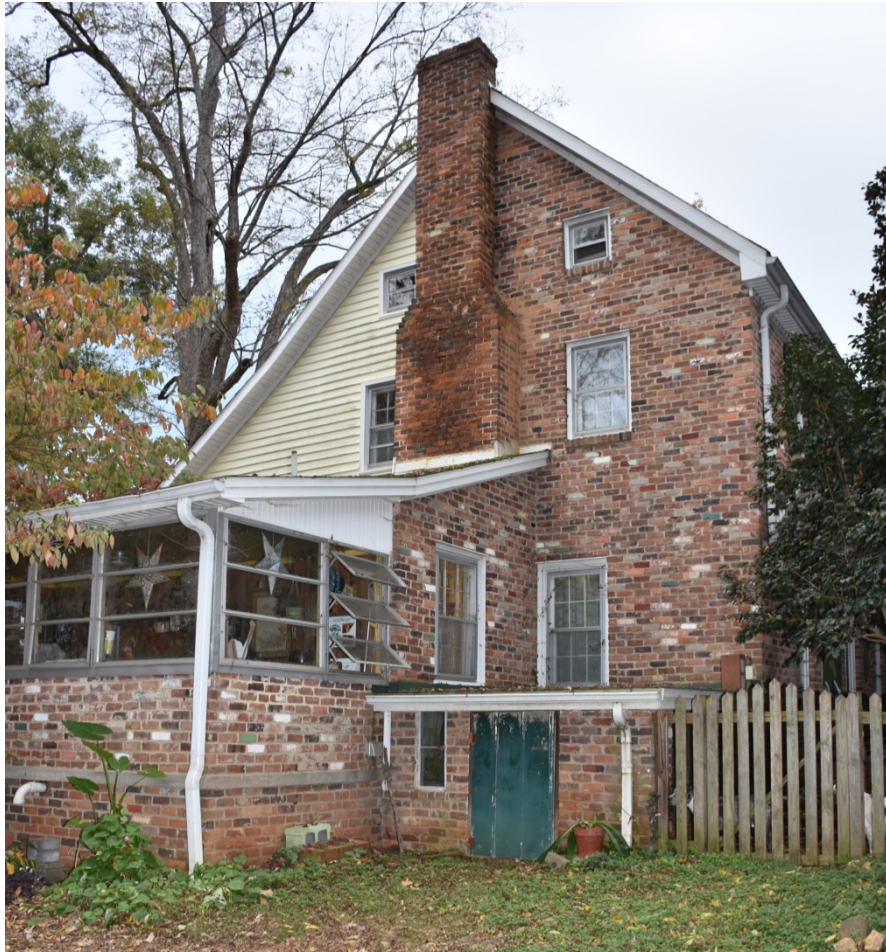
West elevation

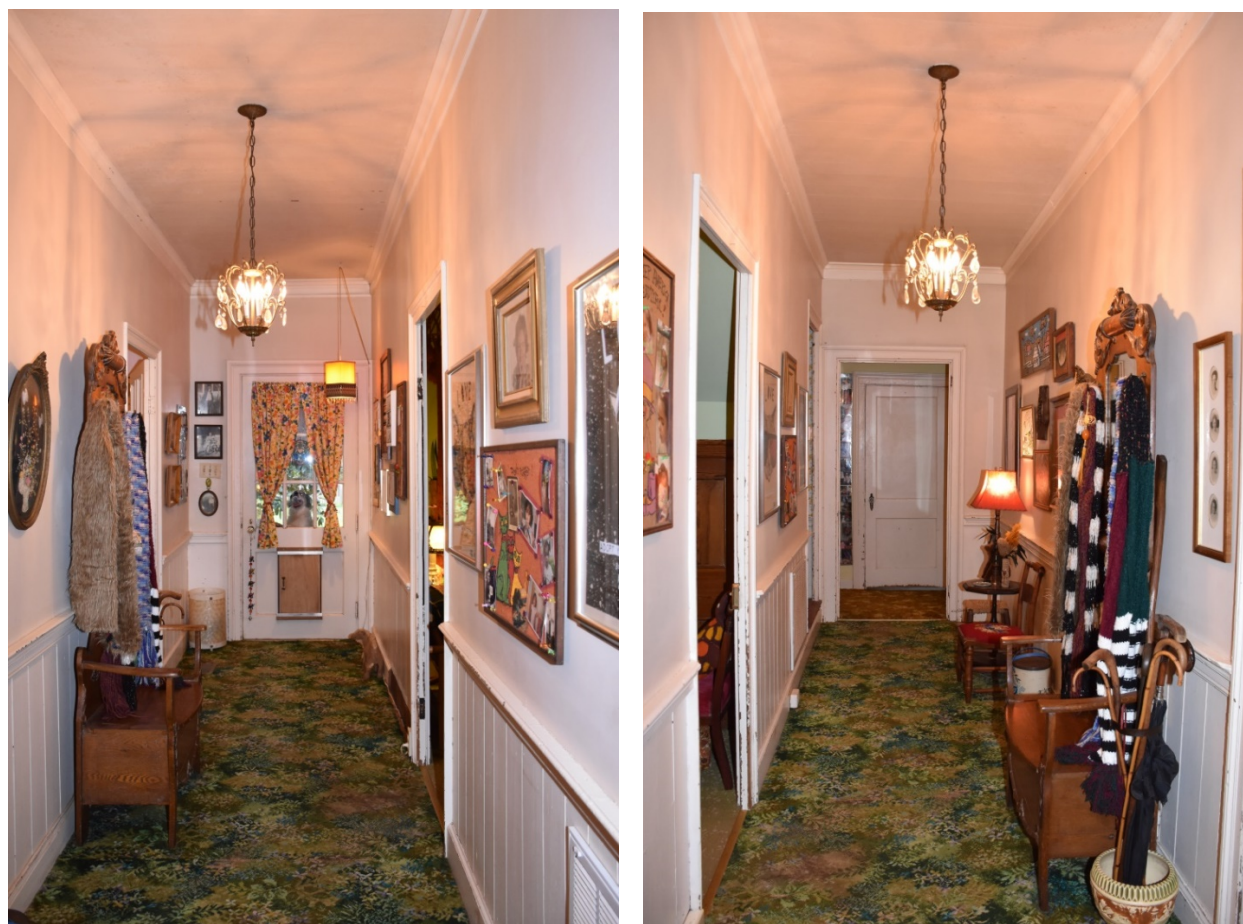
Center hall, looking south (left), and looking north (right)

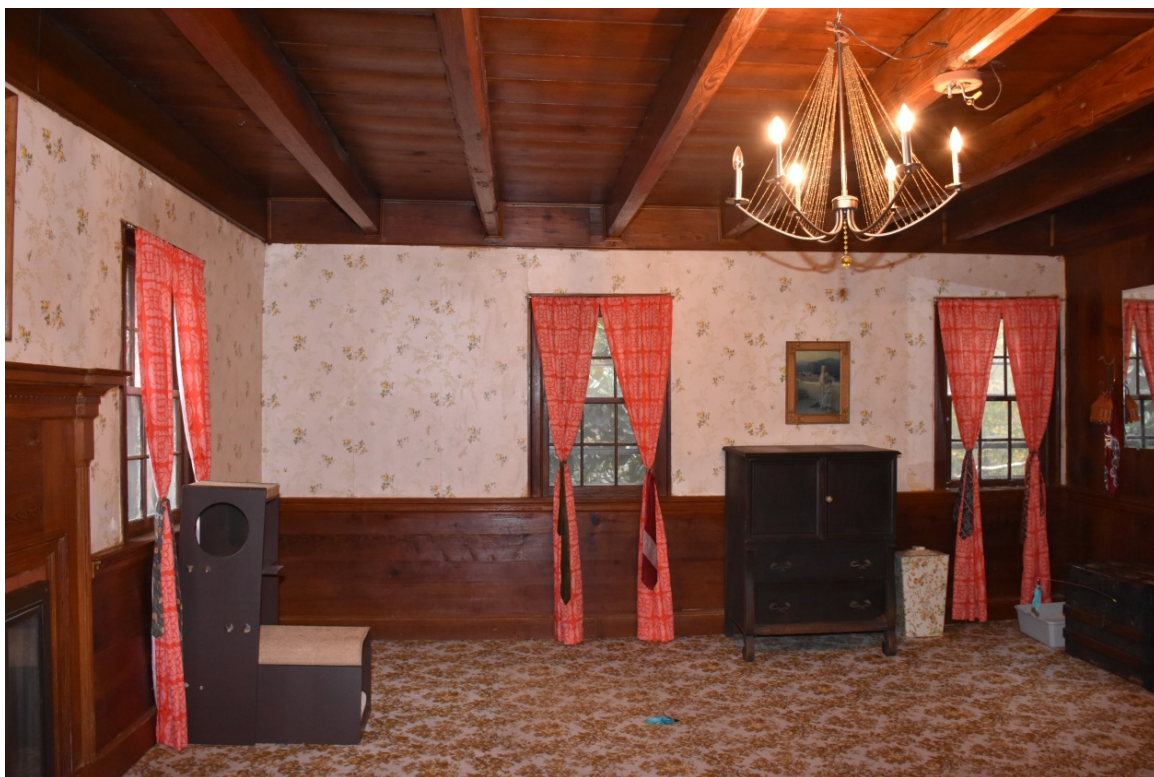
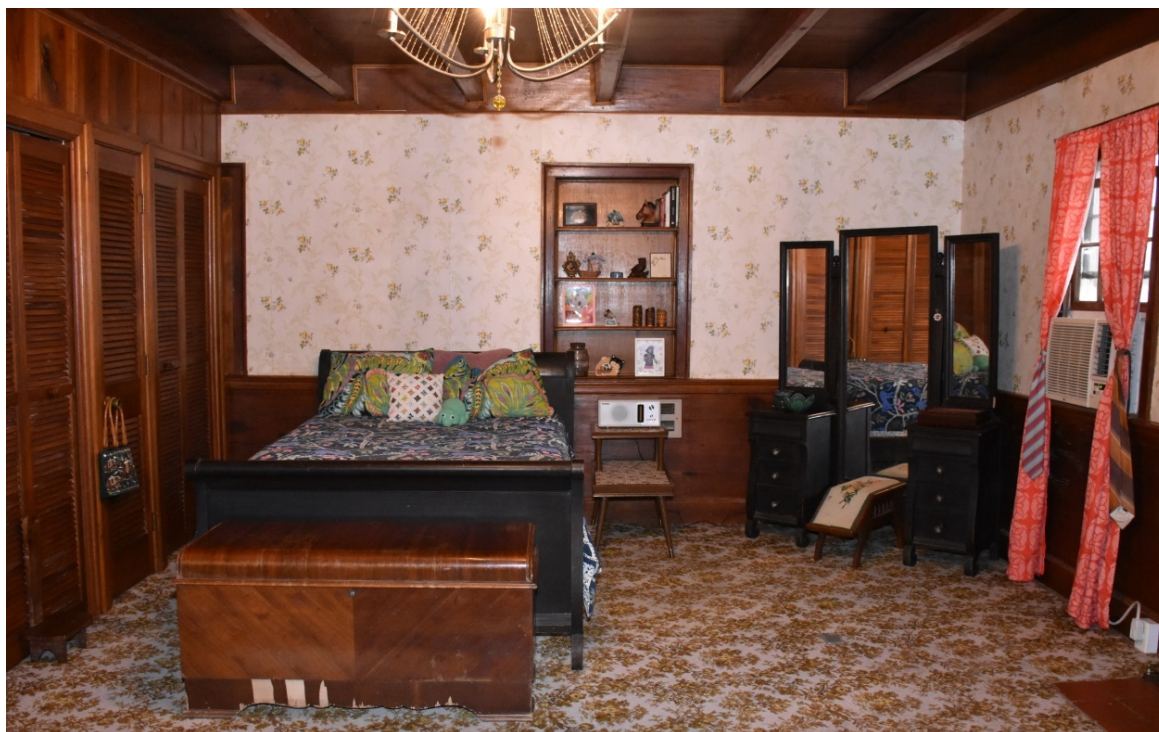
A single-leaf raised-six-panel door with brass box lock and hinges secures the east bedroom entrance. The tall mantel at the east wall's center comprises a molded firebox surround, narrow fluted pilasters, plain frieze, molded cornice with a scalloped upper edge, and molded shelf. Shallow shelves have been inserted in the former window opening on the north wall. Mid-twentieth-century knotty-pine paneling and louvered-wood doors enclose the long closet north of the entrance on the west wall.

East bedroom, looking south (above) and looking north (below)

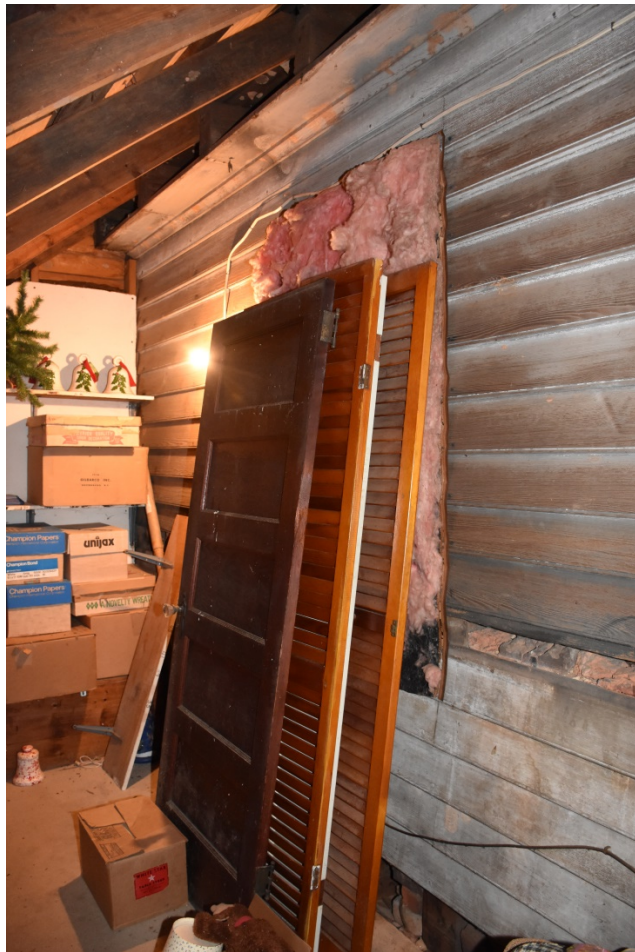
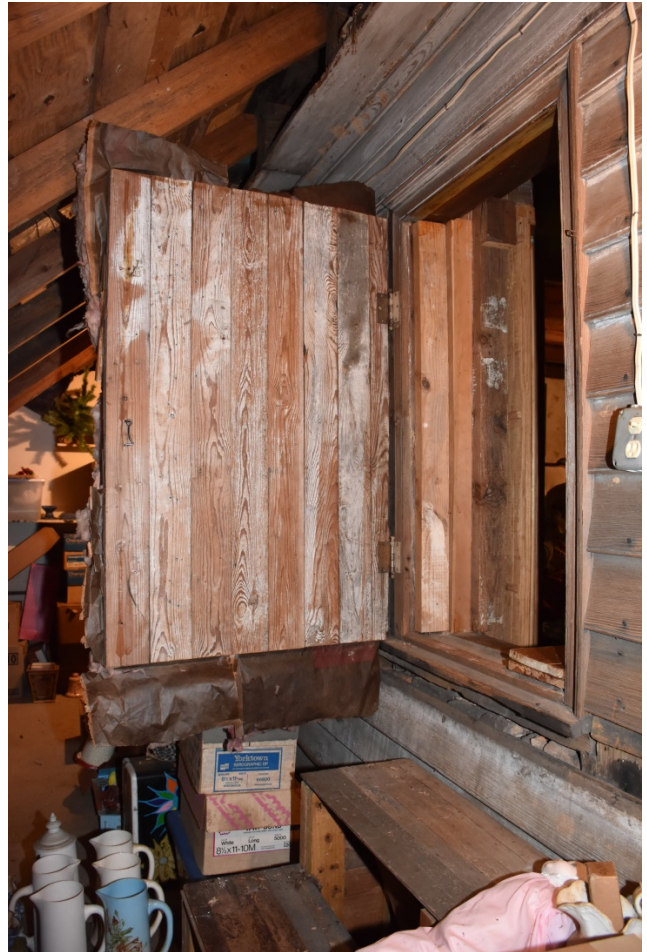
Within the closet, the former window opening at the north wall's center provides the only access to the attic above the dining room addition, which encapsulated the original second-story beaded clapboards and boxed cornice. A board-and-batten door fills the opening.

North elevation, second story, encapsulated in attic above dining room addition, looking southeast (left), former window opening (right), looking west

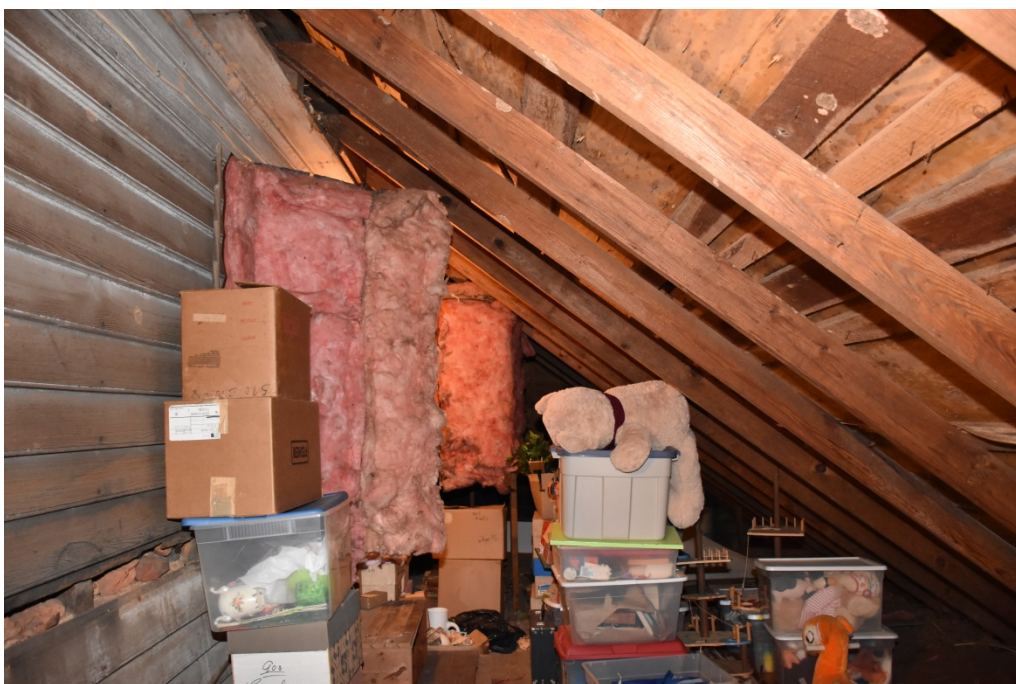
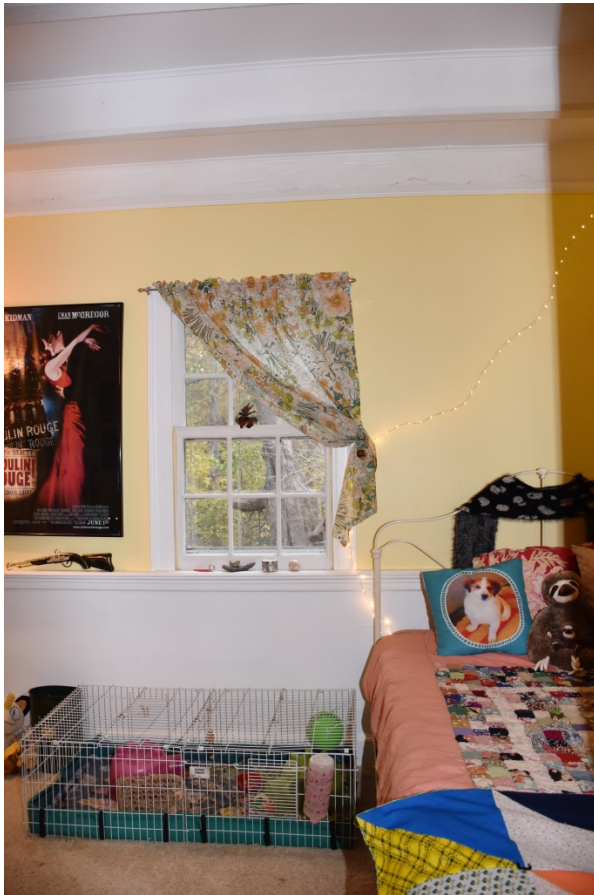
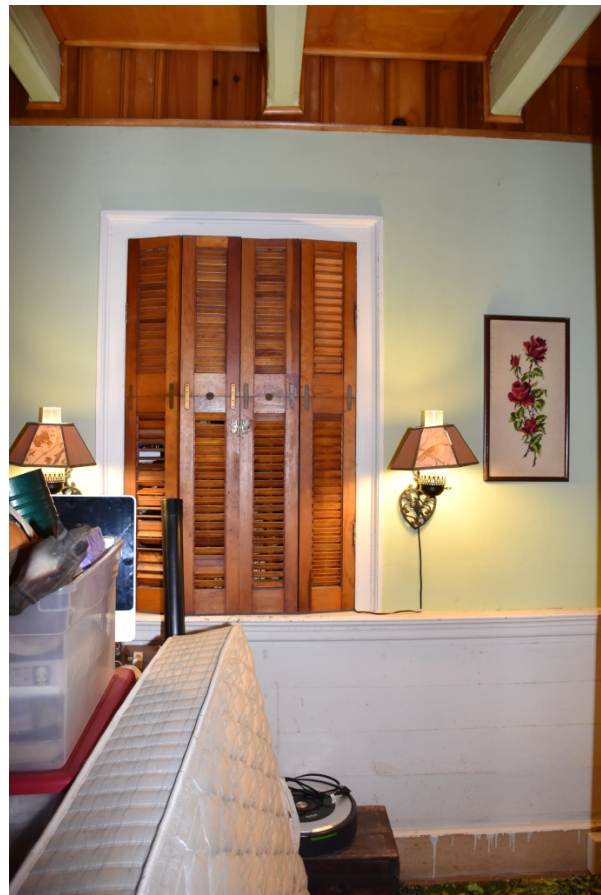
The single-leaf raised-six-panel door at the southwest bedroom's canted northeast corner was cut in half in 2017 to create a Dutch door. The mid-twentieth-century closet with a louvered-wood door that spans the east wall is sheathed with knotty-pine paneling. The enclosed wood stair at the northwest bedroom's northeast corner leads to the attic.

Southwest bedroom, looking west (above left) and northwest bedroom looking north (above right) and west (below)

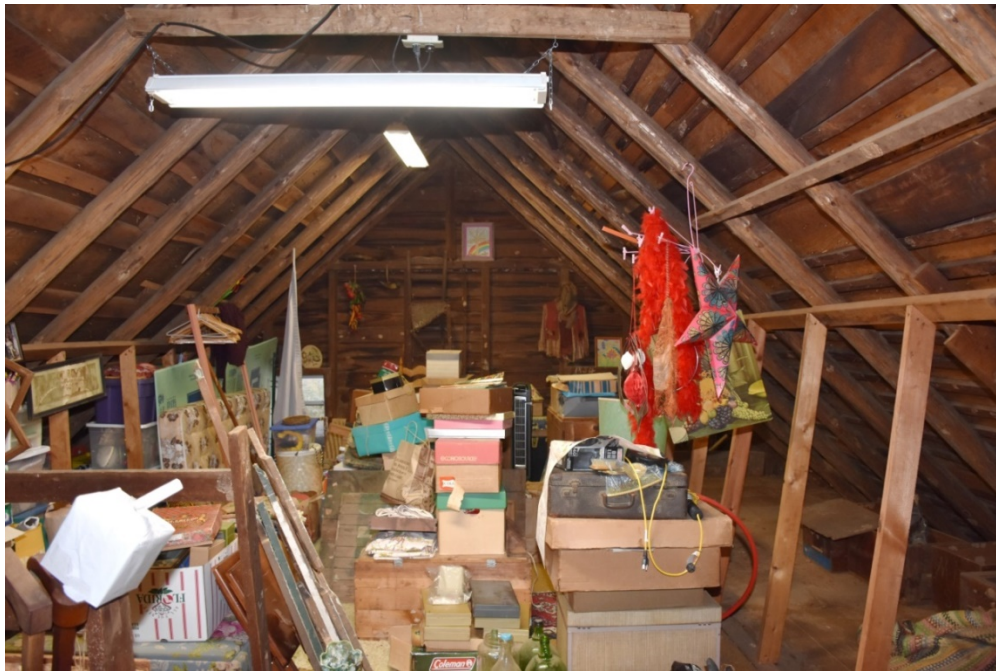
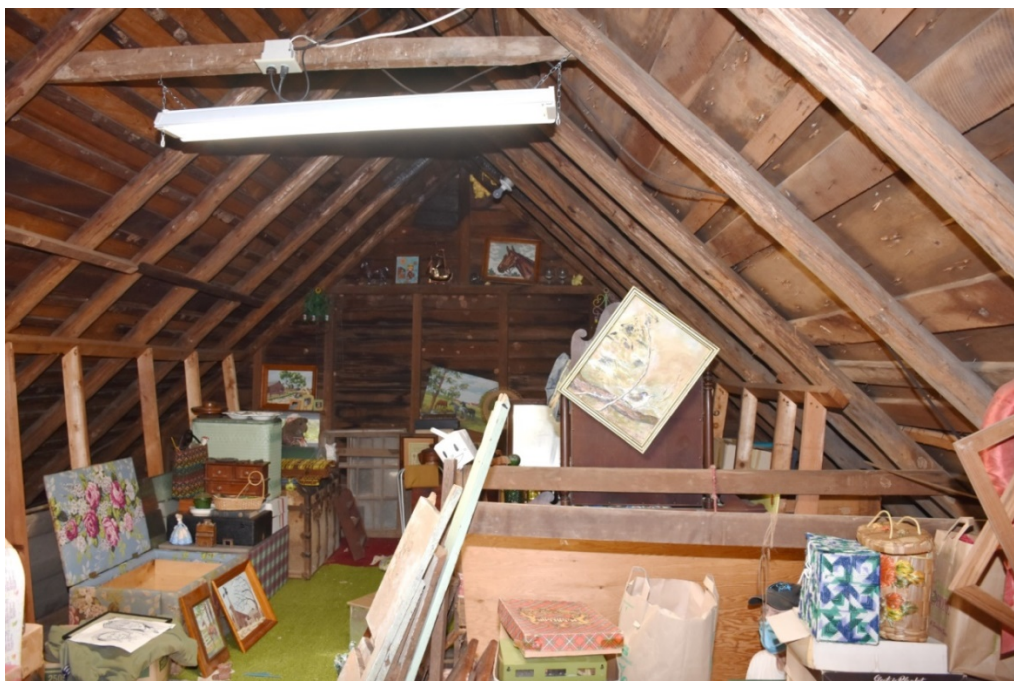
A single-leaf board-and-batten door remains at the attic stair entrance. Vertical board-sheathed walls flank narrow wood steps that turn to a straight run. Simple wood railings secure the stair opening. The roof's exposed structural system comprises stripped-log rafters marked with Roman numerals, wood nailing strips, and wide-board and plywood decking. Some of the westernmost rafters' peak ends were charred in a fire. Dimensional lumber bracing has been added throughout the attic. Carpeting covers wide floor boards. The room has an open plan.

Attic looking east (above) and looking west (below)

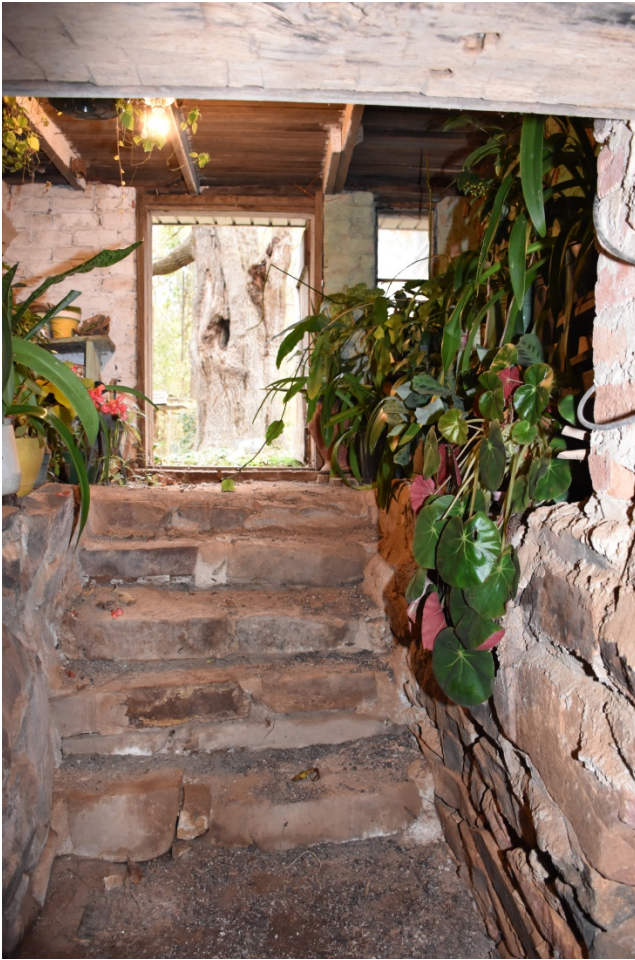
Looking west toward basement entrance

There is no interior access to the unfinished basement. Stone steps lead from the entrance vestibule south of the sunporch to a low-ceilinged room with an earth floor and exposed structural system. The stone foundation, square brick piers, and hewn- and half-round log joists have been supplemented with brick retaining walls and dimensional lumber joists. The undersides of wide first-floor boards are visible. HVAC equipment and ductwork was installed in early 2014.

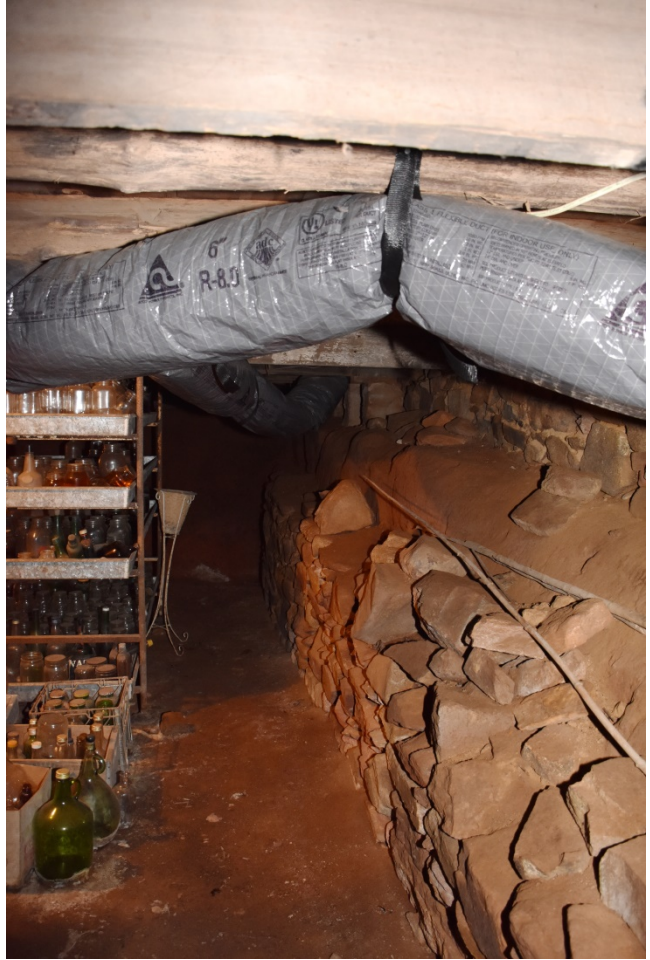
Looking east along south foundation

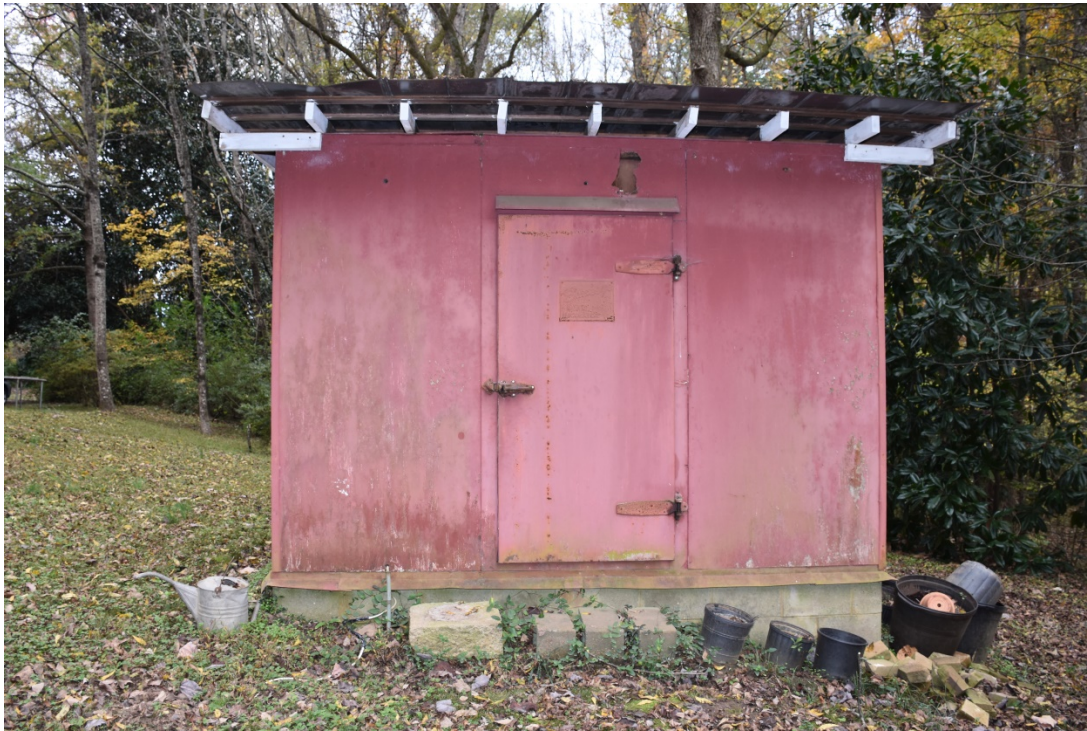
Milk House/Shed, north elevation

The Holcombes moved this milk house from the Quay family's dairy farm on Robinson Church Road in the late 1960s or early 1970s to serve as a shed.⁷ The small, very-low-gable-metal-roofed, painted-plywood-panel-sheathed building rests on a concrete block foundation. Exposed rafter ends support deep eaves. The single-leaf steel door on the north elevation retains original hardware. A three-section aluminum-frame window on the south elevation and a four-section aluminum-frame window on the west elevation light the interior, which has a concrete floor and painted-gypsum-board walls and ceiling.

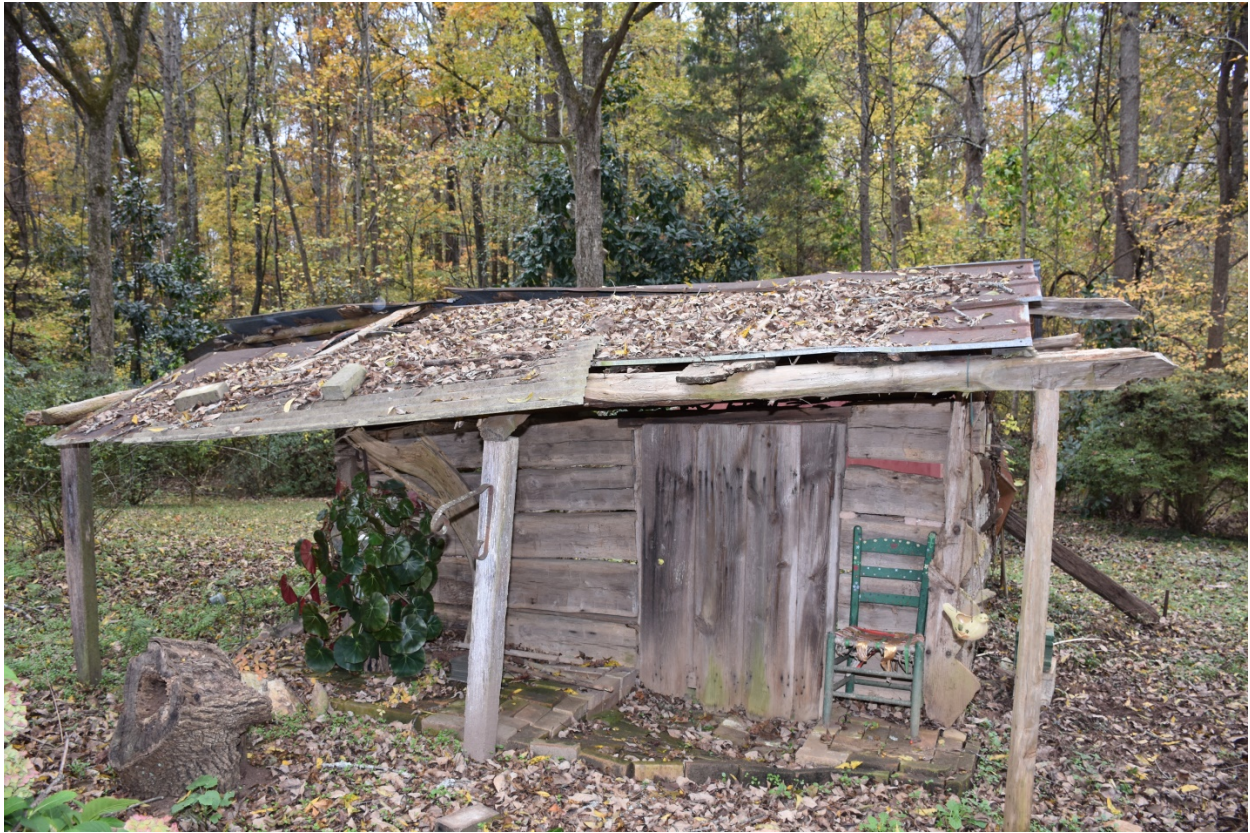
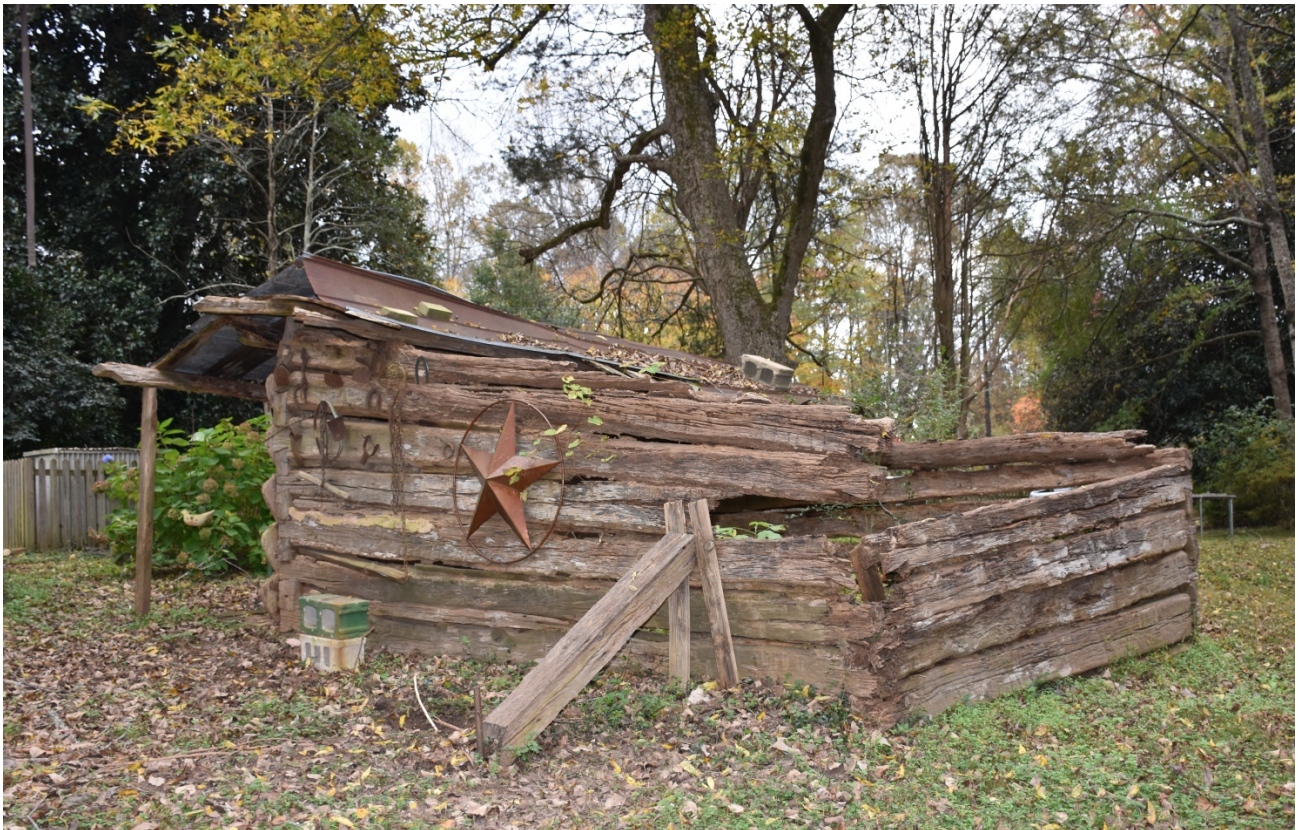
Portions of the walls of a rectangular hewn-log outbuilding with half dovetail joints stand west of the house. Remnants of wood and clay chinking used to fill the space between logs remain. A short board-and-batten door pierces the east elevation. The roof system is missing with the exception of a small section adjacent to the east elevation where the Holcombes extended the east roof slope to create a full-width porch with a brick floor. The building's original function is unknown.

Log Outbuilding, east elevation (above) and northwest oblique (below)

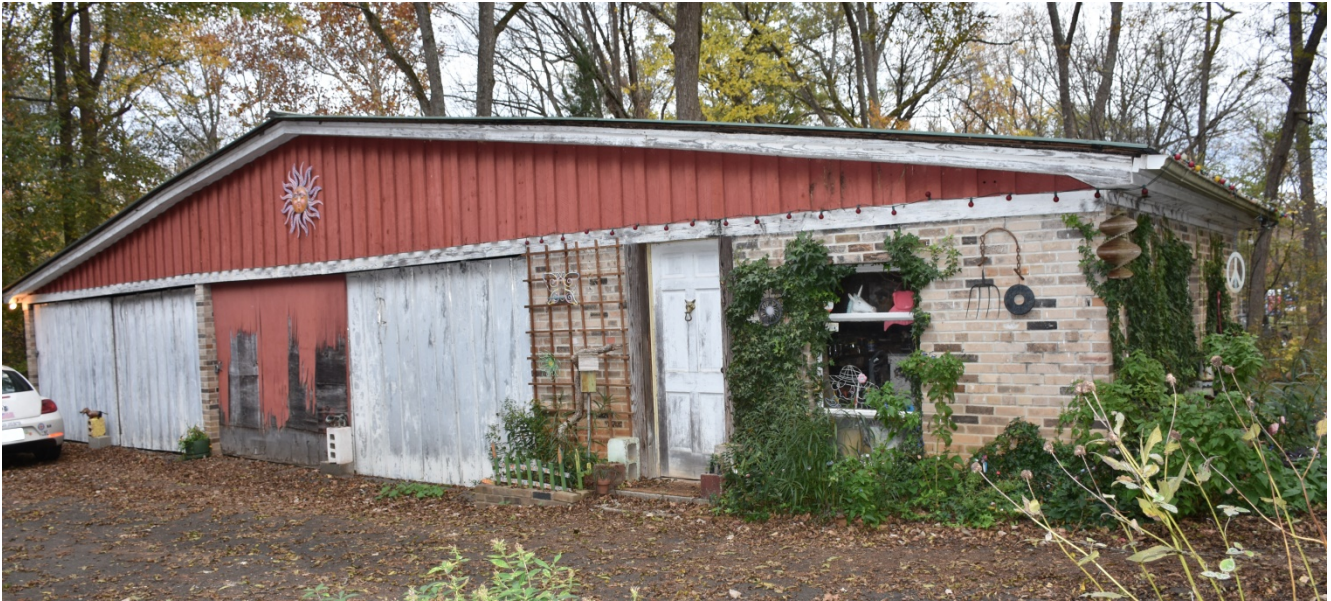
Garage, southeast oblique

The Holcombes erected the wide, rectangular, low-front-gable-roofed garage with variegated taupe- and brown-brick walls and board-and-batten-sheathed gables that stands northwest of the house in two phases. The west two garage bays were constructed in September 1963 and the east workshop bay in October 1965. The building has a poured-concrete foundation and floor and a corrugated-metal roof. Sliding corrugated-metal doors secure the garage entrances. A single-leaf six-panel wood door provides workshop access. The steel-frame sash east of the door and at the east elevation's center comprise a square pane surmounted by a rectangular hopper. Structural elements—wood joists, wide-board decking, brick walls, and concrete floor—are exposed throughout the interior. The asphalt-paved driveway leads to a small parking area south of the garage.

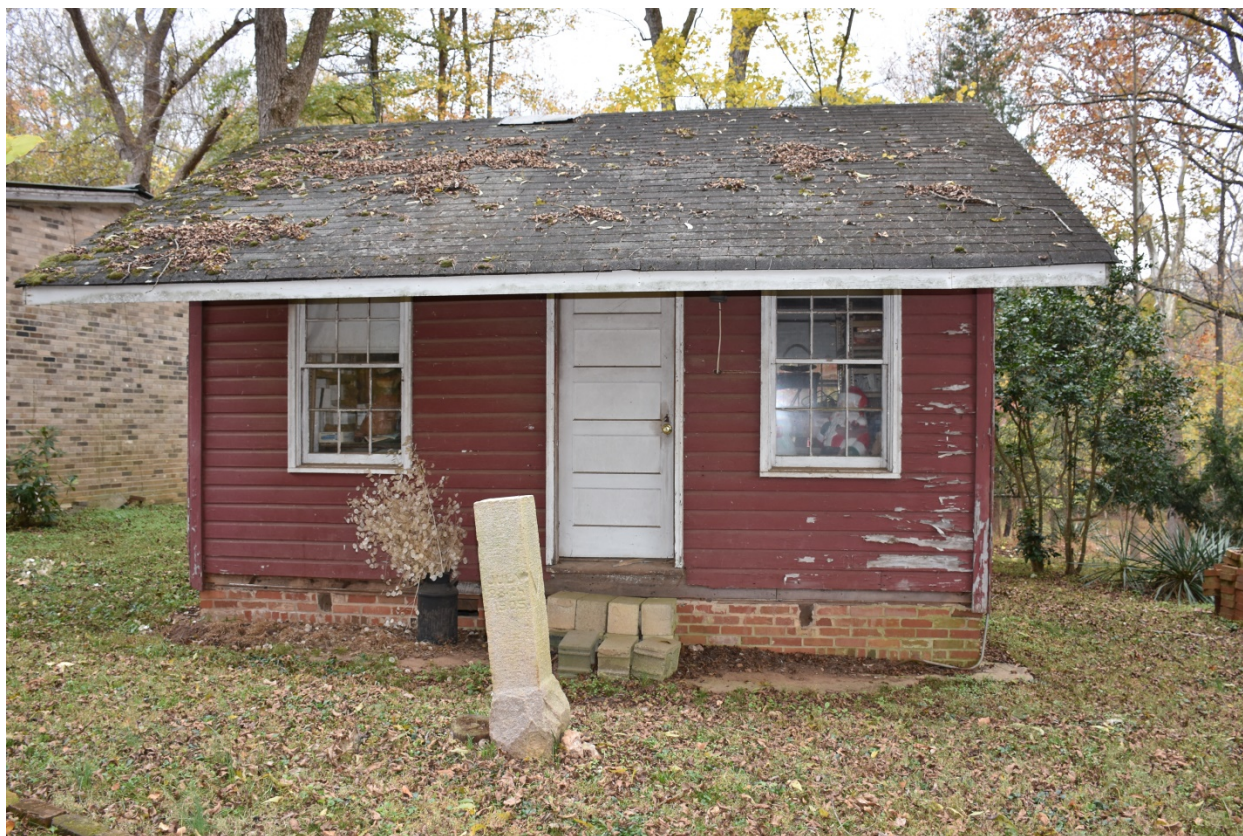
During the 1905 Mecklenburg County survey, a tall square granite marker was placed on the corner of the Mecklenburg/Cabarrus county line that bisected Stafford property. After a heavy rain, Pete Holcombe found the marker near one of his barns and moved it to its current location to serve as a flower pot pedestal for his mother Ida.⁸ The monument inscription reads “July 28th, 1905” on its east face, “M” for Mecklenburg on its north face, and “C” for Cabarrus on its south face.

Outbuilding and County Line Marker, looking west

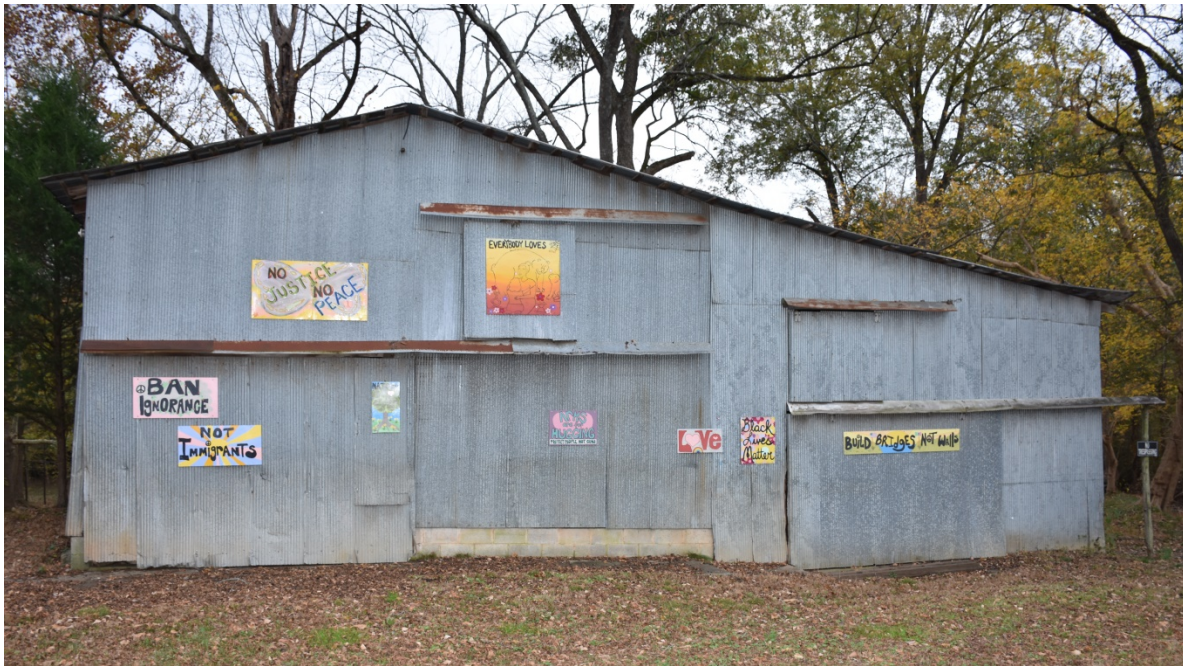
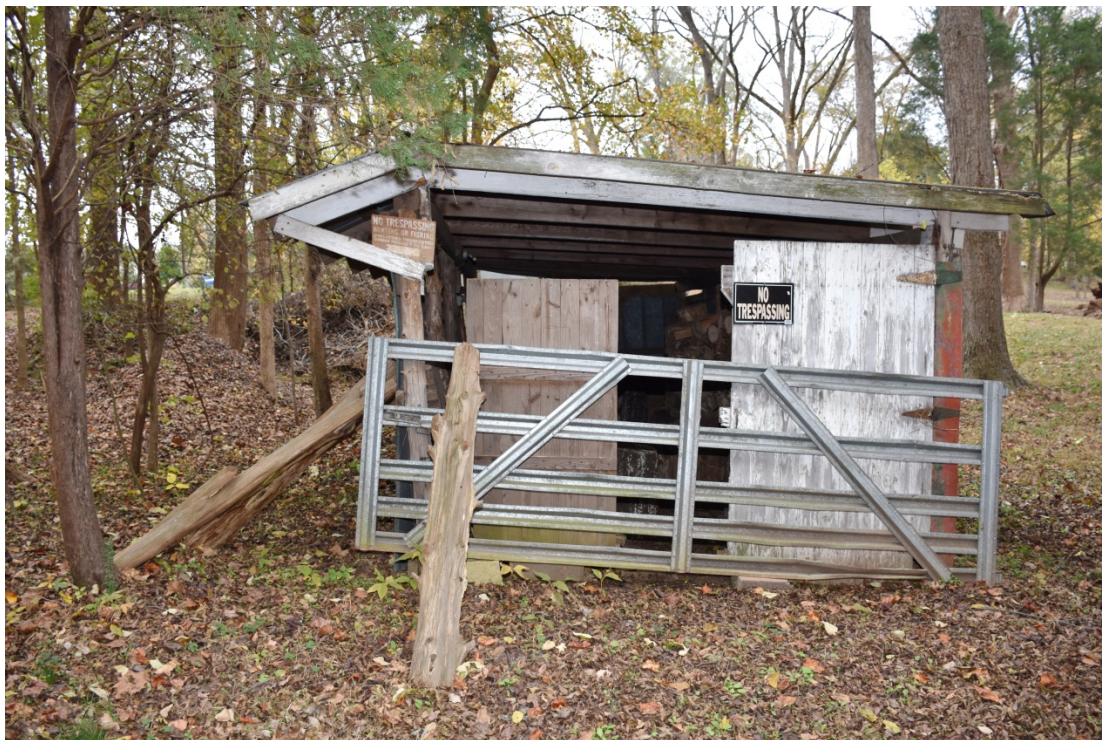
Barn, east elevation (above) and north equipment shed, west elevation (below)

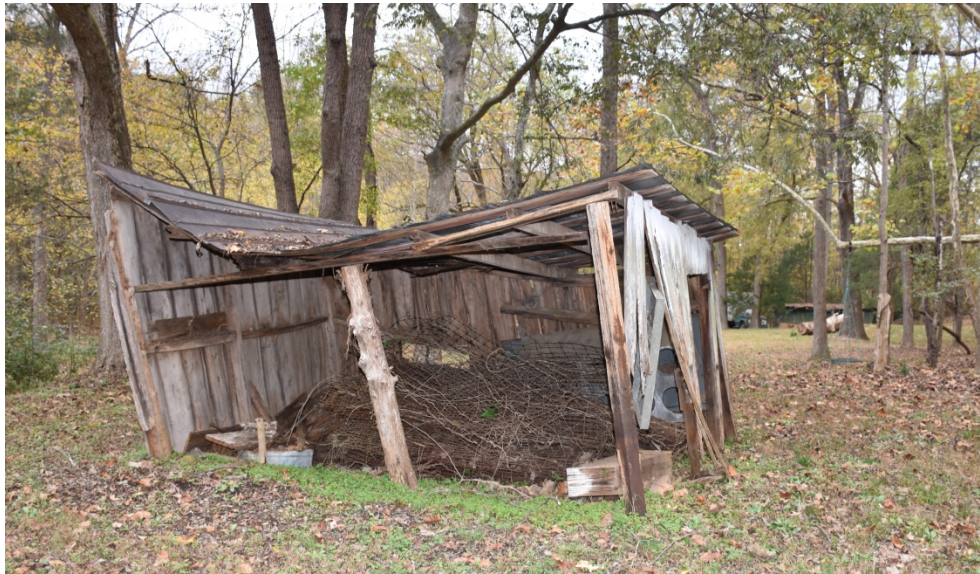
The shed-roofed, frame, two-bay equipment shed in the clearing west of the barn has vertical-board siding and a metal roof. The structure is leaning and on the verge of collapse.

Equipment Shed, southeast oblique (above) and Slave Quarter-Tenant House Site (below)
