**LOCAL HISTORIC LANDMARK
DESIGNATION REPORT**

Stafford-Holcombe Farm

Charlotte, Mecklenburg County, North Carolina

February 2021

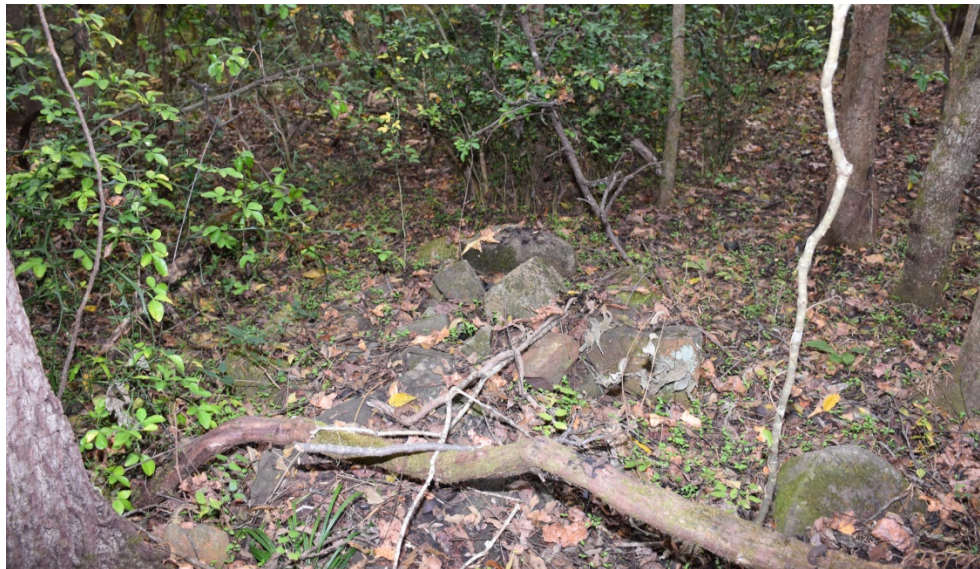
Slave Quarter-Tenant House Site

In the woods northwest of the extant slave quarter-tenant house, small piles of foundation and chimney stones and brick mark the site of the early-nineteenth-century log slave quarter-tenant house that was moved to Stafford property on Plaza Road Extension's east side near the Reedy Creek Road intersection around 1890, where it served as tenant house from about 1910 through the mid-twentieth

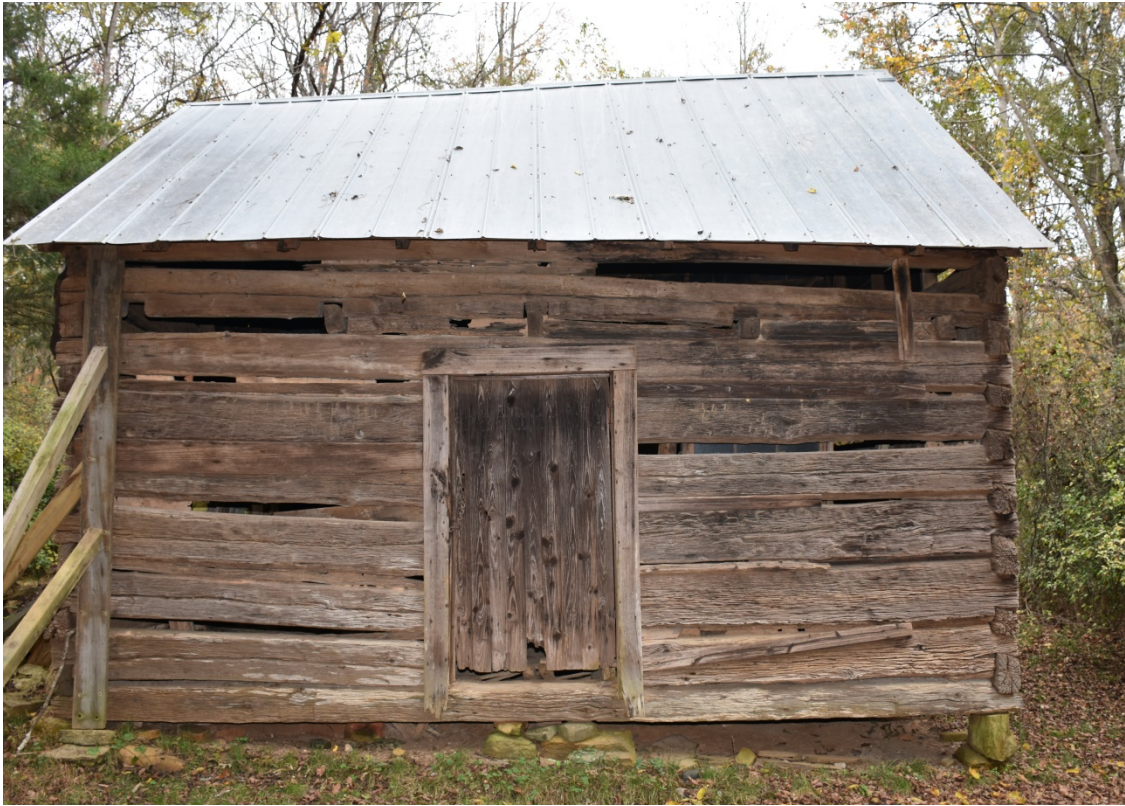
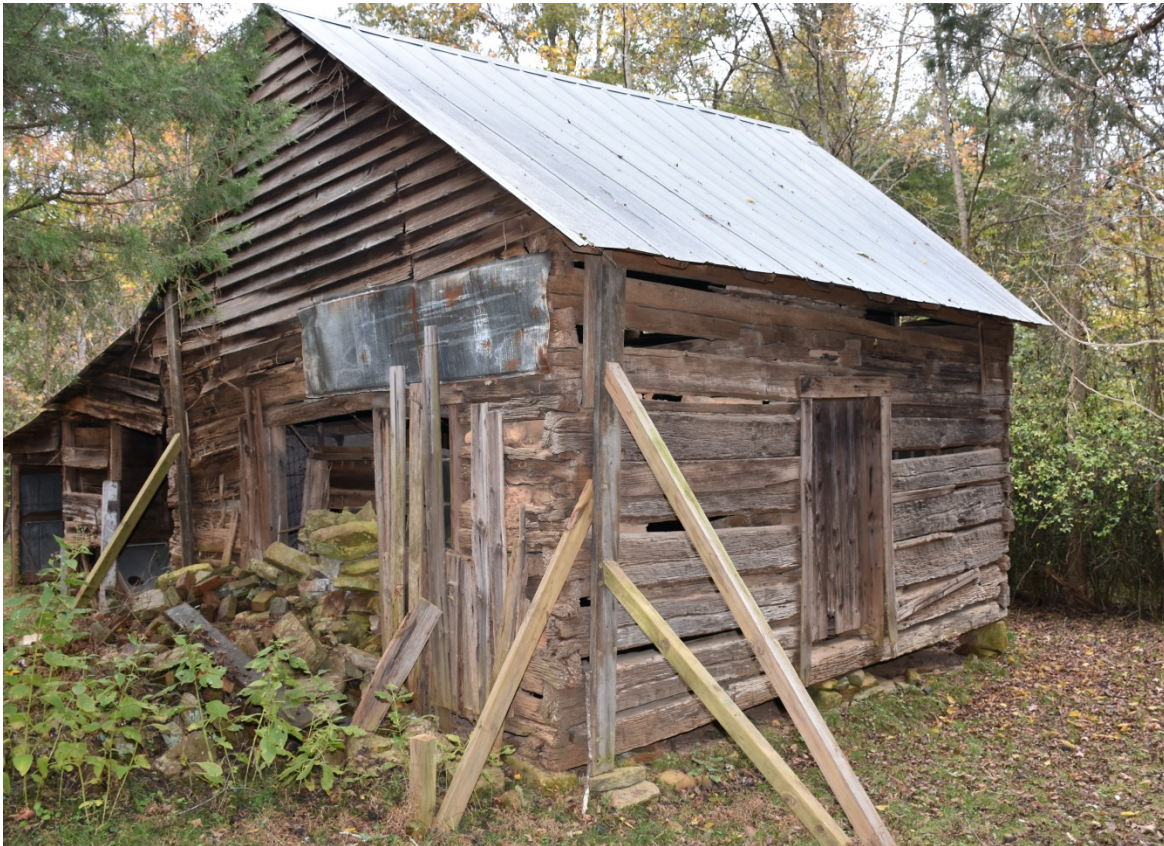
The almost square (approximately sixteen by fourteen feet) log dwelling faces south. Recent stabilization efforts include the installation of a roof system comprising dimensional lumber rafters and nailing strips sheathed with corrugated-metal panels, as well as lumber braces to support the partially collapsed hewn-log walls with half-dovetail joints. Remnants of clay, wood, and cement chinking used to fill the space between logs remain. The central board-and-batten doors on the north and south elevations have flat-board surrounds. The nine-pane wood sash south of the fireplace opening on the west elevation is the sole extant window. Logs fill the window opening north of the collapsed stone and brick chimney. Most of the floor system has also collapsed, but rectangular hewn joists and some wide floor boards remain. The attic, probably used for sleeping and storage, likely had similar floor boards, but all have been removed. The hewn joists that supported the attic floor survive, however, and nail-pattern evidence indicates that the primary room received a beadboard ceiling in the late-nineteenth or early-twentieth-century, probably in conjunction with the rear shed room's construction. The painted mid-nineteenth-century post-and-lintel mantel, which is much more elaborate than mantels typically found in rural slave quarters, was a later addition. The mantel features chamfered pilasters on tall plinths and a shaped frieze base with a central pointed arch and scalloped edges.

Slave Quarter-Tenant House, south elevation (above), and southwest oblique (below)

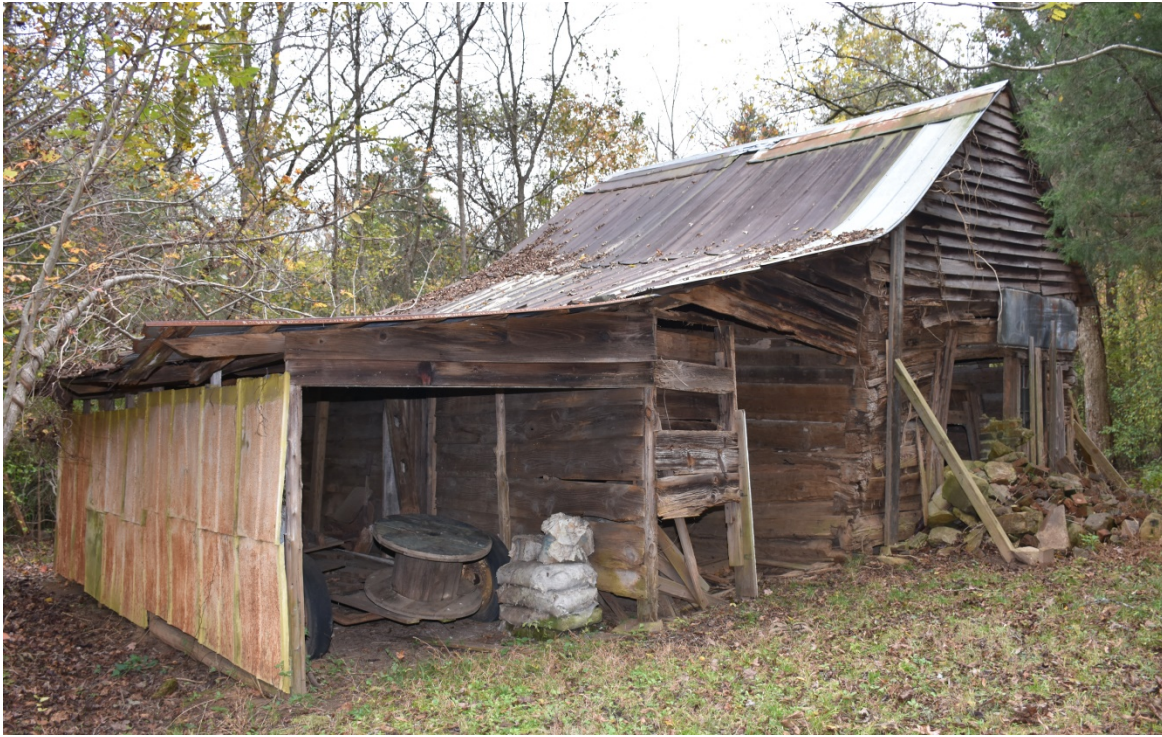
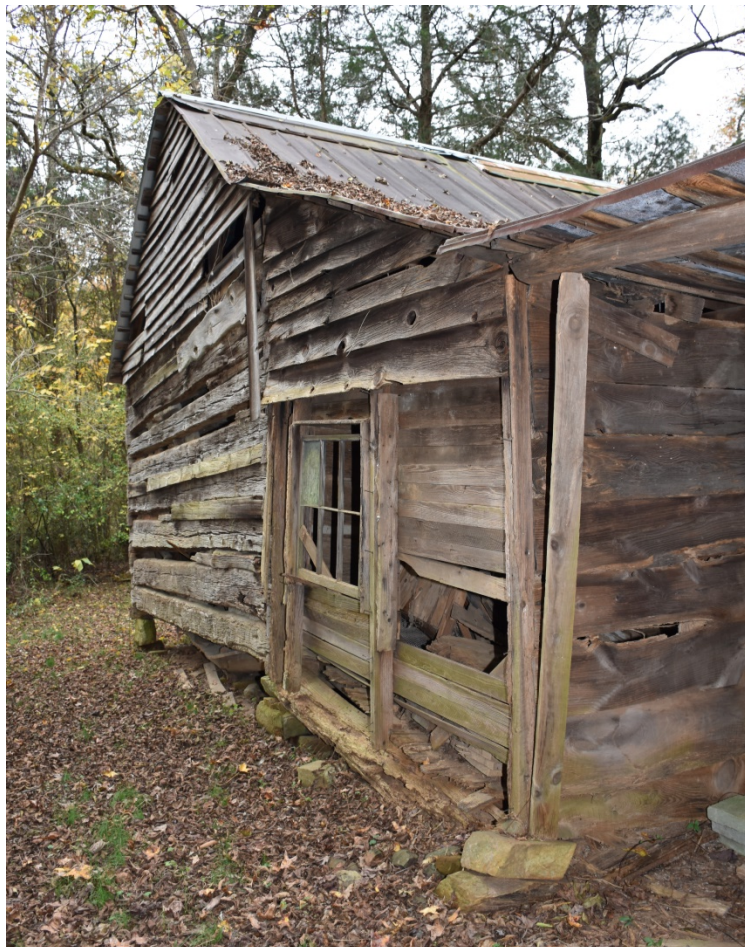
Slave Quarter-Tenant House, northwest oblique (above), and east elevation (below)

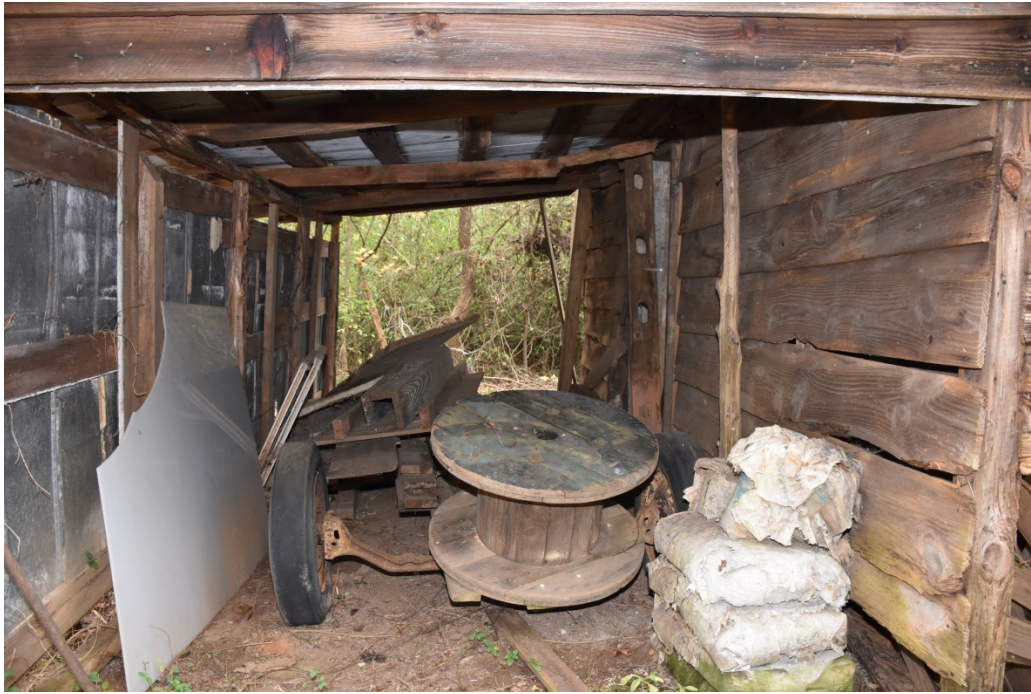
According to James Stafford, the late-nineteenth or early-twentieth-century frame shed addition served as a kitchen.¹¹ Wide boards cover the north wall and portions of the east and west wall. A six-pane wood sash pierces the east elevation's center. The floor joists have collapsed and the floor boards have been removed. Some narrow beaded ceiling boards remain where they have fallen at the room's east end. Matching boards cover portions of the east and north walls. The board-and-batten door at the north elevation's center provides access to the mid-twentieth-century frame equipment shed. The shed's east and west ends are open and the floor is earth. Metal panels sheathe the north elevation.

**Mid-twentieth-century shed addition, looking east (above) and
Late-nineteenth or early-twentieth-century frame shed addition, looking west (below)**

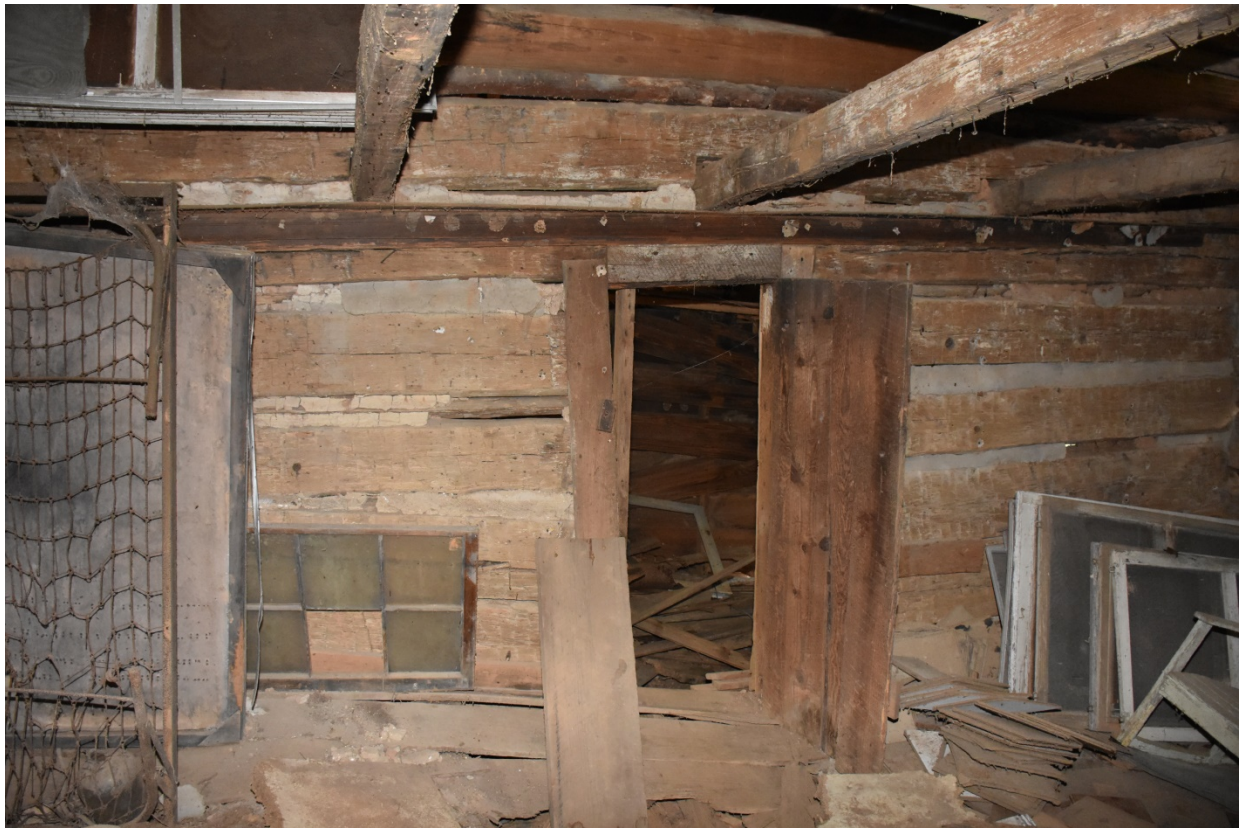
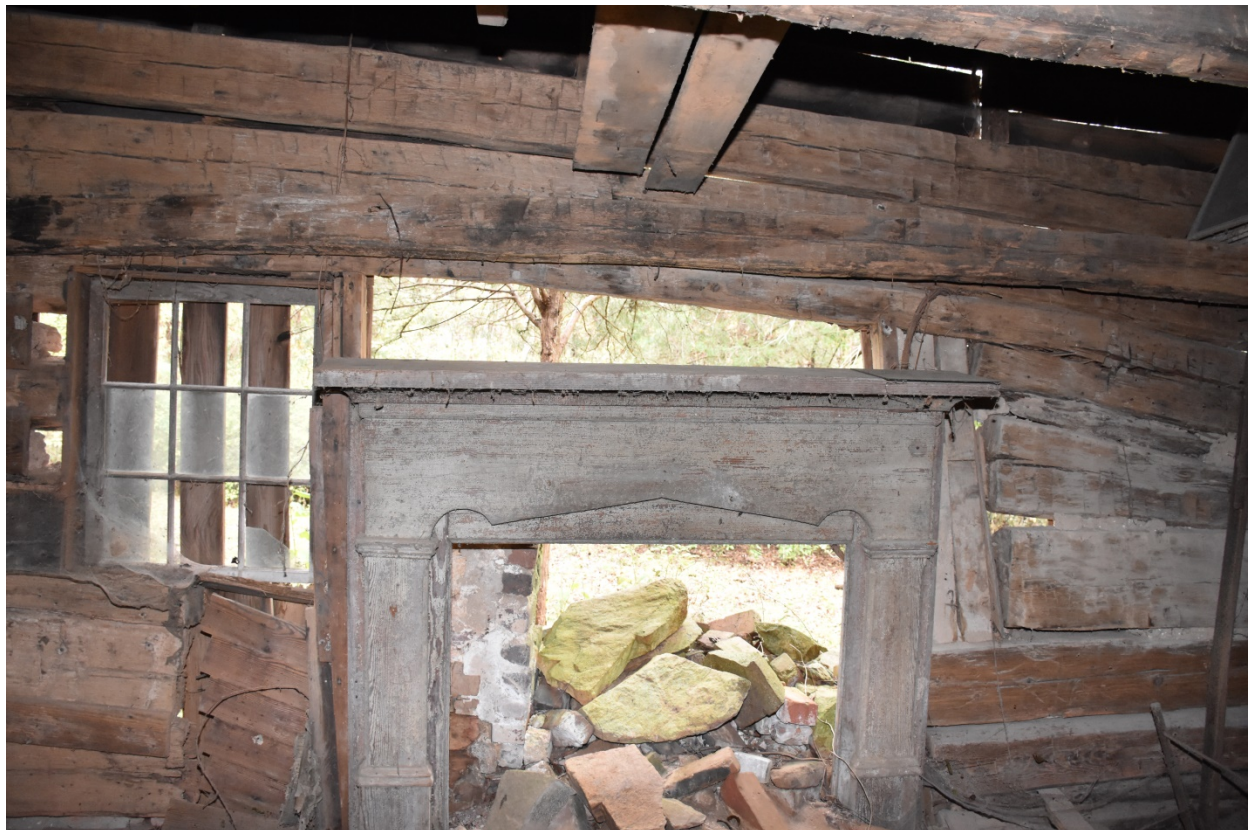
Slave Quarter-Tenant House, north wall (above) and west wall (below)

Two early-nineteenth-century outbuildings remain: the rectangular log building west of the house and the log slave quarter-tenant house in the wooded area northwest of the house. The rectangular hewn-log outbuilding with half dovetail joints is in fragile condition as the roof has collapsed, but portions of the walls remain. The one-story, side-gable-roofed, hewn-log slave quarter-tenant house with half dovetail joints is one of only a few identified extant slave quarters in Mecklenburg County. A late-nineteenth-century frame shed addition and mid-twentieth-century frame equipment shed extend from the one-room dwelling's north elevation. Weatherboards sheathe the gable ends. The building rests on stone piers. Although the dwelling is in deteriorated condition, three board-and-batten doors, one nine-pane and one six-pane wood sash, and some log joists and wide floor boards remain. The painted mid-nineteenth-century post-and-lintel mantel, which is much more elaborate than mantels typically found

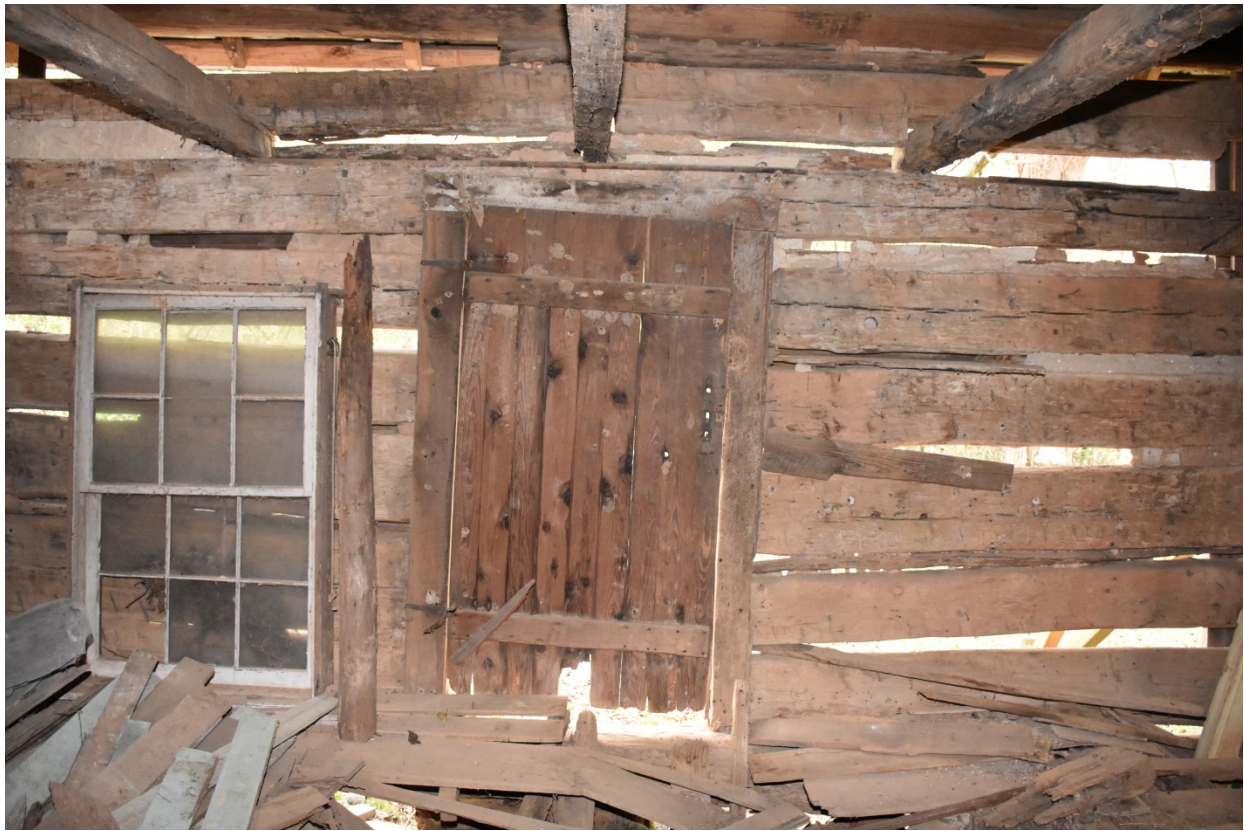
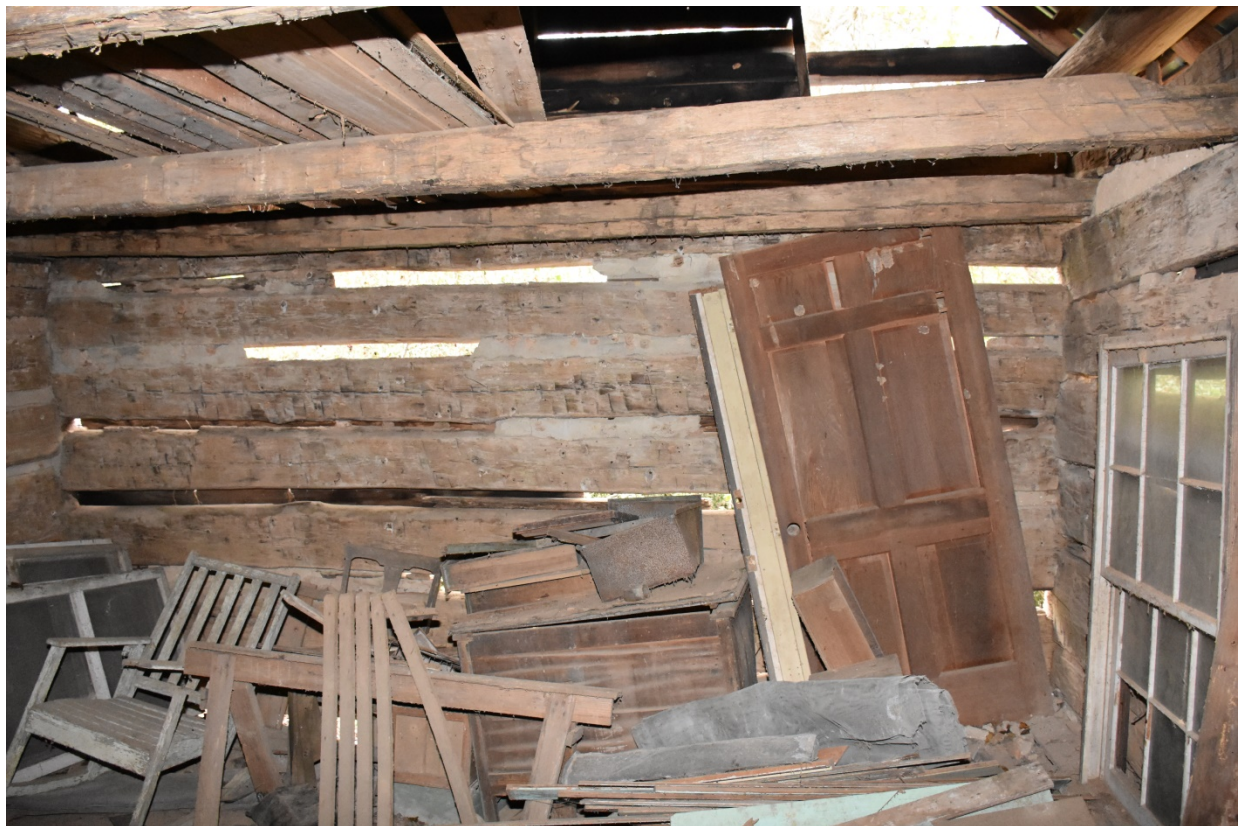
Slave Quarter-Tenant House, south wall (above) and east wall (below)
