AN ORDINANCE ORDERING THE DEMOLITION AND REMOVAL OF THE DWELLING AT 2000 PURSER DRIVE PURSUANT TO THE HOUSING CODE OF THE CITY OF CHARLOTTE AND ARTICLE 19, PART 6, CHAPTER 160A OF THE GENERAL STATUTES OF NORTH CAROLINA, SAID BUILDING BEING THE PROPERTY OF RBP INVESTMENTS, LLC PO BOX 11113 CHARLOTE, NC 28220.

2000 Purser Drive

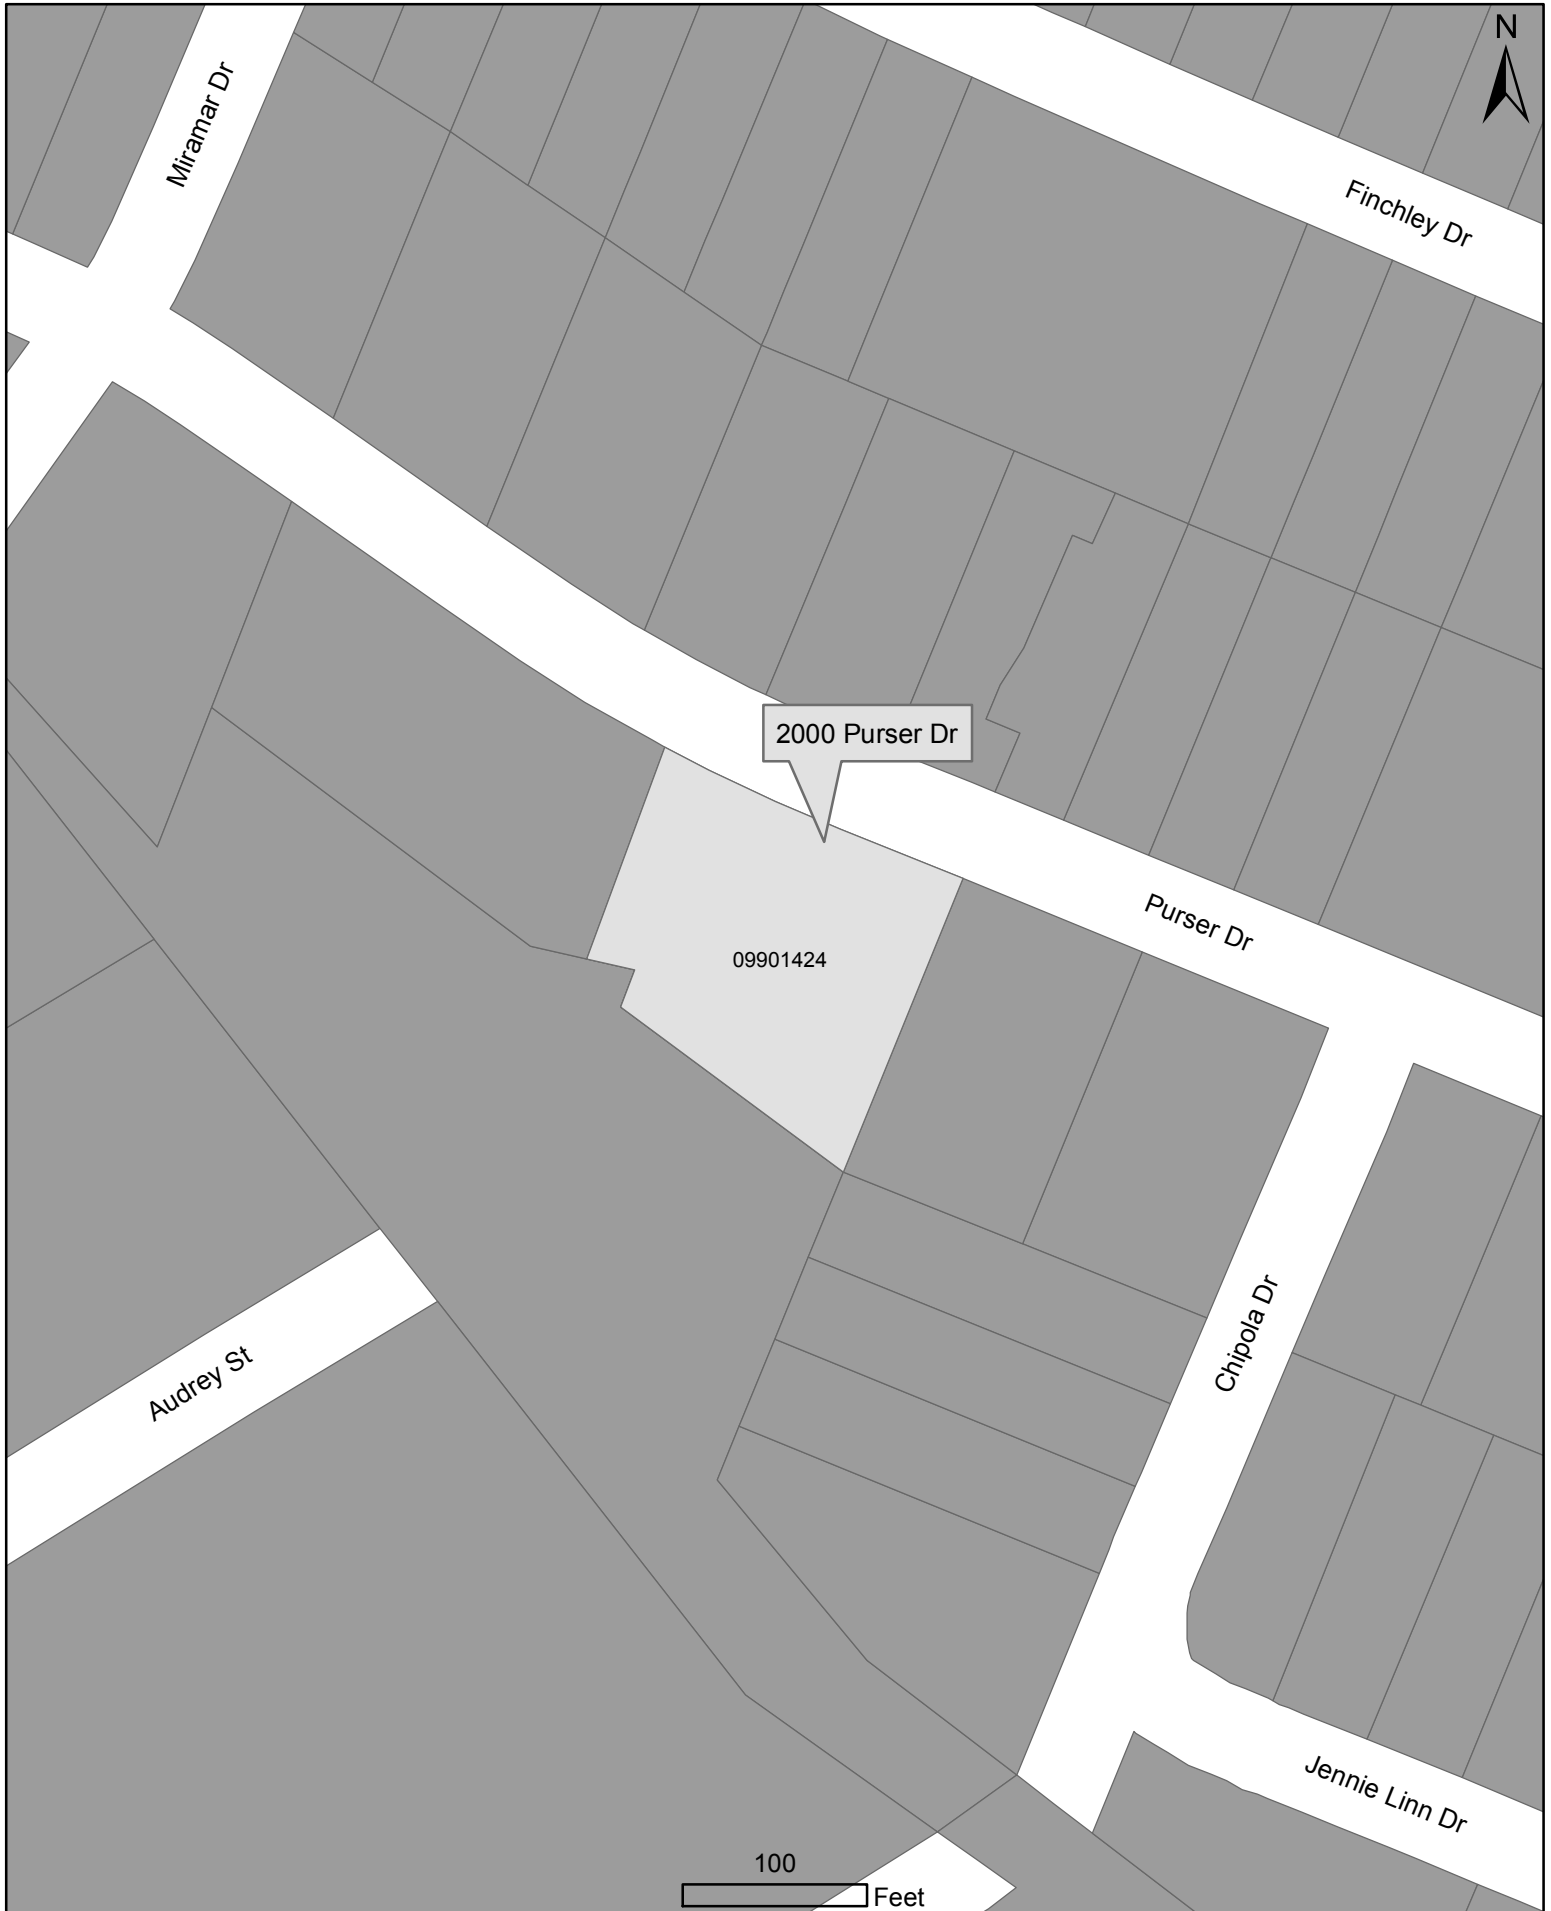
- City rehab costs analysis shows that rehabilitation is not feasible because the cost is prohibitive.
- New construction analysis shows that new construction is not feasible because the cost is prohibitive.
- Violations include: Structural, electrical, plumbing and heating violations. Holes in walls and ceiling covering. Multiple broken window glass. Missing smoke and carbon monoxide detectors. Utility room areas of roof sheathing not structurally sound, roof covering loose/damaged. Sections of electrical wiring missing/cut. Missing plumbing fixtures. Heating equipment not present.
- The building is 66 years old and consists of 1,227 square feet total.
- A new 1,227 sq. ft. structure can be built for \$84,663.

Demolition is recommended because:
