Highland Park Mill No. 1, Charlotte
Survey and Research Report

Prepared for the Charlotte-Mecklenburg Historic Landmarks Commission
by Heather Fearnbach, Fearnbach History Services, Inc.

October 2017

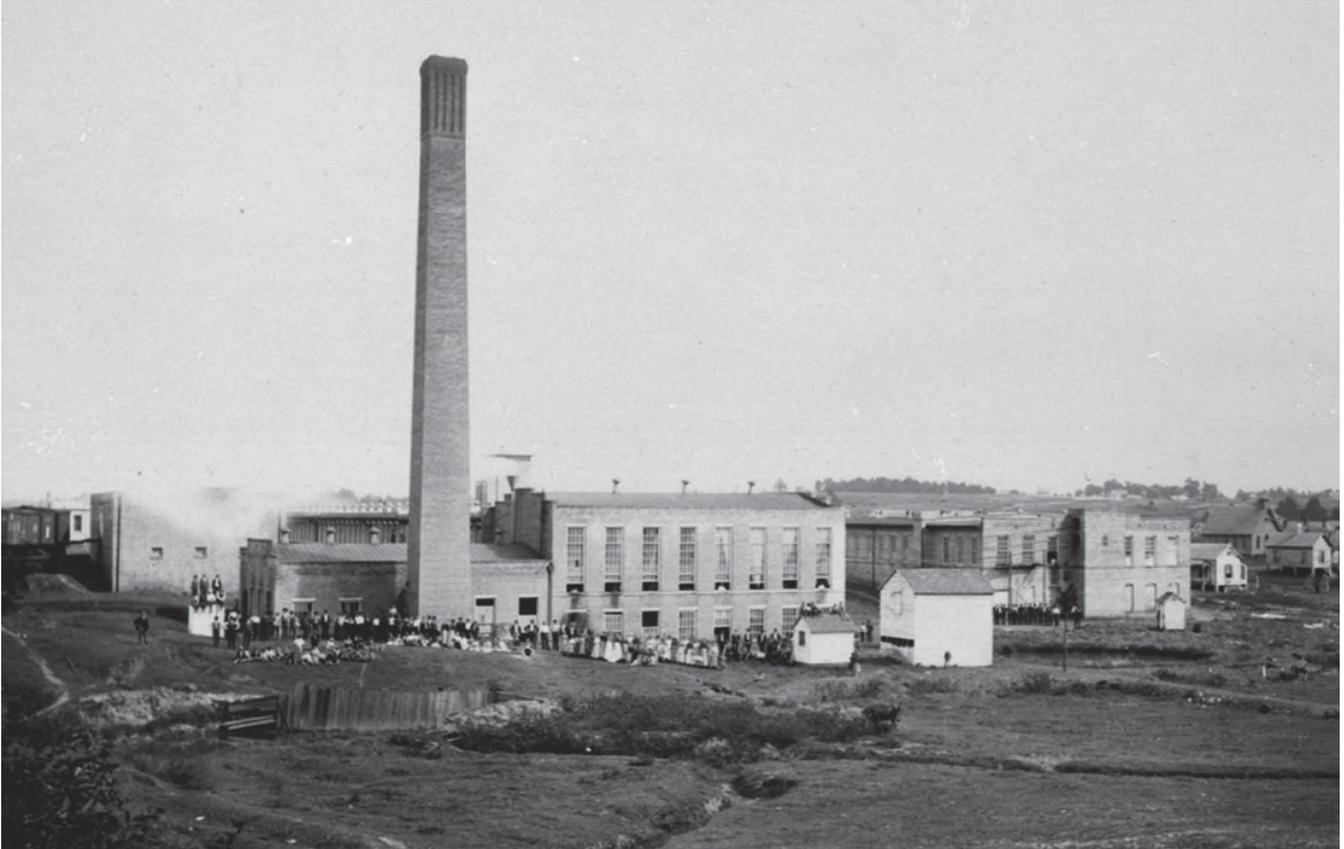
*South elevation, undated photograph from the Mary Lois Moore Yandle Collection,
Charlotte Mecklenburg Library, Robinson-Spangler Carolina Room*

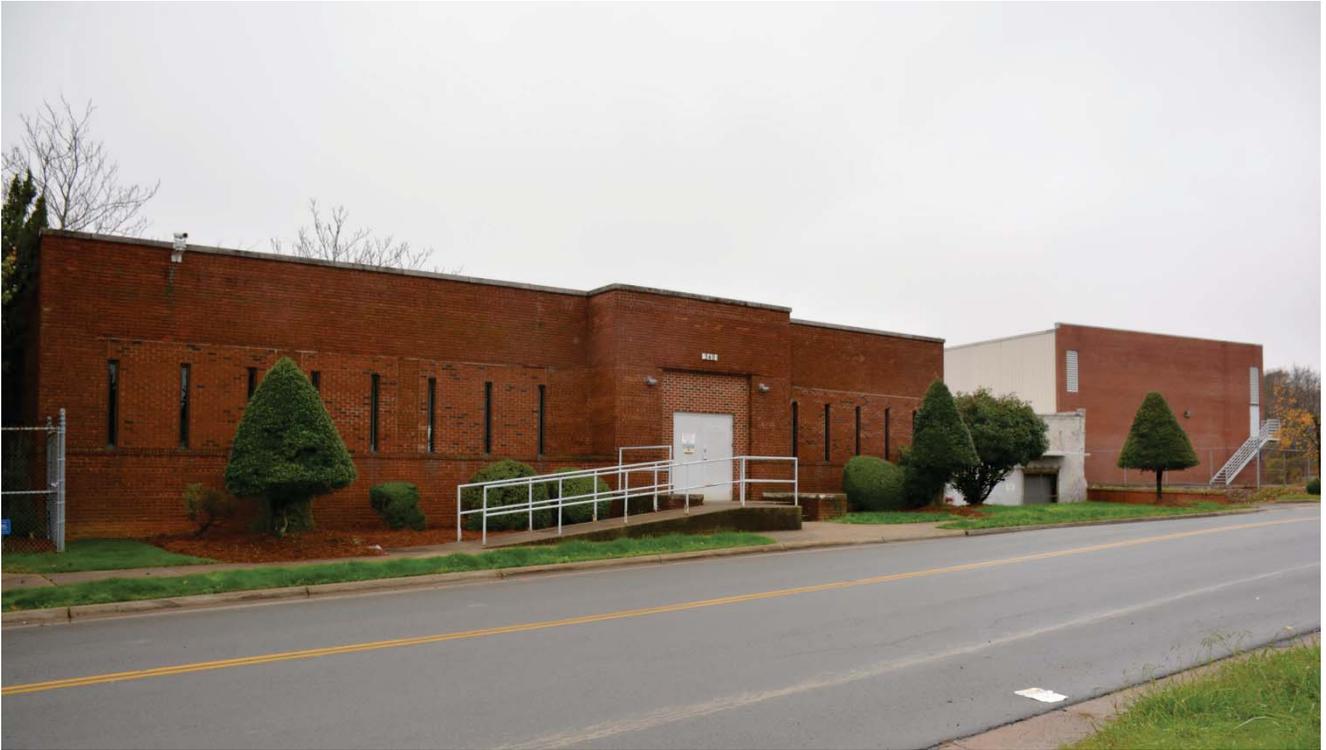
North elevation, looking west from ca. 1950-1953 office (2015)

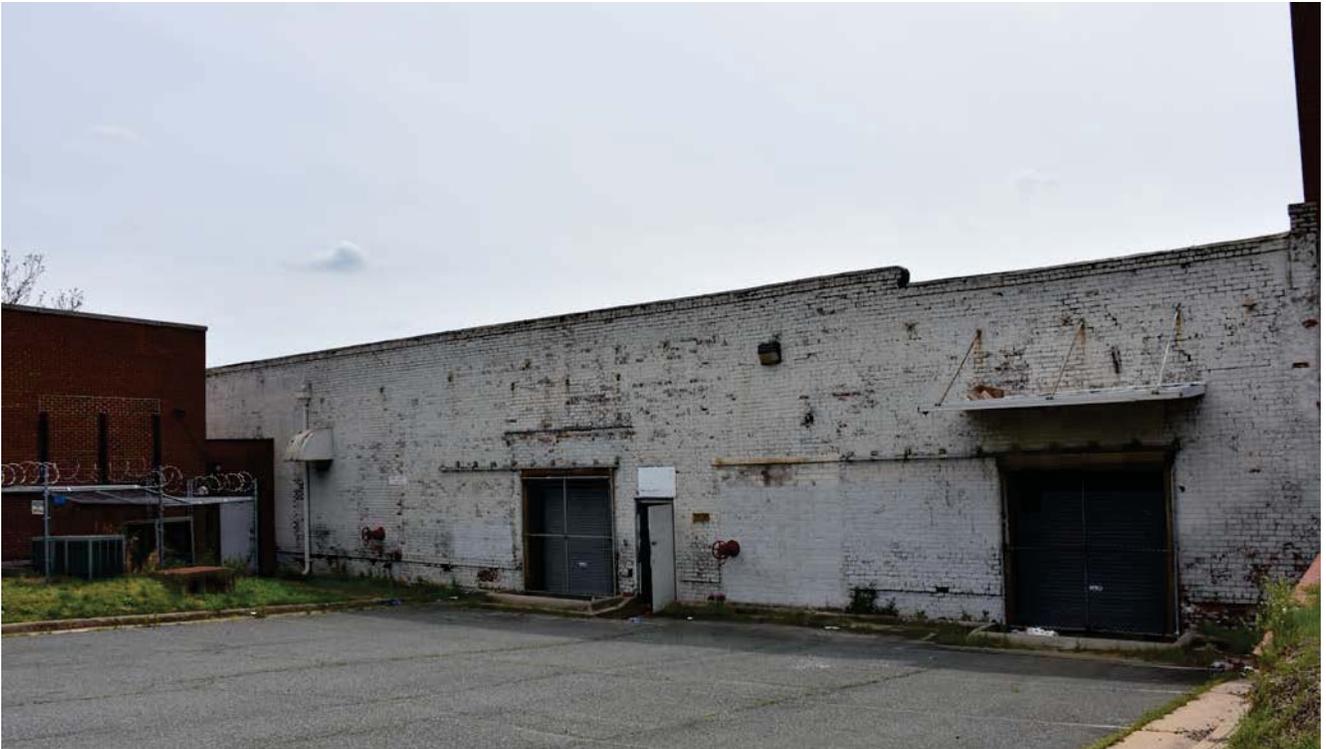
North elevation, 1891 mill (2017)

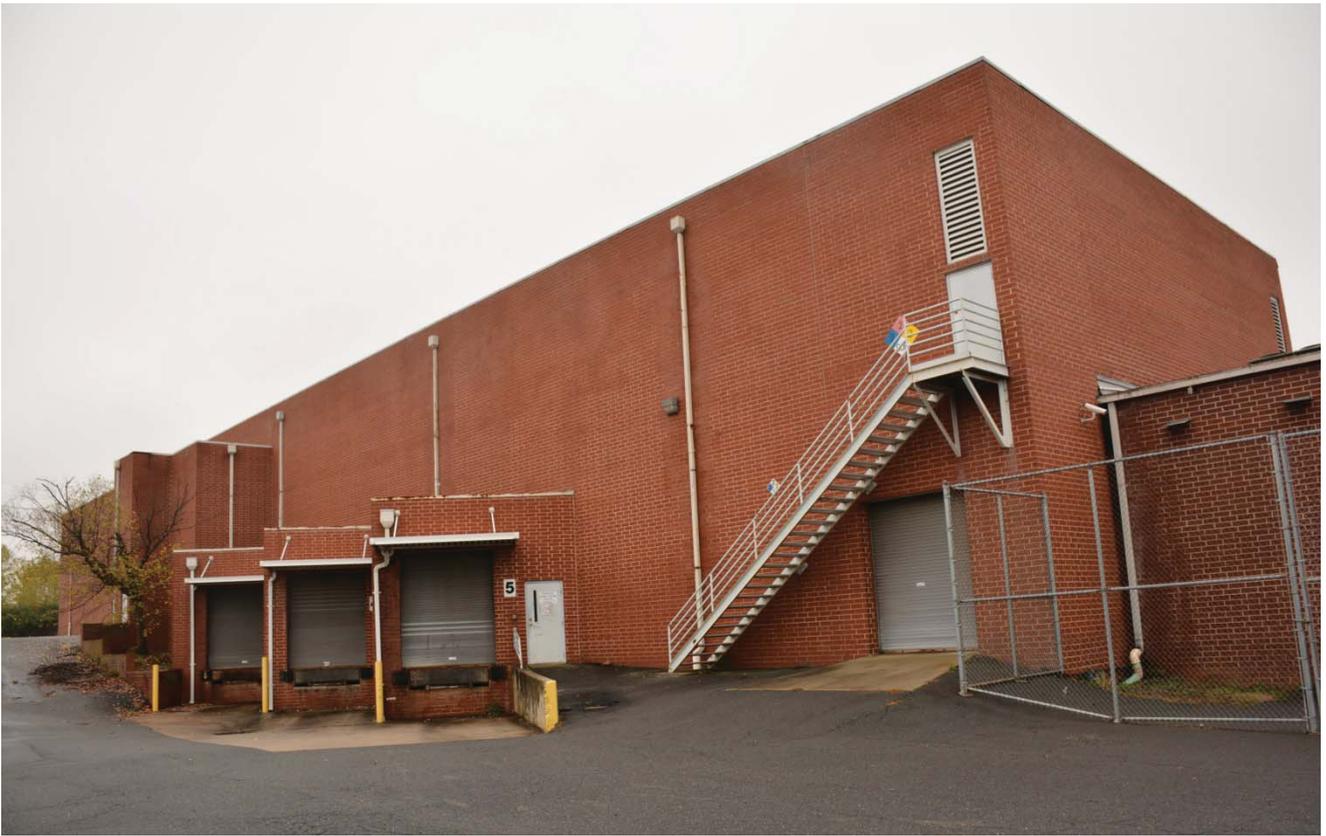
West elevation, 1989 addition, looking north (2015)

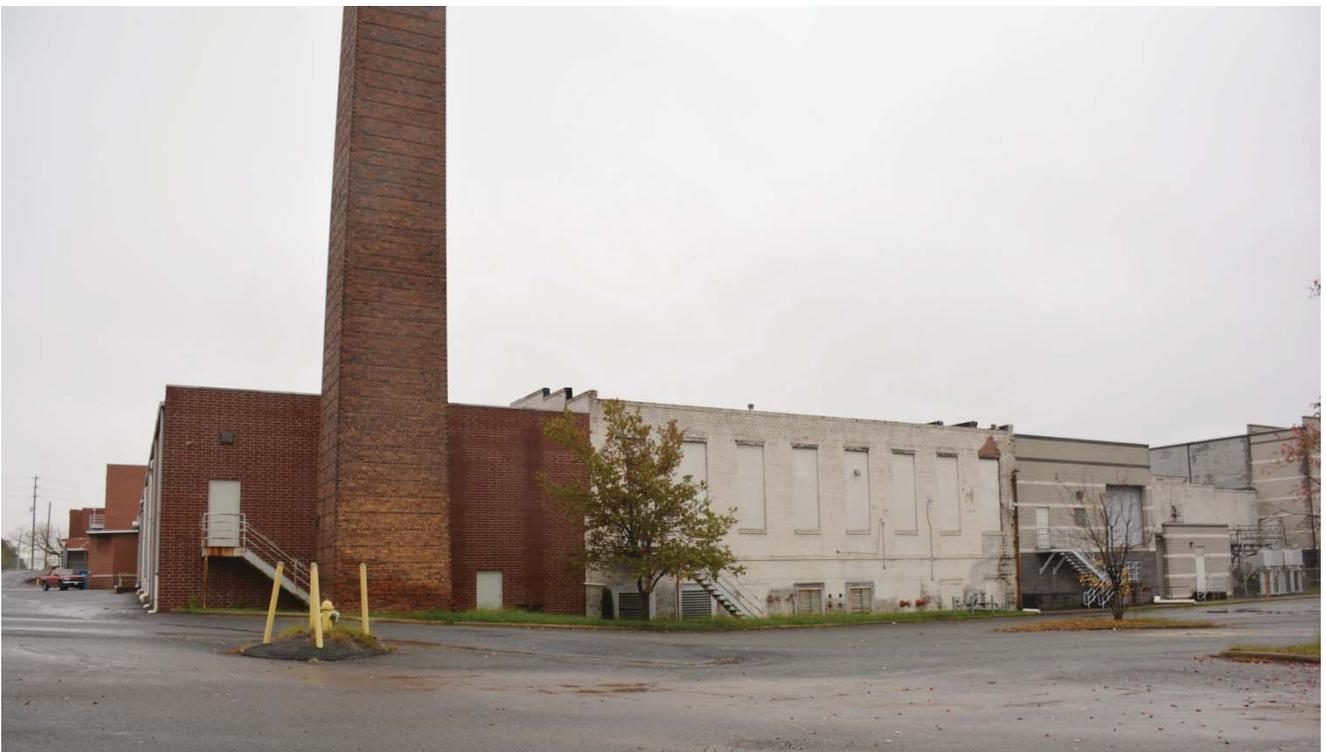
South elevation, from left to right: 1987 addition, 1895 addition, 1992 additions, 1895 spinning mill (2015)

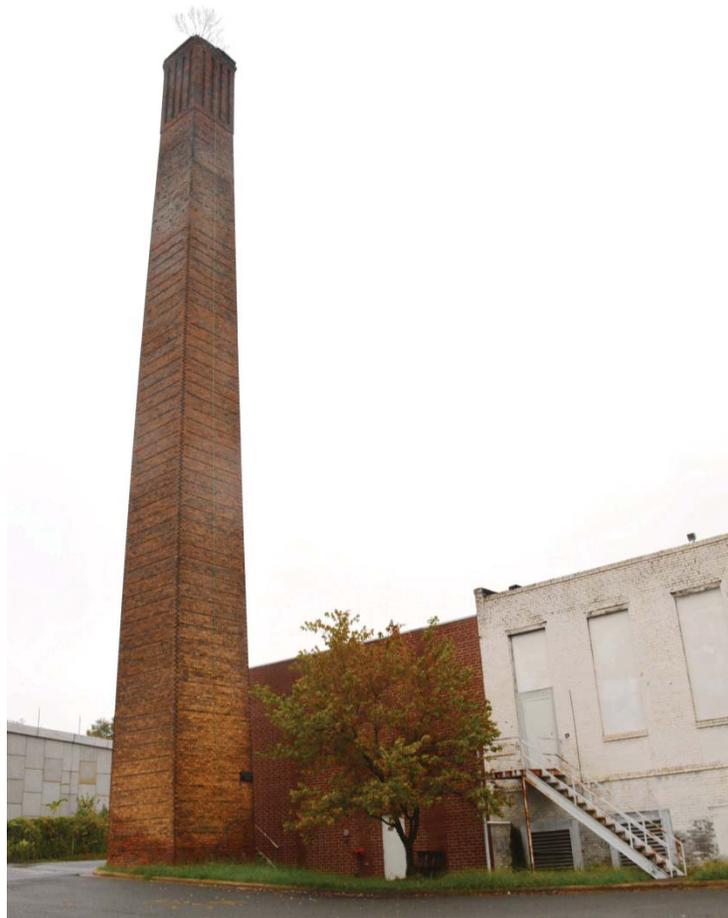
1895 smokestack (2015)

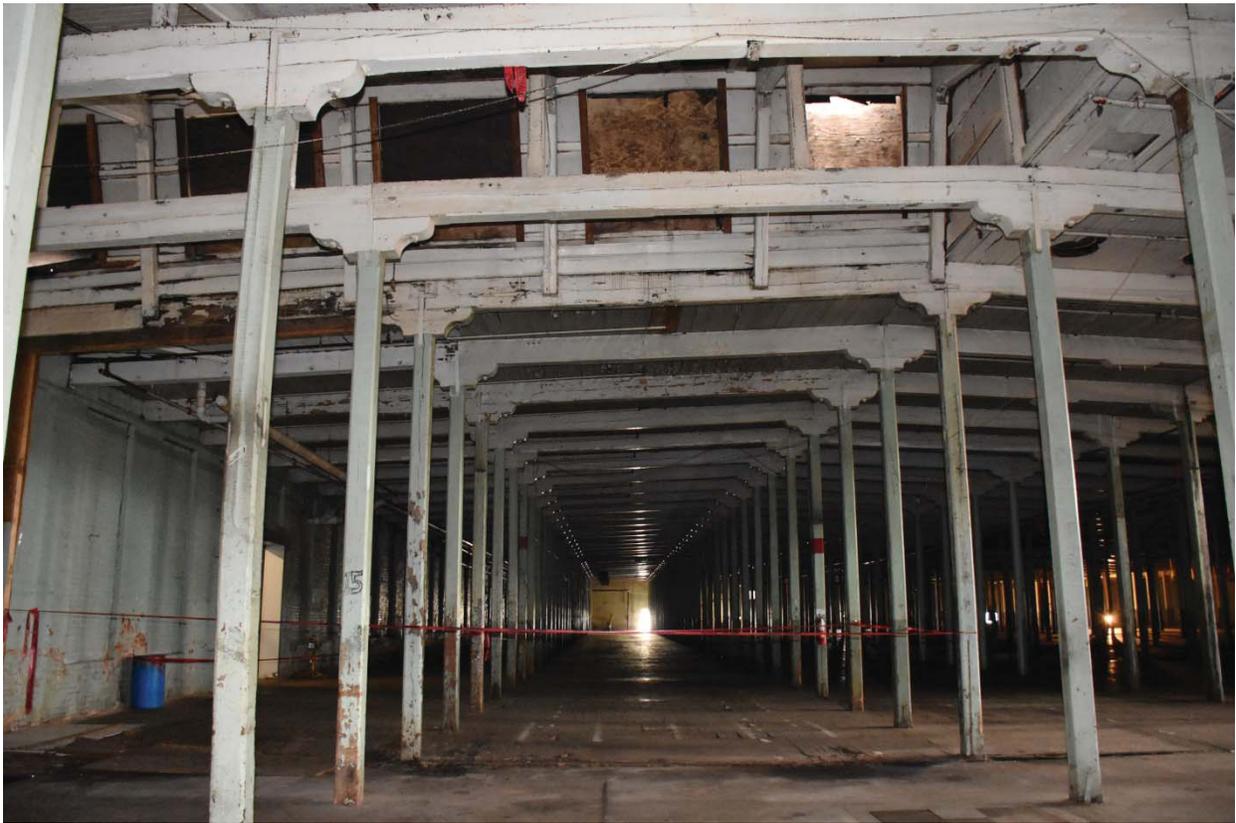
1891 mill, looking north (2017)

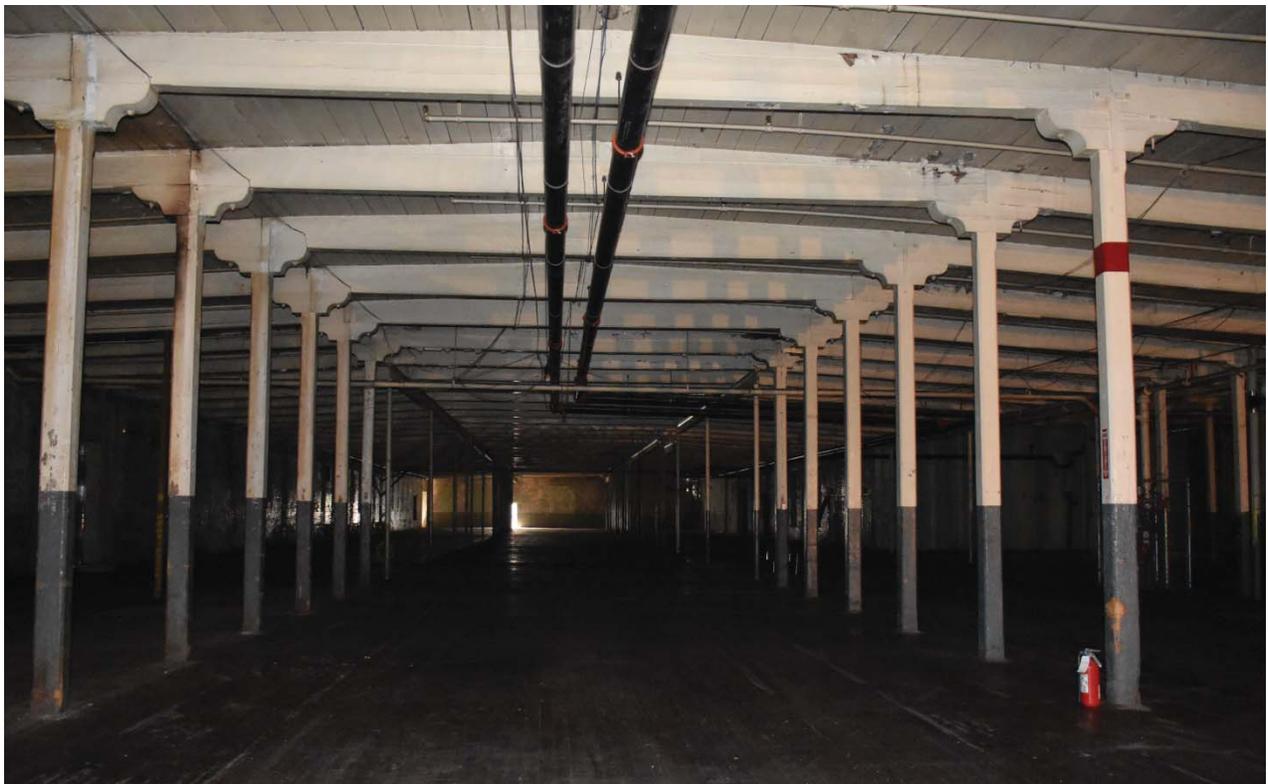
1912 addition, looking south into 1895 spinning mill (2017)

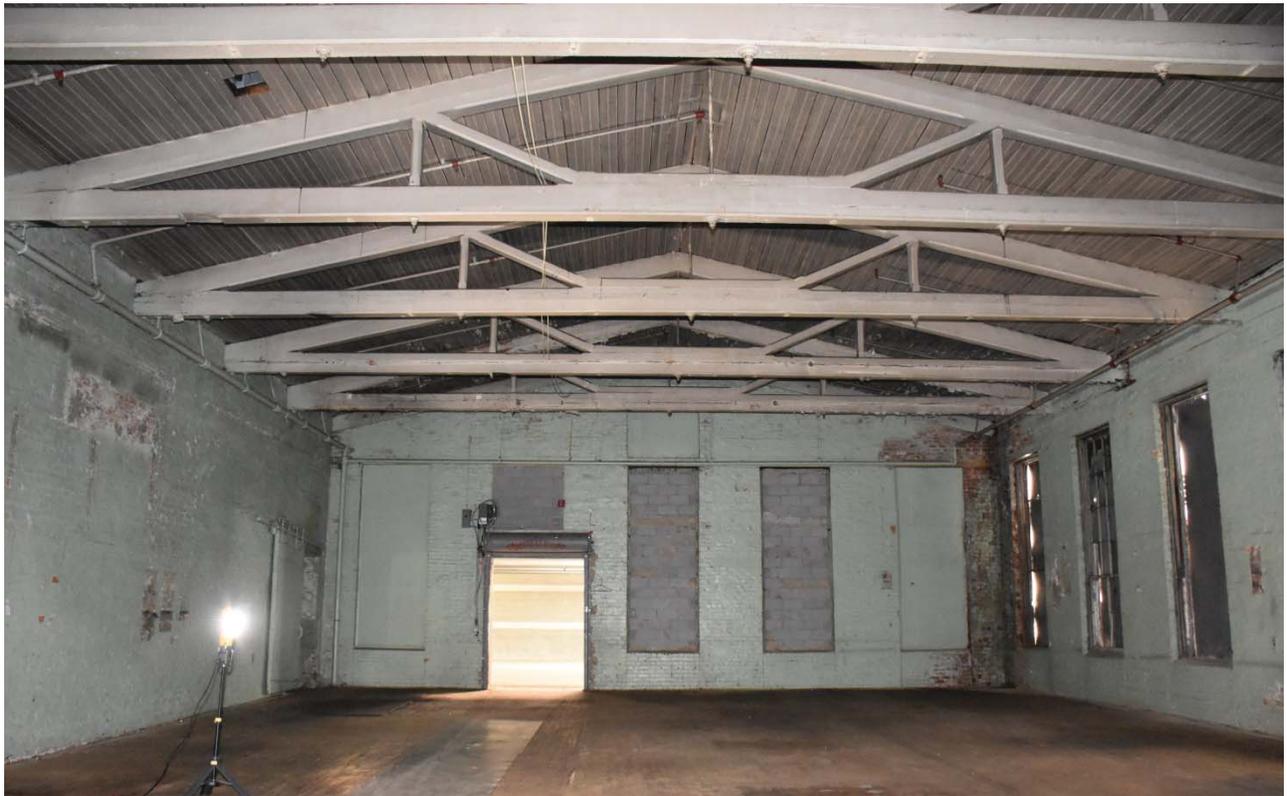
1895 addition, machine shop, looking east (2017)

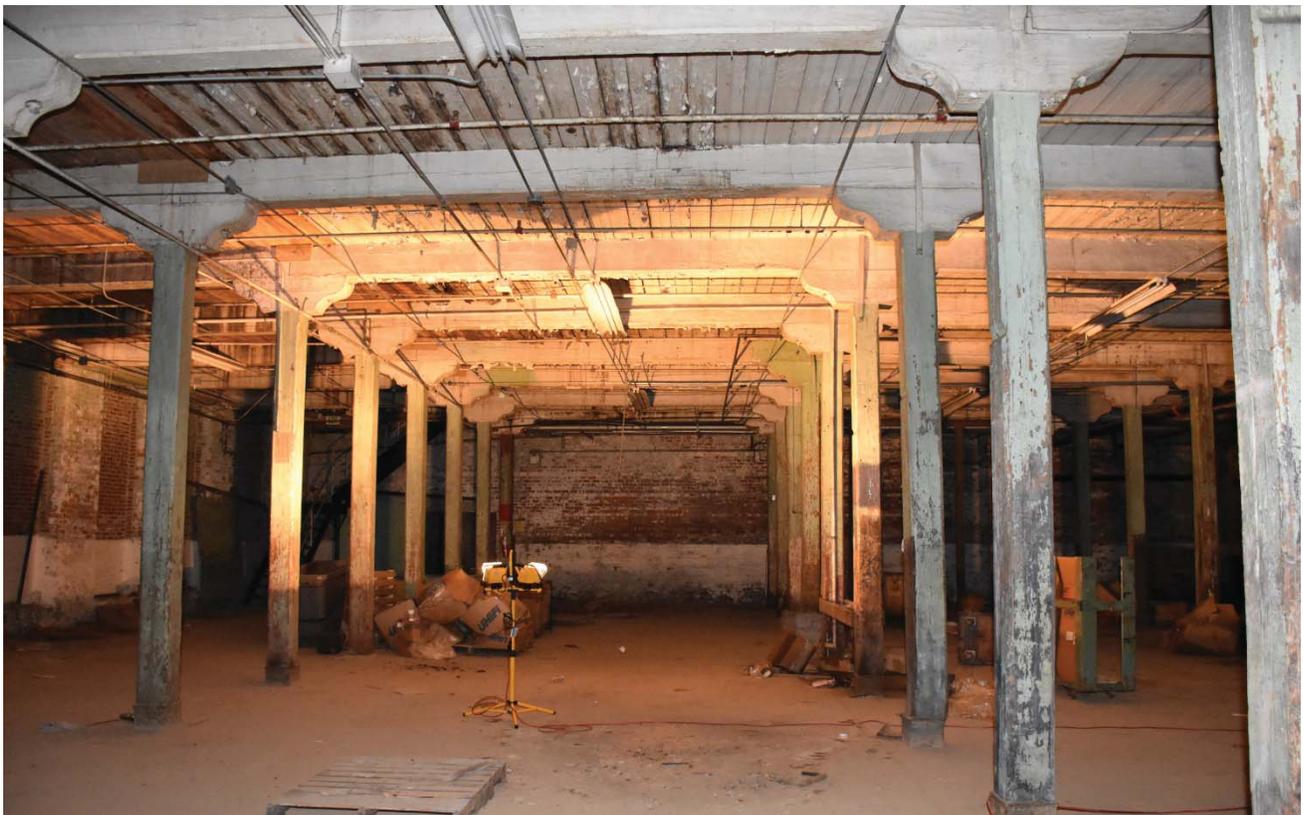
1895 addition basement, dye house, looking north (2017)

poured-concrete floor. Metal-clad kalamein doors, corrugated-metal roll-up doors, and single-leaf steel doors secure entrances. The upper eight-pane sash are fixed in three window openings on the dye house's east elevation, as well as four window openings on the engine room's east elevation and the easternmost bay of its south elevation. Portions of the eight-over-eight sash remain in the sixth bay from the west end. The third bay contains the most intact basement window, but the upper sash is damaged. All sash are in poor condition.

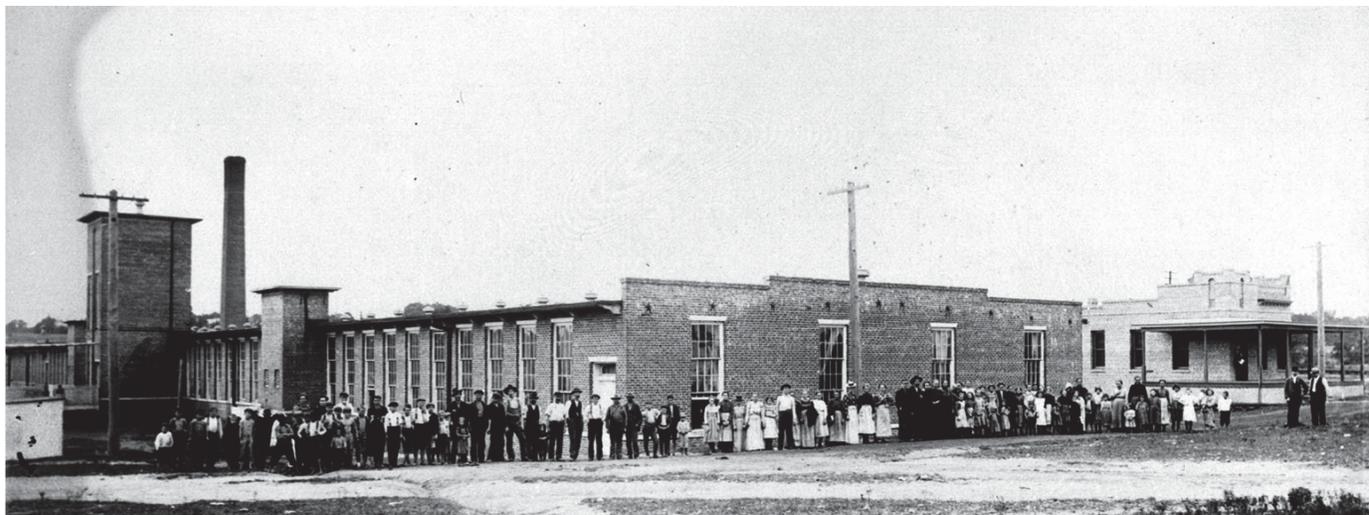
North elevation, 1891 mill, undated photograph from the Mary Lois Moore Yandle Collection, Charlotte Mecklenburg Library, Robinson-Spangler Carolina Room

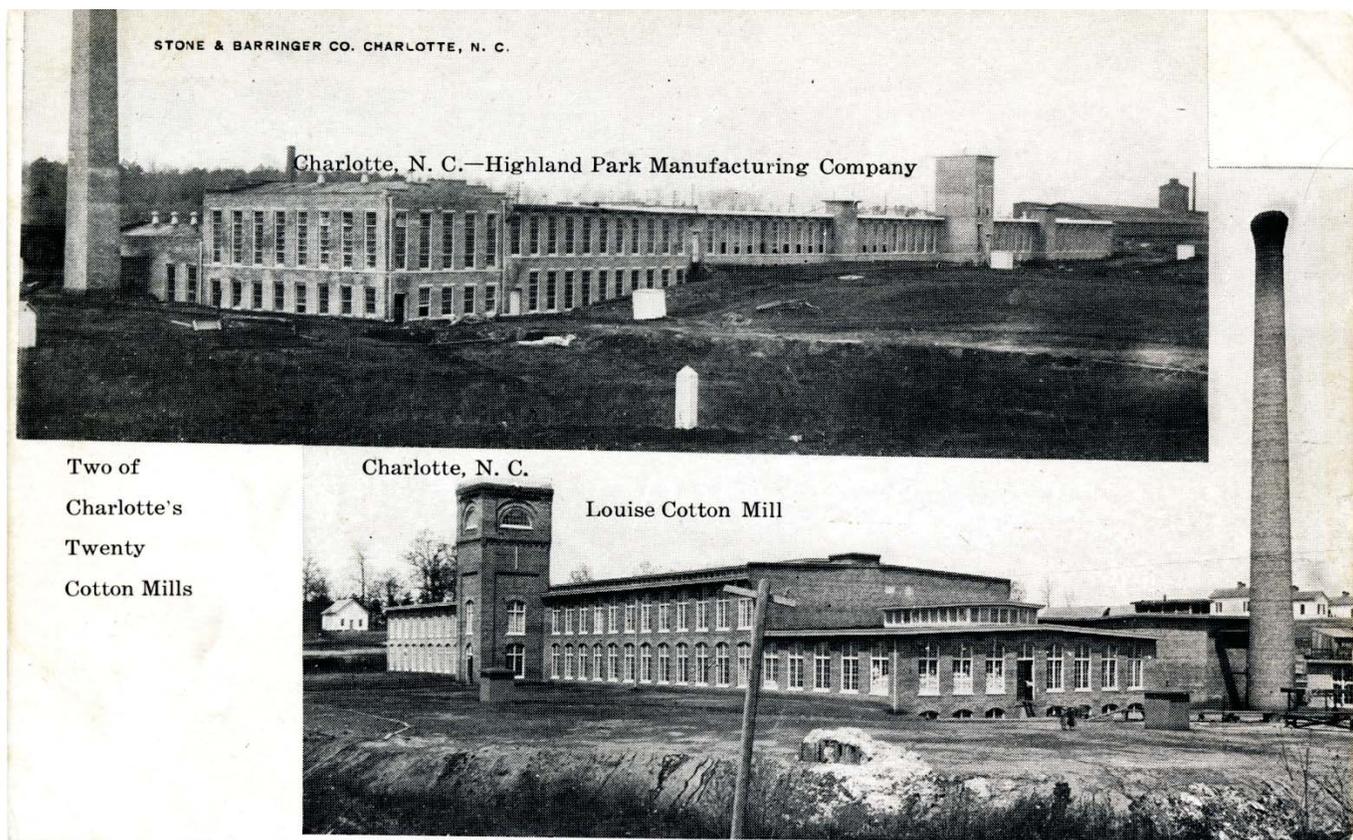
1891/1895 mill, southeast oblique, undated postcard from the Mary Boyer Collection, J. Murrey Atkins Library, University of North Carolina at Charlotte
